THE INFLUENCE OF HUMAN ACTIVITY OVER THE ROTOPĂNEȘTI-RĂDĂȘENI-FÂNTÂNA MARE DRAINAGE SYSTEM NETWORK

Oprea RADU¹

Abstract

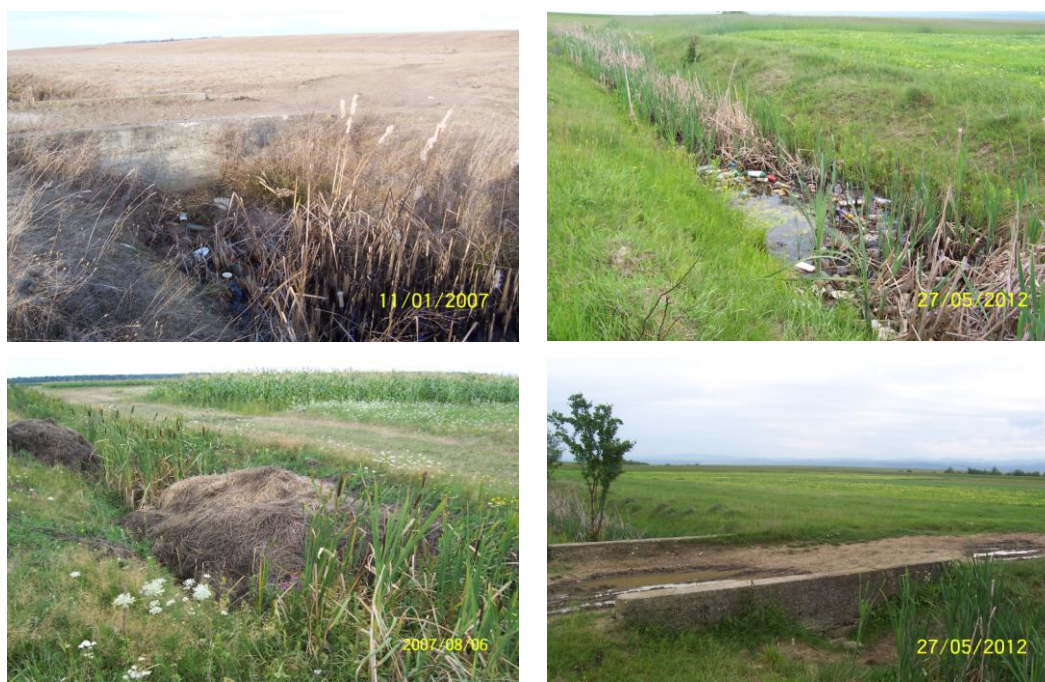
The 1 m diameter culvert located 2100 m from the upstream end of the ring canal CC₁ presents a blocked section due to household residue deposits and of various nearby packaging materials, to neglected maintenance as well as to inappropriate use of the areas surrounding this section of the canal, having been used as pasture since 1992 (*fig. 2*).

Figure 2 **Clogged culvert showing vegetal and household residue within the canals**

Grazing throughout the section of the canal and throughout the times when the soil is saturated with water, repeated animal crossing through unequipped areas have caused an effect of shore erosion and canal clogging which lead to canal's geometric and hydraulic components alteration.

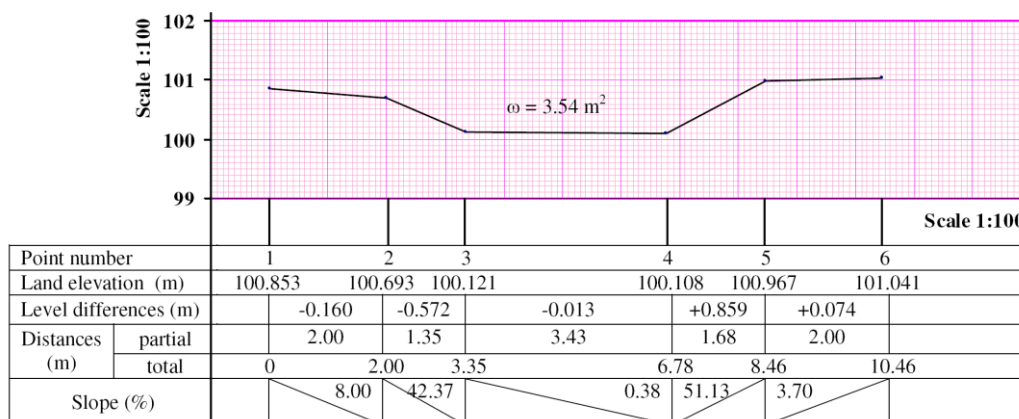
The transversal profiles made every 25 m along the CC₁ ring canal on a 100 m length upstream of the blocked culvert show a narrowing

of the canal. The transversal section made 100 m upstream of the blocked culvert (*fig. 3*), highlights shore erosion and canal clogging, which led to light channel enlargement from 5.10 m (Radu O., 2012), to 6.46 m, also to the enlargement of the canal's bottom width from 0.60 m to 3.43 m and to the reduction in depth from 1.80 m to 0.86 m, and to a section narrowing from 5.13 m² la 3.54 m².

Figure 3 **Transversal section through CC₁ canal 100 m upstream from the blocked culvert**

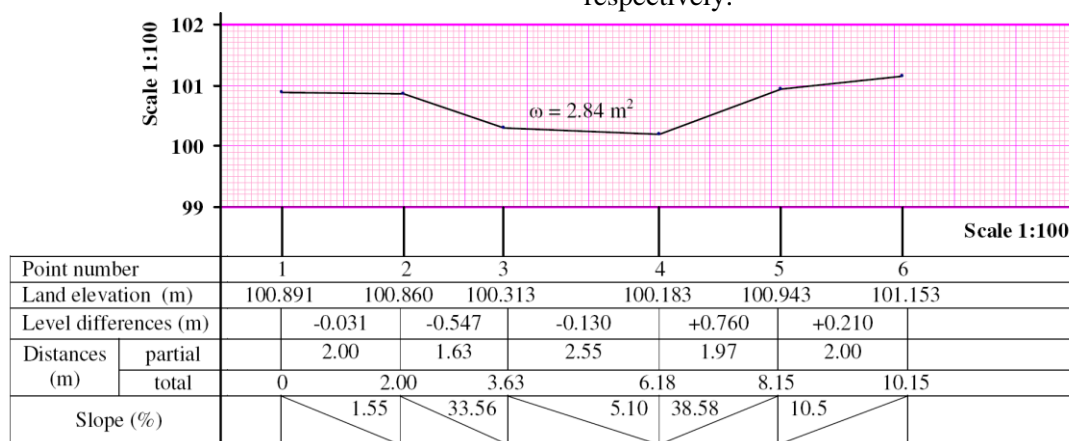
Due to vegetal and household residue deposits as well as to silt depositing near the culvert, at the time when the latter was still operational, the flowing section measured beside the culvert in the upstream is lesser than that recorded at 100 m and it measures 2.84 m^2 (fig. 4).

Figure 4 Transversal section through the CC₁ canal, upstream, beside the blocked culvert

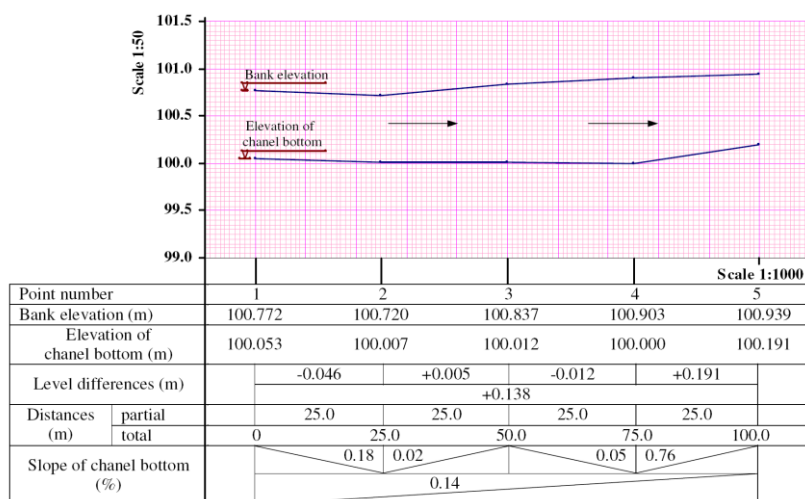
The obstruction in the culvert's section also caused the longitudinal slope of the canal to change, as fig. 5 is showing. By analyzing fig. 5 one notes different values in the canal longitudinal slope in different sections and the creation of counter-slopes from between 0.02% to 0.76% respectively.

Figure 5 Longitudinal section on the CC₁ canal, upstream of the culvert

Throughout the 100 m studied section of the canal, a 0.14% counter-slope is always present, which causes, during periods of heavy rain, as well as at the snow melt, the water to flow towards the

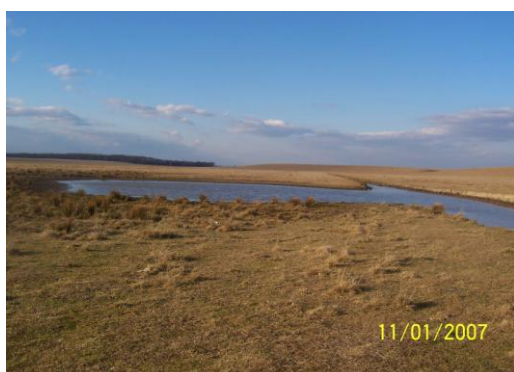
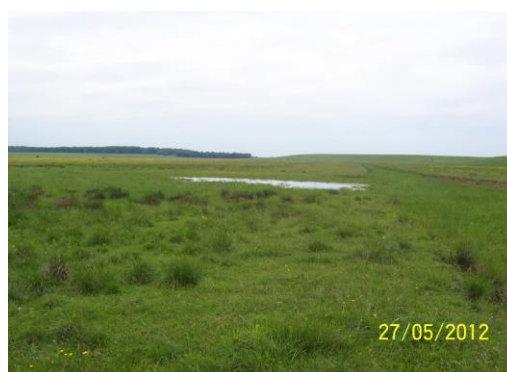
upstream end of the CC₁ canal, overflowing at approx 250 m upstream of the blocked culvert, where a pond was thus formed (fig. 6).

Figure 6 Water overflowing the canal and the subsequently formed pond

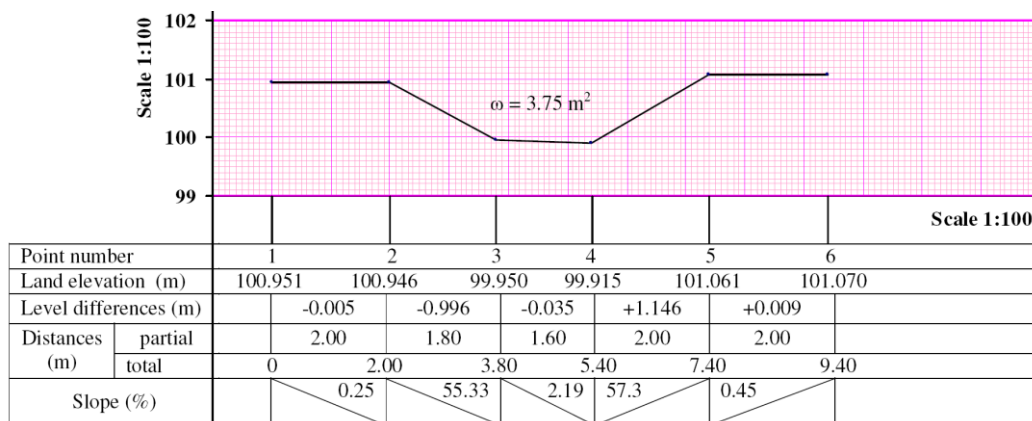
Within the transversal profile made beside the culver and downstream (*fig. 7*), the section flow of 3.75 m^2 is larger by approx 1 m^2 than the value recorded at the section upstream of the culvert. The narrowing in section flow at this point is due to vegetal and household depositing beside the culvert.

The bottom of the canal elevation is lesser downstream by some 35 cm than that of the upstream bottom elevation, the downstream section of the canal not being altogether clogged.

Figure 7 Transversal section through the CC₁ canal, downstream, nearby the clogged culvert

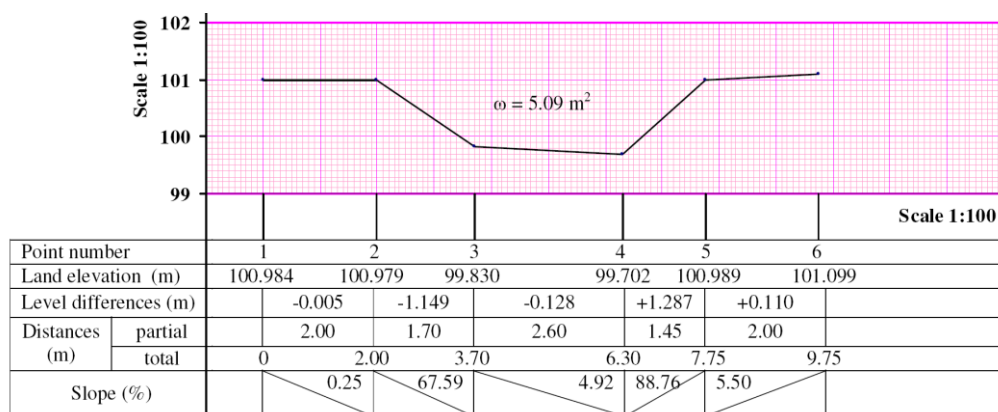
100 m downstream of the clogged culvert the section flow of 5.09 m^2 , decreasing downstream (*fig. 8*).

Figure 8 Transversal section through the CC₁ canal, downstream, 100 m from the clogged culvert

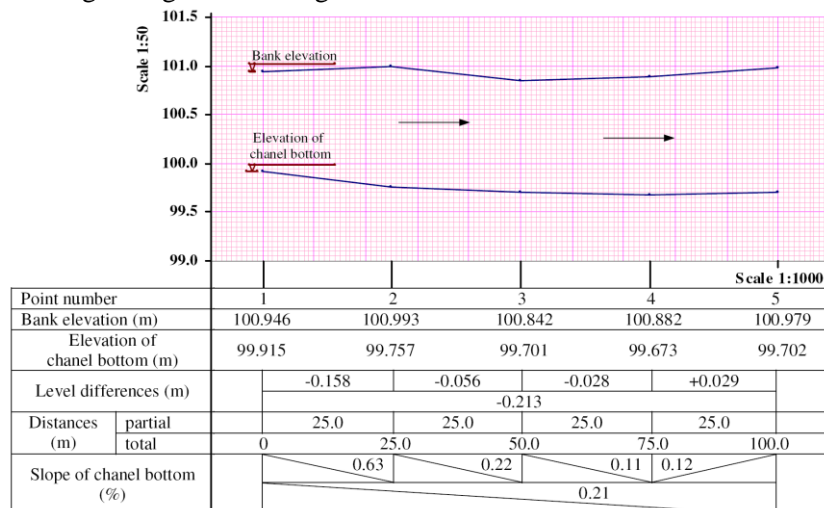
Analyzing the longitudinal profile made on the 100 m section, upstream of the culvert (*fig. 9*), we notice that here as well a counter-slope has been formed, due to neglecting of mowing the

Figure 9 Longitudinal section on the CC₁ canal, upstream of the culvert

On the overall 100 m control section there's always a 0.21% longitudinal slope in place, fact that maintains the water flow and evacuation in the Șomuzel main collecting canal.

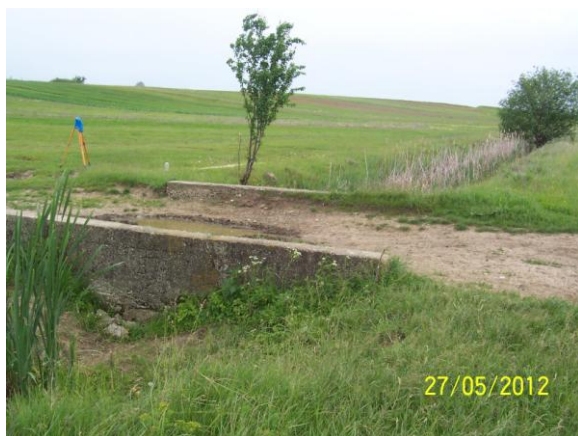
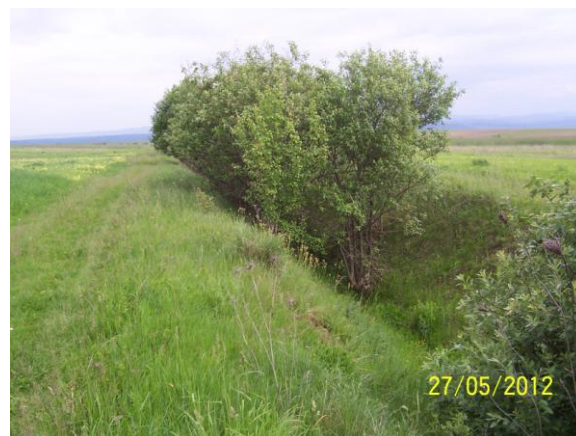
grass, to the appearance of hydrophilic vegetation and of shrubs that hinder the water flow and favors silt sedimentation (*fig. 10*).

Figure 10 **Hydrophilic vegetation and of shrubs on the canal**
