THE REHABILITATION OF PIPE NETWORK FROM SPRINKLER IRRIGATION PLOTS

Mihail LUCA¹, Alexandru-Lucian LUCA², Nicolae MARCOIE¹ Ilie LOGIGAN¹

Abstract

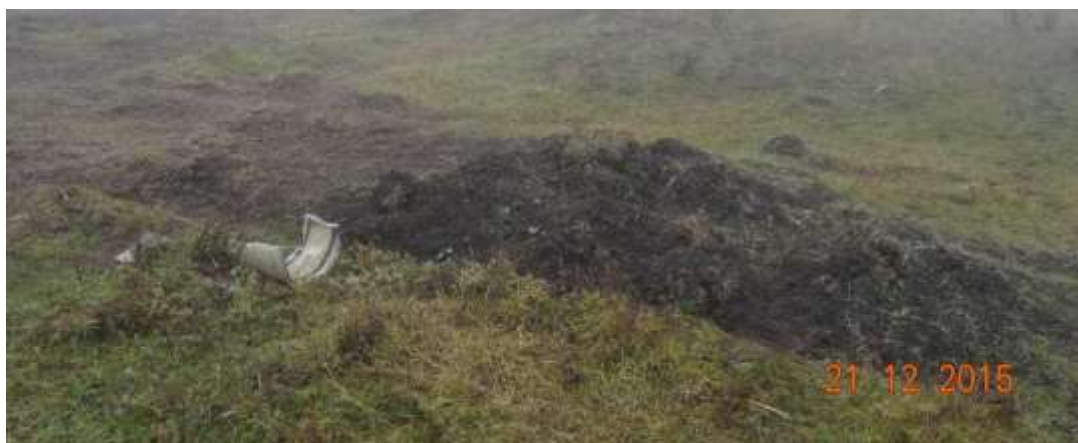
Figure 3 Detail on the state of pipe sections made of asbestos tubes (damage to joints, tube breaks) (Luca M., 2016)

- tertiary irrigation lines with serial connected pipe sections are degraded and the material is aged; the bursting percentage of asbestos pipes is high in the current state (*figure 3, 4, 6*);
- irrigation hydrants are worn out, have a high percentage of damage and do not allow the connection of modern watering equipments;
- simple and reinforced concrete chambers have degraded structural components, with internal infiltrations, uncovered plasterings, cracks in the wall, absence of covers, etc.;
- the hydraulic installation used for hydraulic shock protection is not complete or is missing;

a. Replacement of sections from tertiary irrigation pipes (degraded sections are replaced, and those with good structural condition are preserved). The materials used must be mechanically and hydraulically viable for the irrigation plot (steel, HDPE, ductile iron, etc.). The materials used must allow quick interventions and repairs in case of damage.

b. Total replacement of the tertiary irrigation pipe. This option is more expensive but is

recommended when the piping lifetime has been exceeded and the number of bursts is high during the irrigation season.

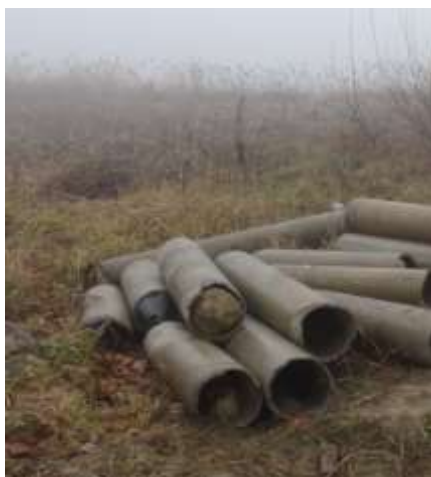
Figure 4 The state of replaced asbestos irrigation pipes (Luca M., 2016)

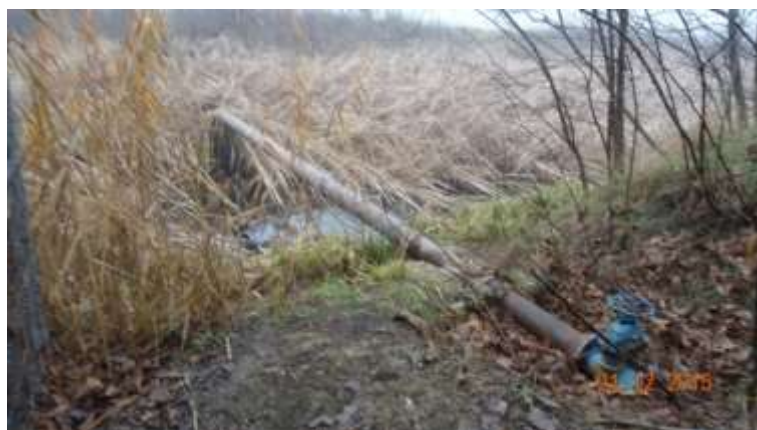
- canal overcrossing pipes are worn out, corroded, show displacements from the original position; anchorage blocks made of simple concrete are structurally degraded, settled, and do not ensure anymore that the pipes are properly supported (*figure 5*);

due to the large quantity of alluviums transported, influences the degree of silting of the distribution pipes, especially on the final sections (*figure 5a*).

Figure 5 View of the structural condition of the supply canal crossing: a – general view of the pipeline location; b – the state of the right bank anchorage block (Luca M., 2016)

a. Preservation of the current pipe section with the rehabilitation of joining fittings and anti corrosive insulation. Verifying and restoring the assemblage slope.

b. Complete restoration of simple concrete anchorage blocks.

c. Installing the ventilation system.

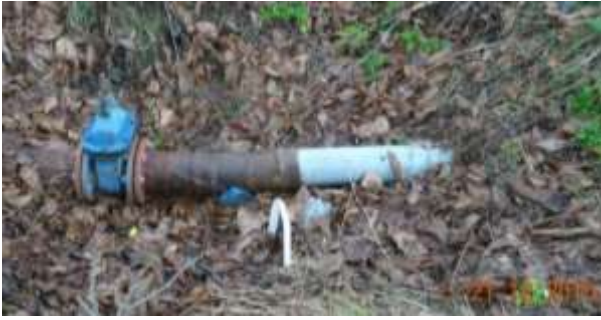
- the tertiary irrigation pipe connection to SPPM has no chamber, a situation in which the hydraulic installation is physically and chemically degraded (*figure 6*);

Figure 6 **State of SPPM connections to tertiary irrigation pipe**

a. Rehabilitation of the constructive structure through structural restoration of the construction or replacement of the chamber with a new one.

b. Rehabilitation of the hydraulic installation through complete replacement of the pipes, fittings and fixtures used for bypass and control.
