STUDIES REGARDING THE SAFETY IN OPERATION OF THE NEGRENI RESERVOIR, BOTOȘANI COUNTY, ROMANIA

Abstract

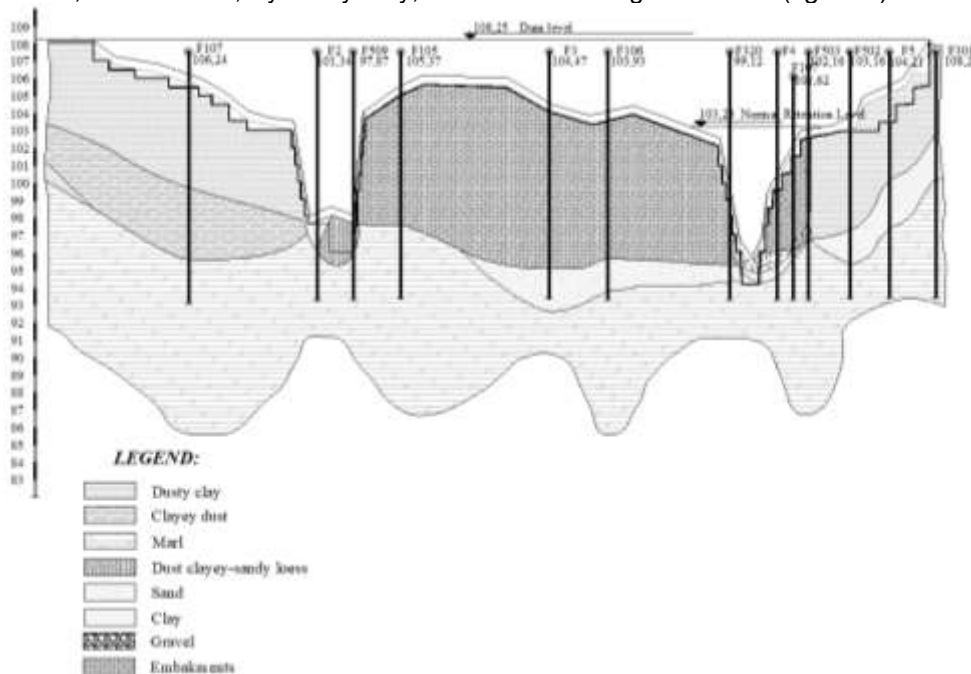
Figure 2 – Longitudinal view of the geological stratification for the dam foundation

The site of the Negreni reservoir is a part of the Moldavian Platform, which is characterized by uniformity of deposits that compose it. The foundation is mainly made of marl with great consistency, at a depth of more than 9.0 m. The foundation is covered, in the basin, by dusty clay,

The hydrostatic level of groundwater with free level in the storage area of the reservoir is cantonated at depths between 3.0 and 4.0 m from the natural ground level (figure 2).

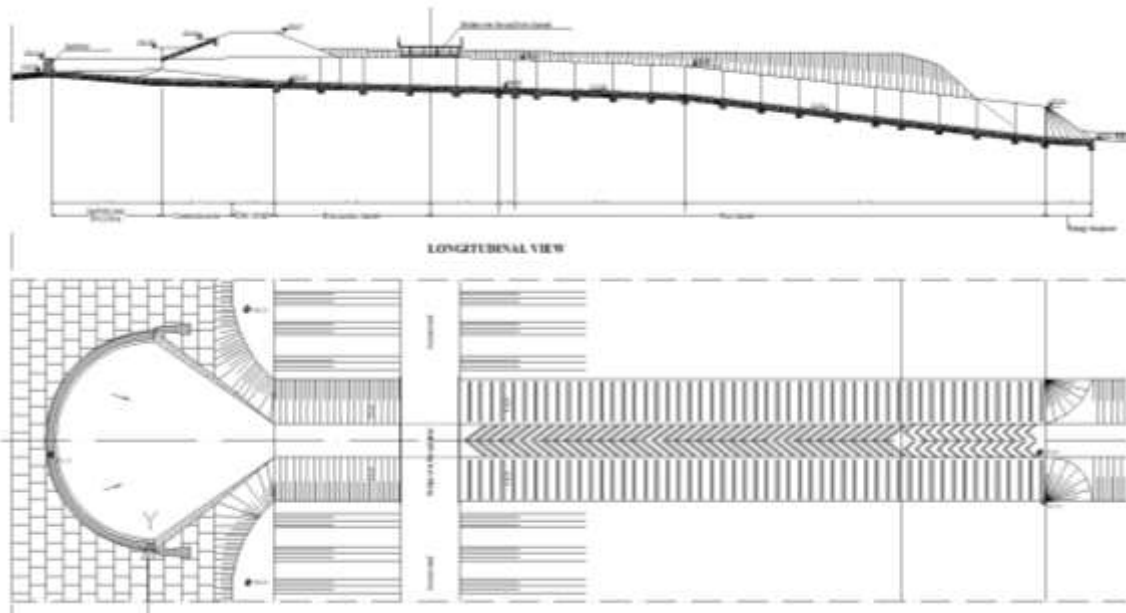
Figure 3 Highwater surface outlet - longitudinal and plan views

We can observe that the maximum water level in the reservoir (104.99 maBS) was inferior with 0,14 m to the surface outlet - threshold weir (105.13 maBS in the year 2006, before the recent measurements). The surface spillway that was deteriorated during the evacuation of flows was later repaired, during the works implemented under the project „*Safety re-inforcement of Negreni reservoir, located on the Baseu River, in Botoșani county*”.

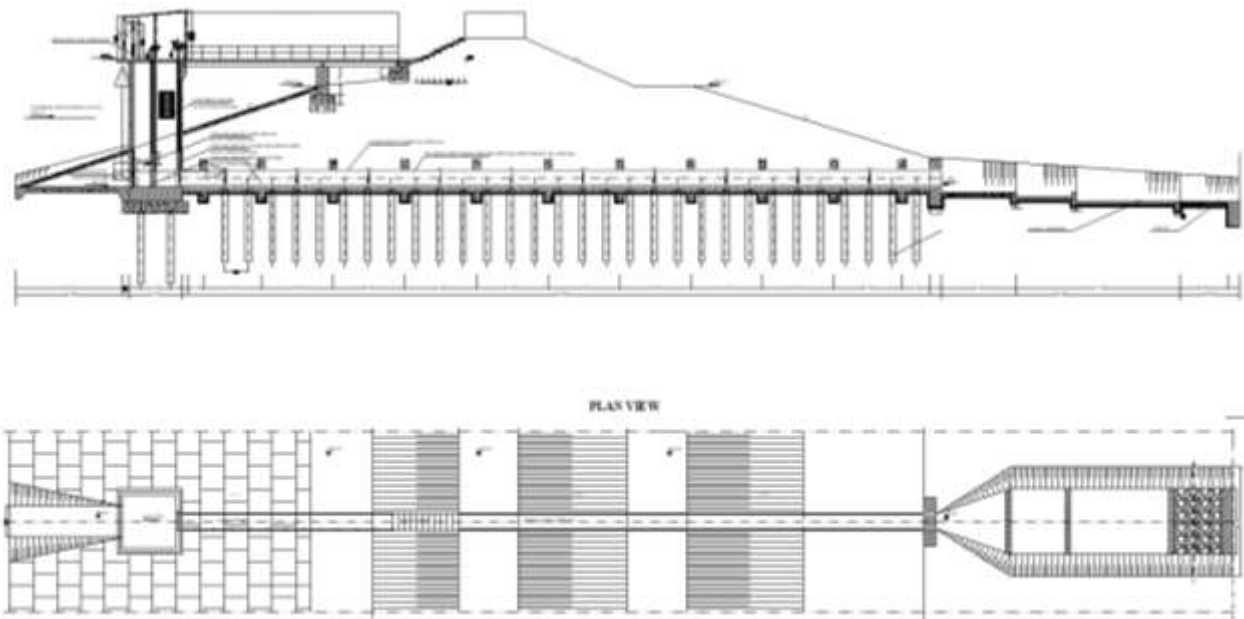
Figure 4 Bottom outlet - longitudinal and plan views

c) The bottom outlet is represented by a circular orifice with the interior diameter of 1200 mm. It is pipe made of fiberglass-reinforced polyester and sand insertion, inside the initial concrete tube with interior diameter of 1400 mm, in 6 m sections for a total length of 78 m.

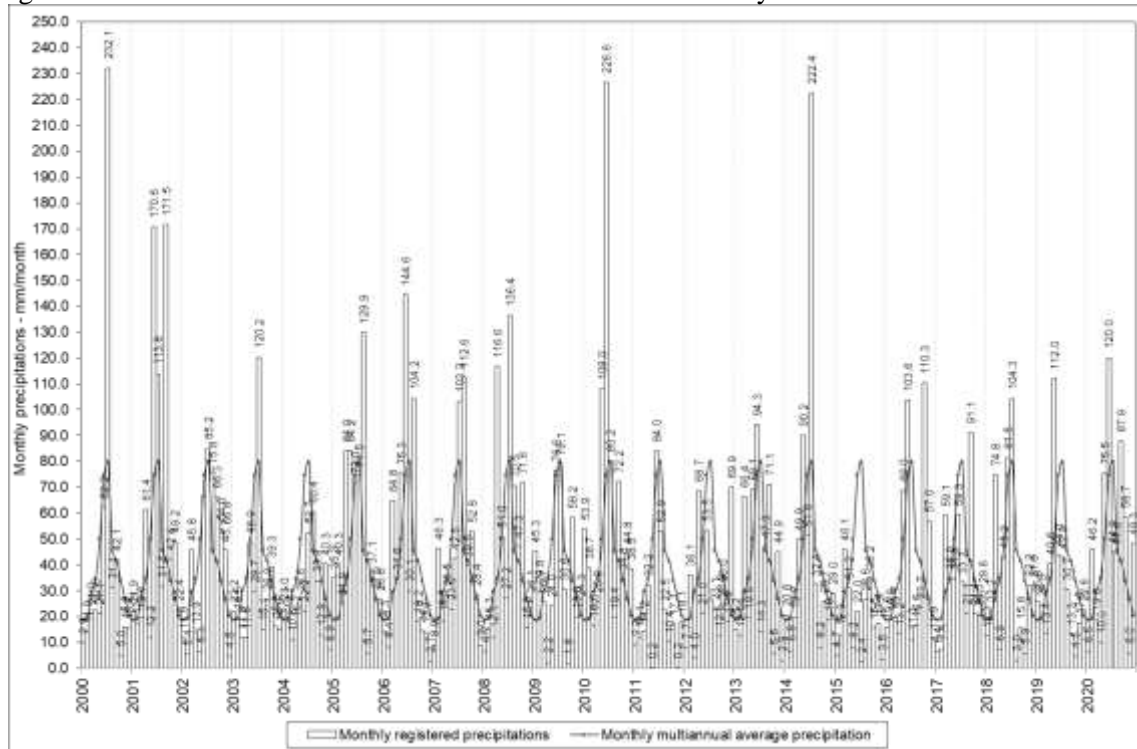
Figure 5 Monthly precipitations during the years 2000 and 2020

Figure 5 shows a comparison of the monthly registered precipitations at the Negreni reservoir with the average multi annual values for Botoșani county, in a 20 years period (*figure 5*). We can noticed that the precipitations recorded at the rain gauge usually follow the multiannual trend, but the years 2000, 2010 and 2014 had a very rainy summer, as precipitations registered in June surpassed the value of 220 l/m².

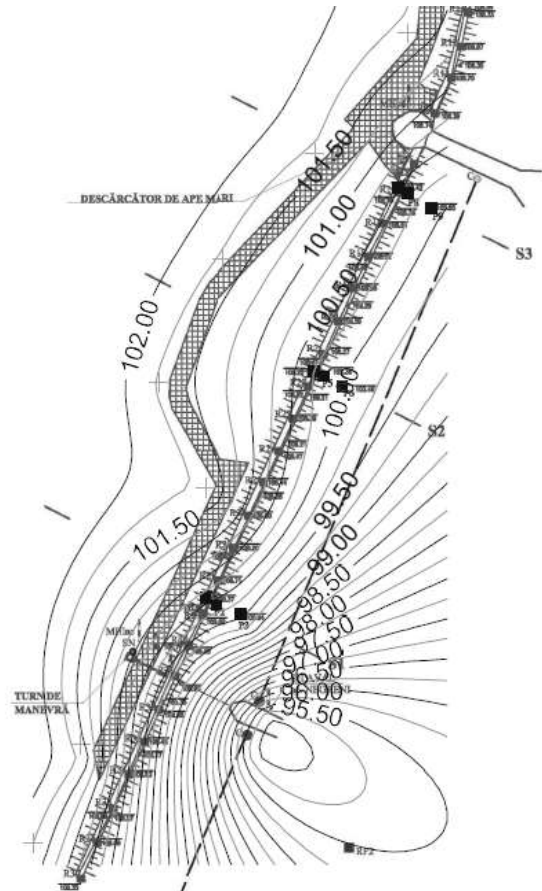
Figure 6 **Hydroisohypses for the infiltration regime**

For further study of the infiltration regime in the dam, we used SURFER program to draw the hydro isohypses for the Negreni dam using the maximum hydrostatic levels in the piezometers measured in the year 2020.

The distribution of the hydro isohypses across the dam is strongly influenced by the location of the piezometers and the other points of measuring the hydraulic head.

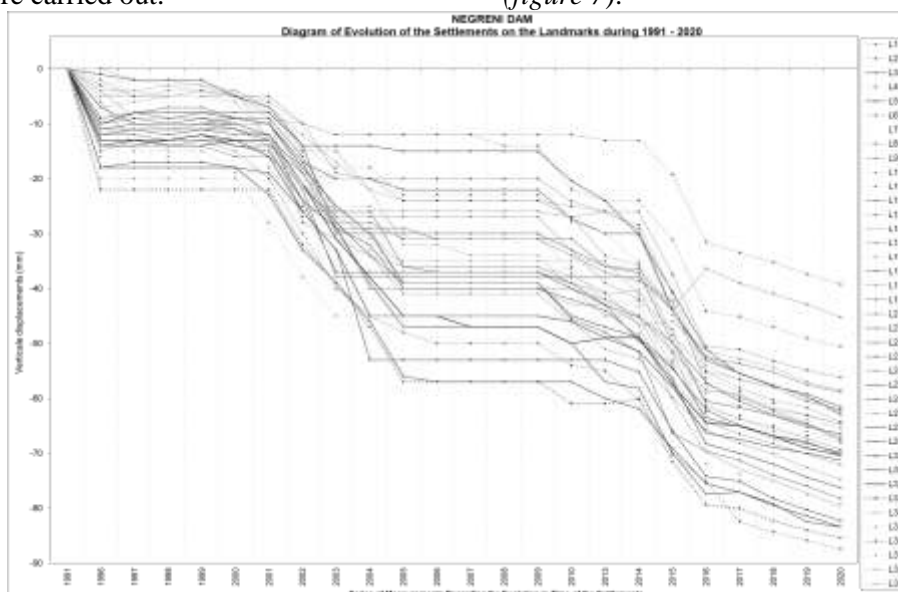
Figure 7 **Evolution of Vertical Deformations of the Dam During the Years 1991 and 2020**

By analyzing the temporal evolution chart of the vertical deformations we have observed a normal evolution of the compaction phenomenon. (*figure 7*).
