DEGRADATION OF EARTH'S DAMS UNDER THE EFFECT OF CLIMATE CHANGE

Abstract

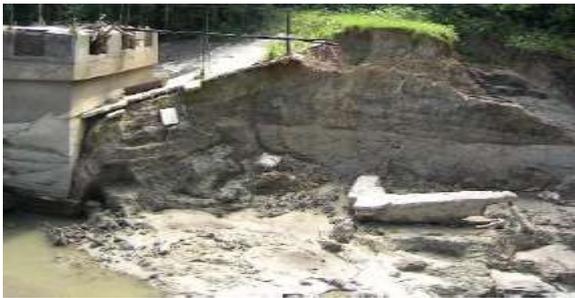
In June 2010, torrential rainfall formed a rapid flood of 133 m³/s in the dam section. Existing unloaders had an evacuation capacity of only 37.71 m³/s. Thus, the flood spilled the dam with a blade estimated at 1 m high. There was a loosening of the downstream slope, and finally a 25 m wide gap developed in the body of the dam between the two bottom drains. (CTM, 2010), (figure 3,4).

Figure 3 Crujana Dam, Suceava County, 2010 - breach through the dam, (ABA Siret, 2010)

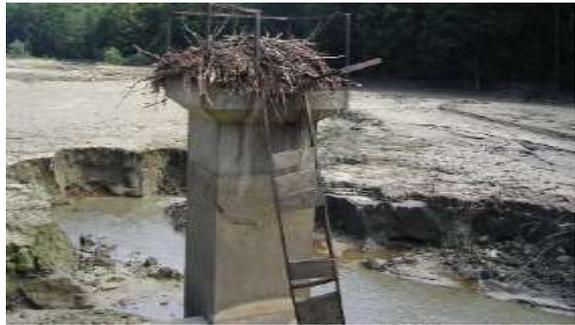
Figure 4 Crujana Dam, Suceava County, 2010 - the maneuvering tower and the lake basin after emptying the lake by breaking the dam (ABA Siret, 2010)

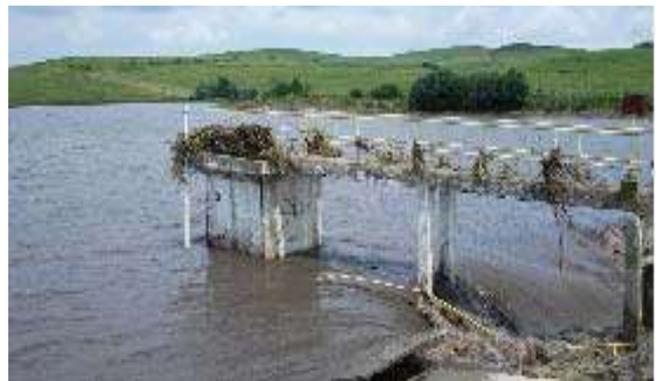
The quantitative precipitations determined the formation of a breach in the dam, in the area of the maneuvering tower (figure 6).

Figure 6 Degradation of the tower at Grănicești Dam, Suceava County, during the 2010 floods (CTM, 2010)

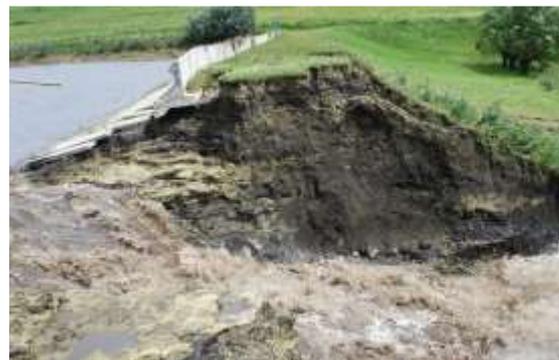
The destruction of the dam was done progressively, the filling material lost its cohesion completely, producing the dislocation and massive entrainment of the material from the dam body downstream. The internal erosion caused the appearance of a rectangular breach which widened to the surface. Shortly the gap became trapezoidal, with depth equal to the height of the dam (figure 7), (CTM, 2010).

Figure 7 Grănicești Dam, Suceava County, Year 2010 - breach in the body of the dam (CTM, 2010)

1. The design did not take into account the creation of a robust connection and a high degree of impermeability between the two materials, thus leading to the destruction of the dam;
2. The selection, sorting and analysis of the filling material in the laboratory was neglected during the execution. The technological standards for filling and the technological standards for compaction, which are frequently encountered in small dams, have not been observed.
3. In monitoring, the fact that small dams are not equipped with measuring and control devices made it difficult to give the responsible bodies instant warning.

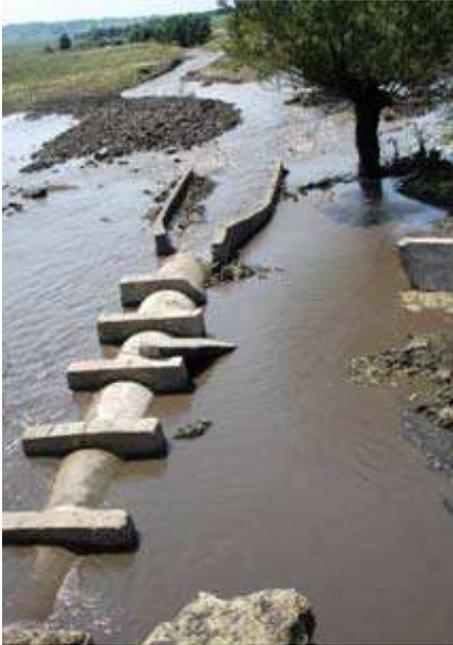
The filling washing took place quickly, that the gap was fully developed after 2 hours. The bottom drain was totally discovered by the floods, the material being driven downstream (*figure 8*).

Figure 8 Grănicești Dam, Suceava County, 2010 - bottom emptying degradation (CTM, 2010)

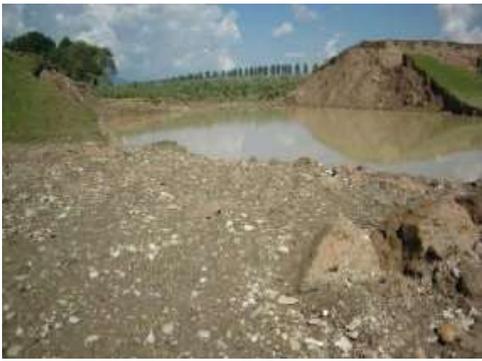
The large, short-term rainfall of 73,2 L/m² and 81,71 L/m², recorded in the period 24 to 27.07.2008, has increased the flows to a maximum of 260 m³/s and a maximum flash-volume of 6,95 m³ (CTM, 2010). These phenomena caused damage to the Horodnic 1 and 2 dams. The body of the non-permanent Horodnic 1 dam broke, forming a 10 m wide gap (*figure 10*).

Figure 10 Horodnic Dam 1, Suceava County, 2008 - dam body degradation (CTM, 2010)

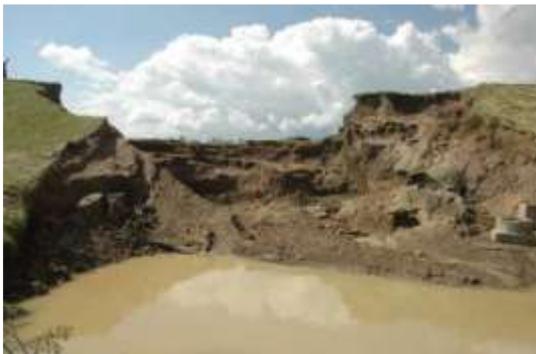
In a short time, a gap was formed in the central area, near the bottom drain, with a length of 30 m. (figure 11, 12).

Figure 11 Horodnic Dam 2, Suceava County, 2008 - dam body degradation (CTM, 2010)

The cause of the accident was the large amount of precipitation. These focused on high flow rates that exceeded sizing assurances. The damage to the Horodnic 2 dam was also caused by the breaking of the Horodnic 1 dam.

the accumulation. the dam drains must be resized in accordance with the conditions for the formation of the maximum runoff from the river basin, which is severely affected by deforestation.

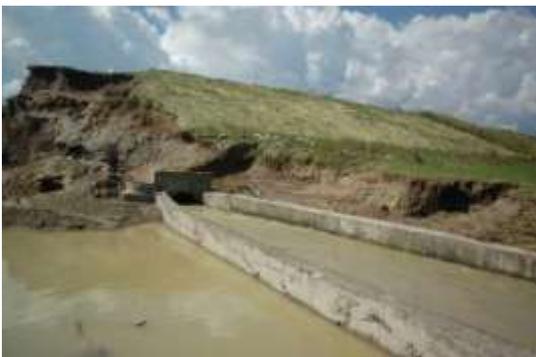
Figure 12 Horodnic Dam 2, Suceava County, 2008 - bottom emptying degradation (CTM, 2010)
