DEGREE OF THE RIPARIAN ENVIRONMENT IN THE TROTUS HYDROGRAPHIC BASIN AFTER THE FLOODS IN THE YEARS 2016

AVRAM Mihaela¹, LUCA M.¹

Abstract. *The paper presents an analysis of the degradation phenomena of the riparian environment in the Trotuș river basin following the floods produced in the summer of 2016. The Trotuș River has been affected by many floods over the past 28 years, 2004, 2005, 2011 and 2016. The riverine environment was affected by the degradation of shore defence works, the morphological modification of the riverbed, the destruction of the roads, the erosion of the agricultural land, the deposition of pollutants on the land adjacent to the river, etc. The June 2016 flood in the Trotuș River basin resulted in the degradation to the total destruction of over 318 km of bank defence hydrotechnical works. The floods caused the degradation of 1337 ha of agricultural land, the degradation of 355 km of road and 180 bridges. The floods affected over 376 homes in the studied area, from which it destroyed 76.*

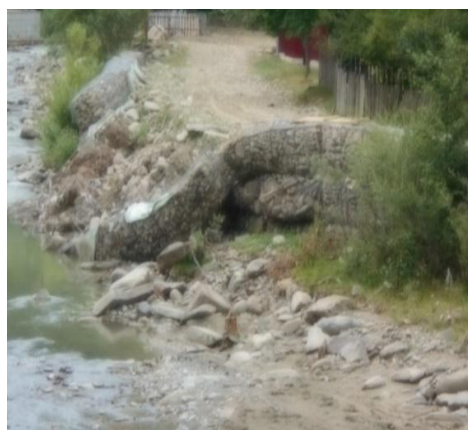
Fig. 2 Degradation on the Asău River in June 2016: a - shore erosion; B- defense of damaged riverbank in the locality of the locality (A.B.A. Siret, 2005).

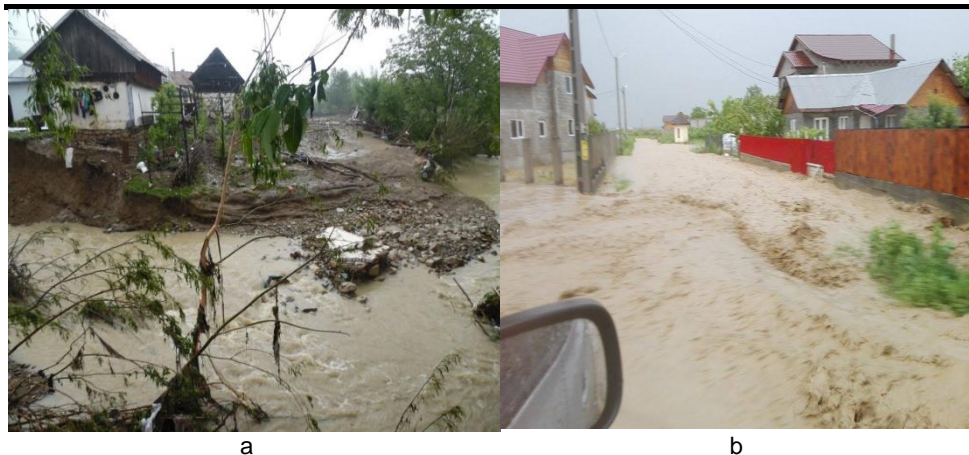
Fig. 3 The evolution of the flood in June 2016 on the river Cașin in the commune of the Monastery of Cașin: a-shore erosions; b-degradation of roads and dwellings (Avram M., 2016)
