ECOLOGICAL REHABILITATION WORKS RIVER MOLDOVA IN THE "NATURAL SITE ONICEȘTI - MITEȘTI"

LUCA M.¹, BĂLAN Anca¹, LUCA Al. L.¹, POP Olga-Adelina¹
e-mail: mluca2004@yahoo.com

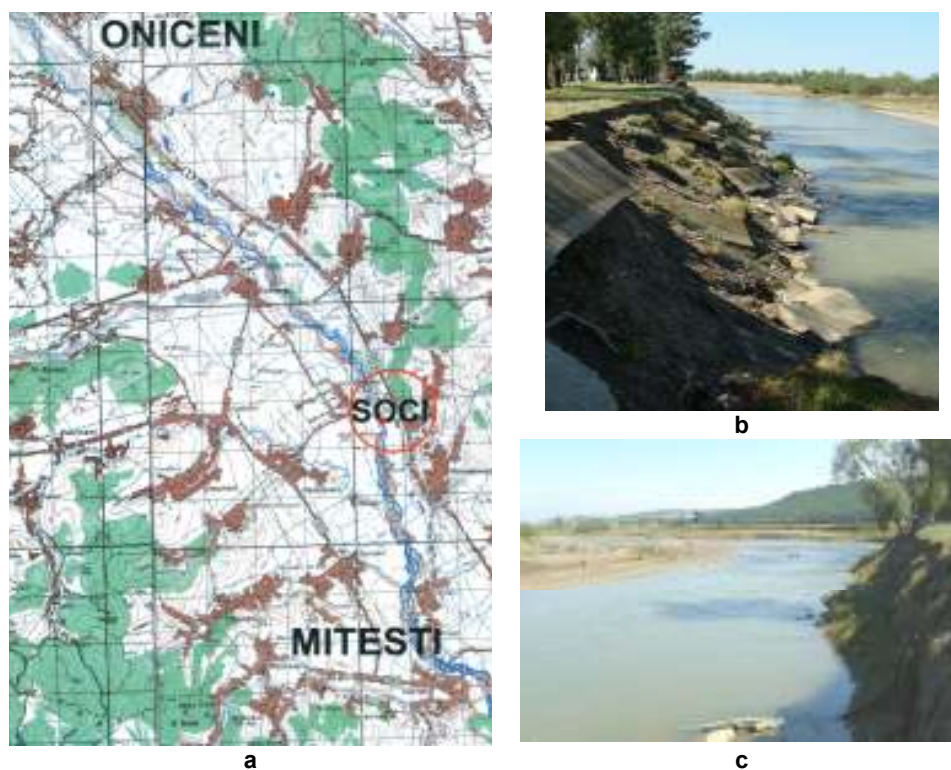
Site location area natural "Oniceni - Mitești" is characterized by various human activities. The main activities are of agricultural, grazing, water catchments, ballast operations etc. In Moldova River Municipal and industrial waste are discharged. They continuously degrade habitat natural site "Oniceni - Mitești". Presence of hydraulic structures in the riverbed alters living conditions of flora and fauna (Fig. 1b and 1c).

Fig. 1 - Framing research area within the "Natural site Oniceni - Mitești";
a - natural site map; b, c - the research work analyzed shore.

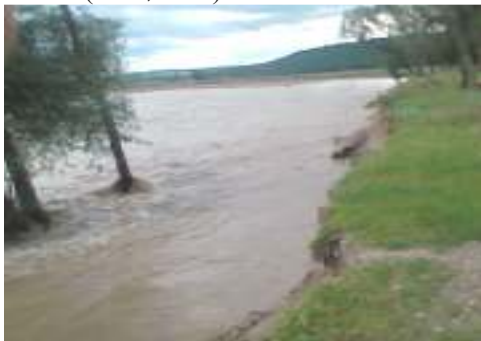
The riverbed Moldova transited in 2005 a flood flow of $1168 m^3/s$. In 2010 there were two floods: the first summer flow of $660 m^3/s$; the second in autumn flow $965 m^3/s$. The effects of floods have resulted in partial degradation of shore defense (Luca, 2012).

Fig. 2 - Left bank degradation and flood defense works in 2008

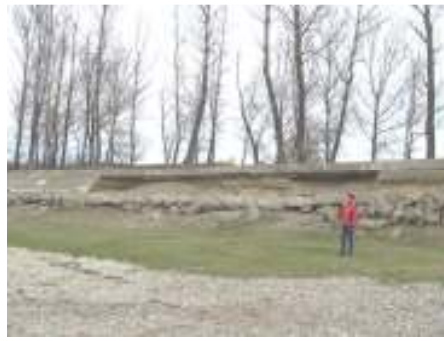
Fig. 3 - State degradation protection of the bank works (year 2014)

branching technological reasons. The flow is divided in two whites and produces increased water velocity. Morphological changes occurred during 2000...2015 partially or completely destroyed buildings shore defenses (Fig. 3 and 4).

- lowering product hydrodynamic erosion riverbed with about 2.0 ... 4.0 m;
- protection of the bank of the left and right have been degraded at a rate of 60 ... 95 % ;
- the left bank of the river is affected by a strong current erosion;
- habitat in the river channel is disrupted and degraded.

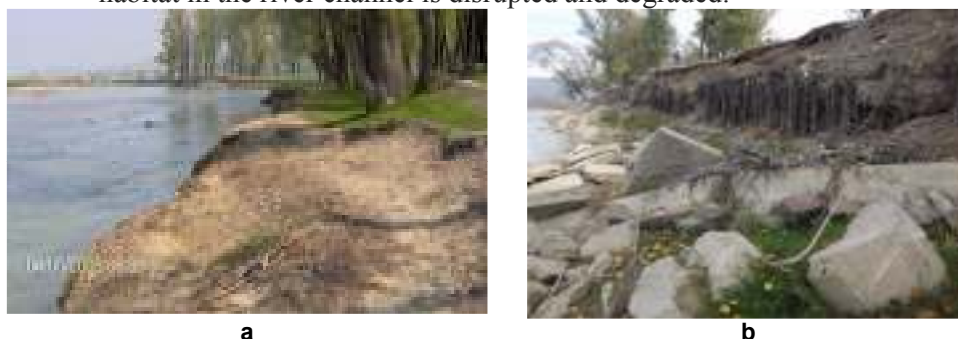
Fig. 4 - Comparative analysis of state left bank in 2005 (a) and 2012 (b)

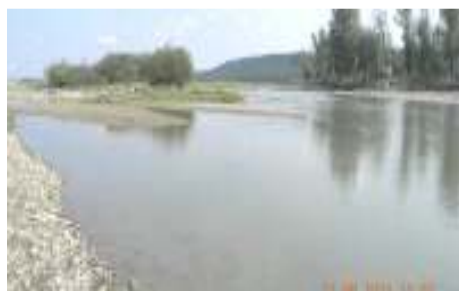
Fig. 5 - Downstream view of the two arms of the river Moldova in the study area

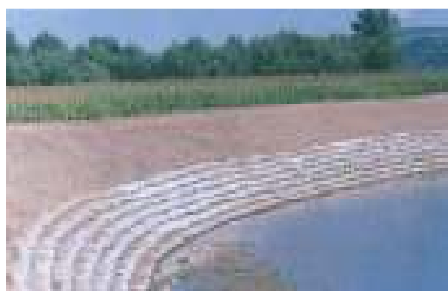
Research findings require implementation of rehabilitation works. Significant degradation of hydraulic structures affecting the stability of the riverbed in the adduction pipes (Fig. 6). Rehabilitation works sector consistent under-crossing has been designed with the requirements of "natural site". They consist of the following (Luca, 2012):

Fig. 6 - Protection of the bank with elastic gabions filled with ballast

- protection of the bank replacing rigid concrete slabs made of elastic works (elastic gabion of the plastic material filled with ballast, Fig. 6);
- achieving a groin on the left for directing water flow and limit bank erosion;
- achieving a bottom sill of the last pipe downstream of the supply; threshold will stabilize the longitudinal profile of the river section;
- achievement of a fish ladder bottom threshold for passage by fish species in the river Moldova.

The works regularization construction was designed and undertaken in 2015. Protection of the bank was designed and undertaken in spring 2015 with elastic gabions. Through its vertical and horizontal mounting of these are done to restore
