RESEARCH ON ENVIRONMENTAL DEGRADATION IN RIVER BRANCHES AREAS

SION PAUL V.¹, LUCA M.^{1*}, TOMA D.¹, DOMINTE Violeta¹

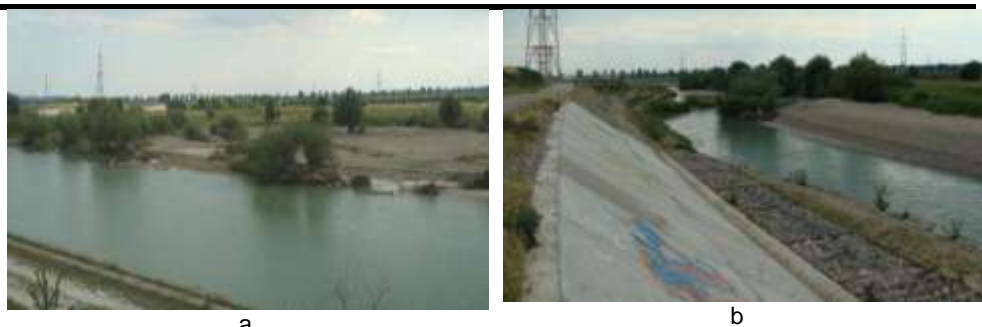
An island with an area of 21.0 ha was formed between the two riverbeds. It is positioned at approx. 6.00 km upstream of the confluence of the Moldova river with the Siret River (fig. 3).

Fig. 3 General view of the island formed by the branching of the Moldova River bed; a - upstream area of the island; b - the main riverbed and the island in the central area (photo Sion 2019)

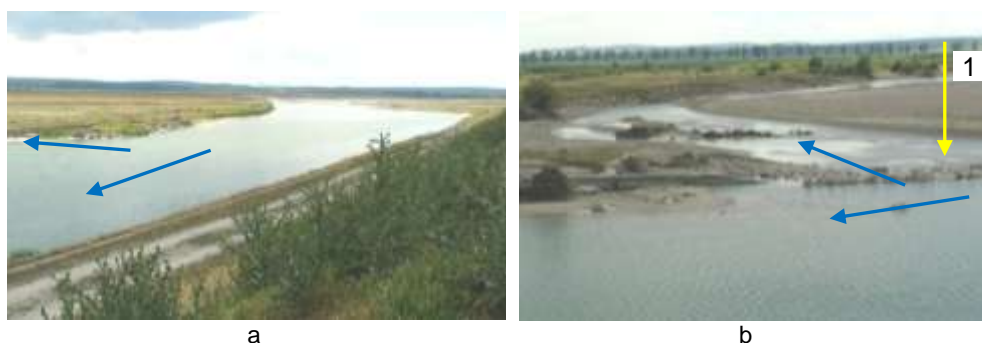
Fig. 4 General view of the Moldova river upstream of catchment: a - riverbed before branching; b - the entrance on the secondary riverbed with the position of the overflow; 1 - spill (photo Sion 2019).

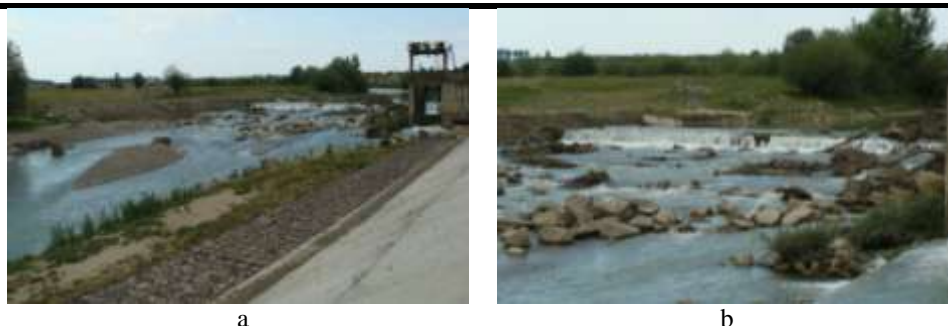
- the main riverbed has a route in the form of a circular arc with a large curvature to ensure the supply of water catchment located on the river bank (fig. 4.a, fig. 5);
- the high speed of the water does not allow the formation and preservation of the living conditions of the flora and fauna;
- the calibrated riverbed is protected on a long length with rigid elements (concrete slabs, gabions, stone), a situation that does not allow the creation of an alluvial layer for the growth of aquatic flora;
- the riverbed calibrated and packed with rigid elements does not allow the fulfillment of the conditions for the growth of the aquatic fauna: in the riverbed it is not possible to create areas of rest of the fish, of reproduction and growth;

Fig. 5 Constructive characteristics of the Moldova River bed in the catchment area: a - general view; b - the energy dissipation basin at the bottom threshold (photo Sion 2019)

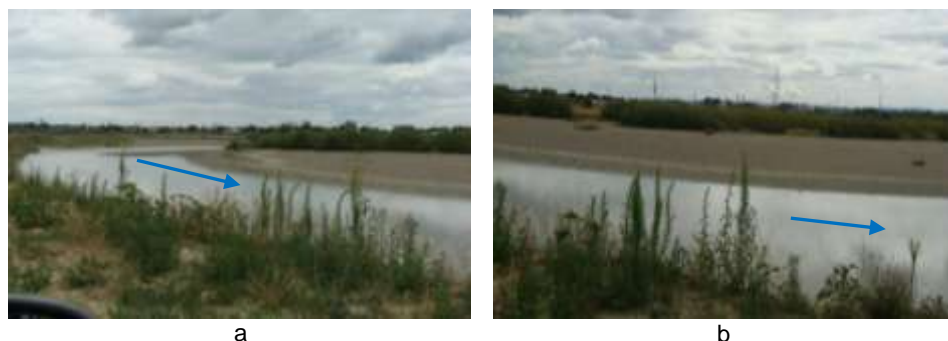
- the secondary riverbed has a linear sector at the entrance, followed by a sector in the shape of a circular arc, and the exit sector is slightly curved (fig. 6);
- the cross section of the right arm is variable in size and length;
- the aquatic environment on the right arm is degraded in the current stage; a negative influence is the exploitation of the ballast on the secondary riverbed;

Fig. 6 The characteristics of the secondary riverbed of the Moldova River: a - the entrance section; b - the central section (photo Sion 2019)
