MEASUREMENTS OF THE VERTICAL DEFORMATIONS AT THE INCLINOMETERS IN THE RIGHT SLOPE OF THE CĂTĂMĂRĂȘTI RESERVOIR DAM, SITUATED ON SITNA RIVER, BOTOȘANI COUNTY – A CASE STUDY

BĂLAN Isabela¹, CRENGĂNIȘ Loredana¹
e-mail: isabela.balan@yahoo.co.uk

Abstract: *In the framework of the investment „Safety re-inforcement of Cătămărăști reservoir, located on the Sitna river in Botosani county” a stabilization platform was built on the location of the old surface outlet, equipped with 8 inclinometers wells to monitor the evolution of the vertical deformations and stability in the right embankment. The vertical deformations were monitored after the final acceptance of the safety works carrying out 4 series of measurements on the inclinometer wells. The measurements were performed with P/N 50302510 Inclinometer Slope Indicator and used as guiding mark the upper elevation of the well pipes. The measurements data were processed using the maximum values of displacements (on the two orthogonal directions A0-A180 and B0-B180). The paper presents the comparative results of 4 series of measurements.*

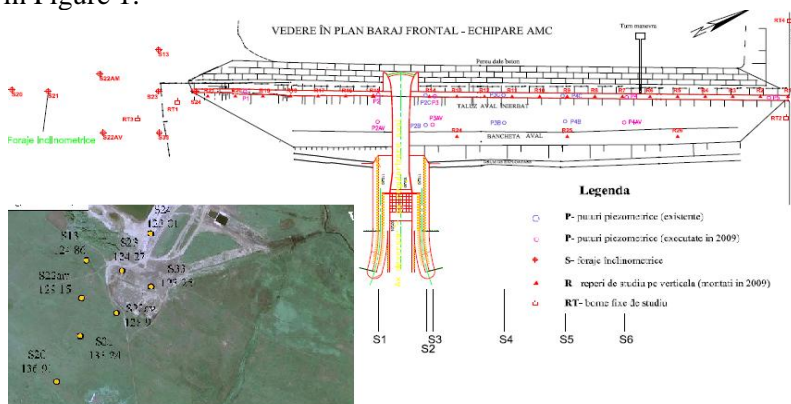
Fig. 1. – The location of the inclinometer wells in the right embankment

The inclinometer wells are aimed to track the evolution of the vertical deformations and monitor the seepage through the dam body and right embankment. They are located on the right embankment, except to the identified as S2.4, which is placed in the dam body.
