RESEARCHES ON THE MODERNIZATION OF THE CONDUCT NETWORK FROM OLD PRESSURE IRRIGATION SYSTEMS

Alexandru-Lucian LUCA¹, Ilie LOGIGAN², Mihail LUCA², Fabian TĂMĂȘANU¹

Abstract

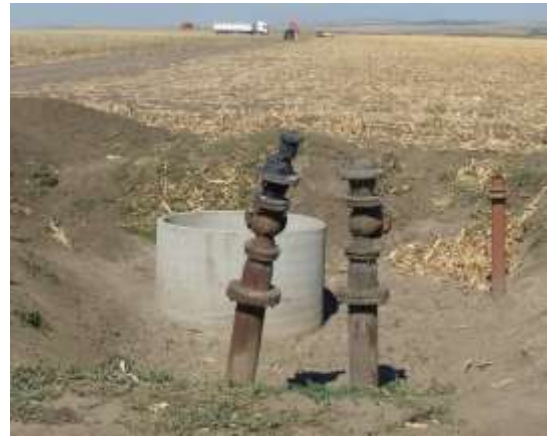
The pipeline network of irrigation plots in operation has a long service life. The absence of maintenance and repair work and overheated lifetime have led to the degradation of structural components of pipelines, hydrotechnical structures on the grid and hydraulic installations in dormitories. In the same situation there are the irrigation channels, which feed the monofilament pumping stations from irrigation plots with sprinkling (Luca, 2016).

Figure 2 **Degradation state of buildings and installations on the pipeline network of the plot Irrigation SPP1b** (Luca, 2015)

The structural degradation of the pipeline led to the occurrence of large water losses, the progressive increase in the number of damages and the increase of the energy consumption (Cismaru, 2004, Luca, 2012, Luca, 2016).

The rehabilitation of the pipeline network of the irrigation plot is based on a technical expertise and a technical project approved by a project verifier on the field of land improvement. The technical design may provide for the partial or total change of piping that forms the pipeline. The hydraulic installation in the dorms needs to be completely changed, as the service life is exceeded.

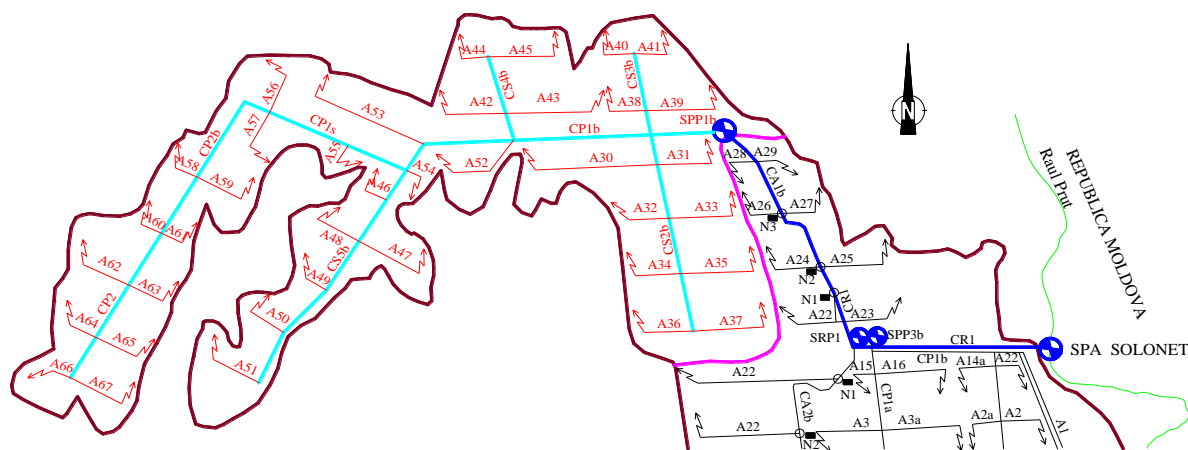
Figure 4 The new piping network layout at the SPP1b South Solonet irrigation plot

The constructive modification of a pipe section or of a main and secondary pipeline within the pipeline requires a new dimension of the grid (figure 4). Changing the type of watering system requires a new dimension of the hydrants and pipelines within the network. The watering equipment used in the irrigation plot is of the "pivot" type (figure 5), which requires a complete dimensioning of the pipeline network, considering the modification of the parameters of the hydrants, changing the flows and pressures in the nodes. The new layout scheme will be designed for a high-pressure pipeline network to ensure the operation of modern sprinkler systems.

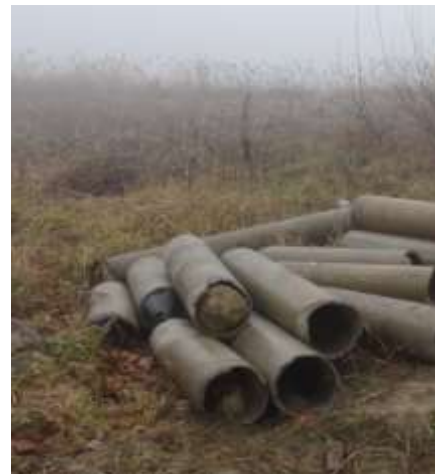
The large number of damages required partial rehabilitation of some pipe sections. The damage was also intensified by the failure of the hydraulic shock protection system. Pipes made from asbestos have been degraded by the hydraulic shock produced during the exploitation process (figure 7) (Luca, 2015).

Figure 7 **Condition of degradation of asbestos pipes in the structure of the pipeline network of "Berezeni Plot 16"** (Luca, 2015)

main pipeline, a rehabilitation project for a 1770 m long section was prepared, where PREMO pipes with PRHD pipe were replaced. Also rehabilitated sections from the tertiary pipes in 3935 m length of asbestos pipe, which was replaced with PEHD pipe (figure 8).

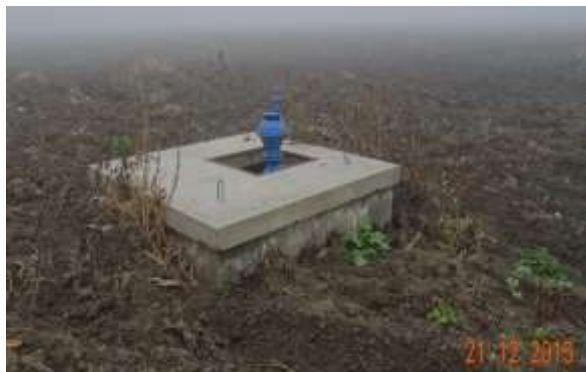
Figure 8 **Rehabilitation of the ventilation chimney on the main pipe CP1 in "Berezeni Plot 16"** (Luca, 2015)
