RESEARCH ON STRUCTURAL AND FUNCTIONAL STATUS OF SUPPLY CHANNELS IN IRRIGATION SYSTEMS

Alexandru-Lucian LUCA¹, Andrei-Ștefan Sticea², Fabian TĂMĂȘANU¹, Mihail LUCA²

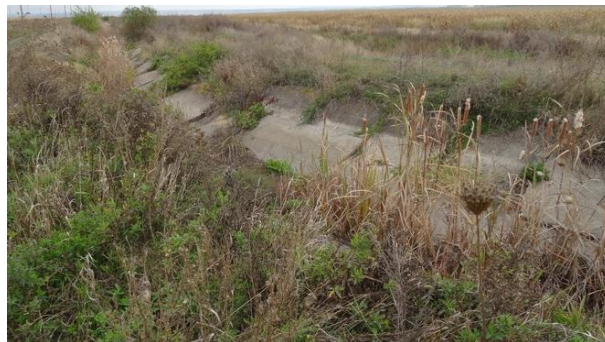
- the channel shows a degradation of the structure in length by settlements, collapses and swellings of the slope, modification of the geodesic slope, etc. (figure 4);

Figure 4 **General structural condition of the CA3 channel between the SPP8 and SPP9 pumping stations (Luca M., 2020)**

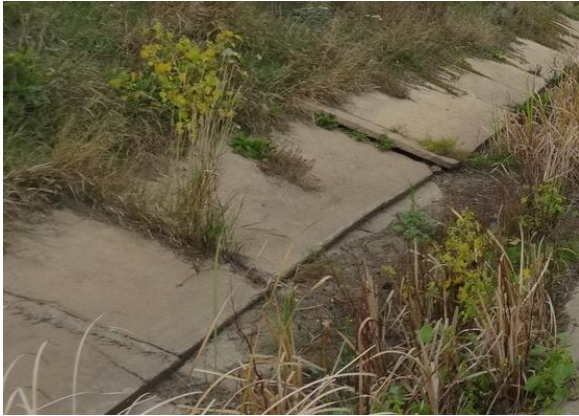
- the joint between the slabs filled with cement mortar was completely destroyed, which

favoured the penetration of water under the slabs and the destruction of the support layer; in the joints a vegetation developed that increased the roughness coefficient (*figure 5*);

Figure 5 General structural conditions of the joints between the tiles of the CA3 channel (Luca M., 2020)

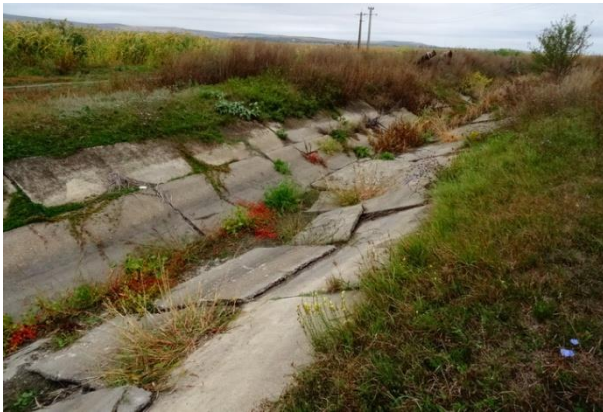
- a large part of the tiles are cracked, displaced or missing (*figure 6a*);

Figure 6 - State of structural degradation of the CA3 supply channel: a - geometric modification of the flow section by moving and fracturing the slabs; b - the presence of arboreal vegetation in the flow section (Luca M., 2020).

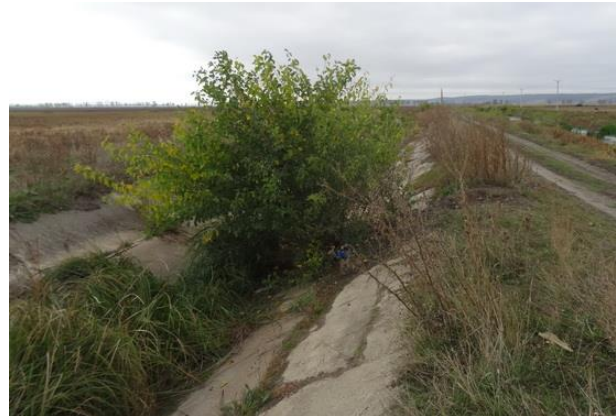
b

- the absence of tile maintenance and repair works determined the growth of vegetation of various species (grass, shrubs, trees, etc.) and dimensions in the flow section (*figure 6b*); vegetation contributed to the dislocation of the tiles, their movement and fracture;

- the canal areas where the irrigation water is captured by the pumping stations (SPP) is in a state of advanced degradation; the section of the channel is deformed due to the movement of the slabs and the hydrodynamic erosion (*figure 6b*);

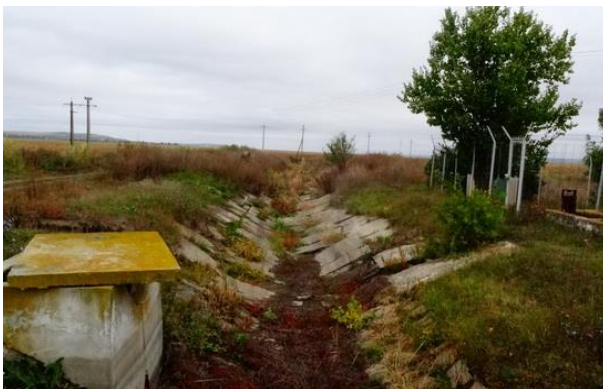
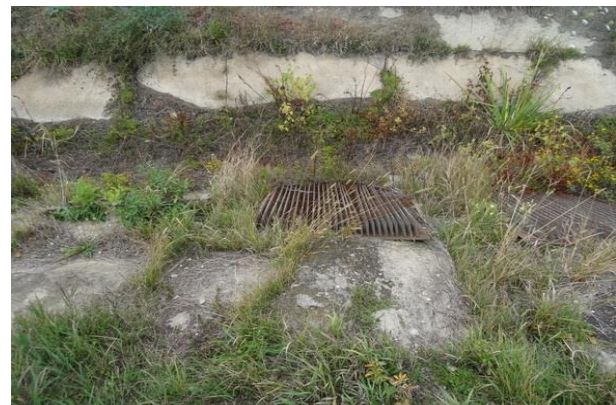
- the water intake taps / pipes located in the canal slope are protected with gratings made of cast iron; the grills are displaced, corroded and unstable; this situation allows the access of large alluvium in the hydromechanical installation of the pumping station (*figure 7*);

Figure 7 - The state of structural degradation of the CA3 supply channel in the SPP catchment area: a - general view of the catchment area for SPP8 Oțetoaia; b - the state of degradation of the grilles on the suction pipes (Luca M., 2020).

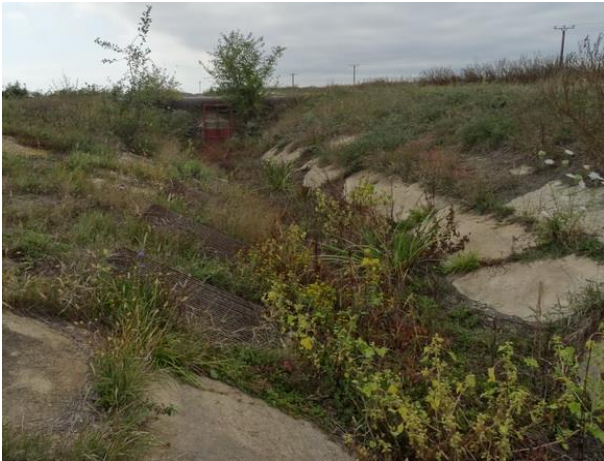
- the channel in the area of the SPP pumping stations is equipped with a dam to create water levels for the sockets / suction pipes (*figure 8a*);

Figure 8 - Degradation state of the CA3 channel in the dam area from SPP8: a - general view of the channel section; b - detail regarding the condition of the dam (Luca M., 2020)

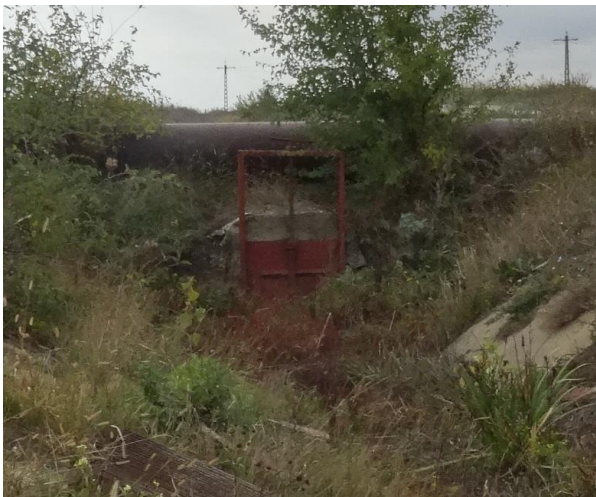
b

- the construction and installation of the dam is degraded in proportion of 80 - 90%, and its operation is deficient (*figure 8b*); the metal

constructions of the dam have exceeded the operating period and no longer provide functional parameters (tight closing, controlled flow transit);

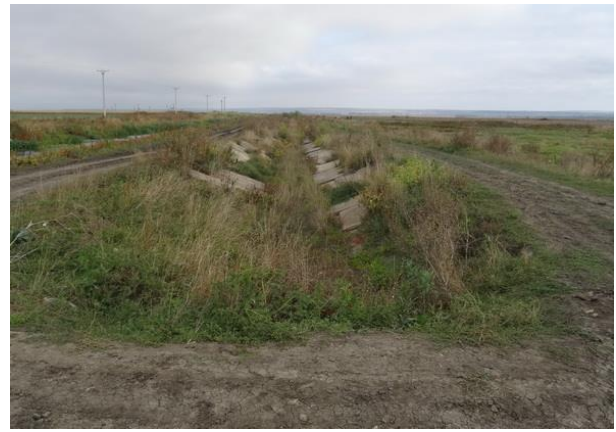
- the bridges used at the intersection of the canal with the road of exploitation are degraded in proportion of 60 - 90%; the construction of the bridges was modified in time by the interventions for repair works (*figure 9*);

Figure 9 - General view of the CA3 canal and a modified bridge at the intersection with an exploitation road (Luca M., 2020)

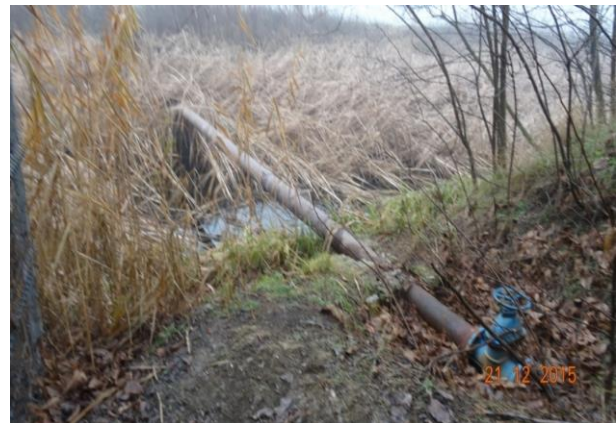
- a part of the adduction channels of the irrigation plots from „Irrigation Systems Albița – Fălciu” are clogged in excess, and in time an abundant vegetation represented by reeds has developed (*figure 10*);

Figure 10 - Condition of the CA5 adduction channel with clogged sections and the presence of reed vegetation (Luca M., 2020)
