## CONSEQUENCES OF THE USE OF AREAS DESIGNED FOR DRY-DRAINAGE WORKS, IN THE ROTOPĂNEȘTI-RĂDĂȘENI-FÂNTÂNA MARE SYSTEM, SUCEAVA COUNTY

**Key words:** *moisture excess, dry-drainage system, hydrotechnical constructions, geometrical and hydraulic elements of drying network*

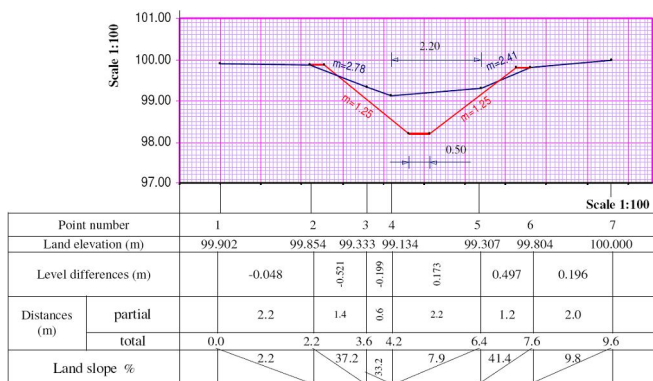
In the second section (*fig. 2*), situated at 400 m downstream the first section, the belt channel (CC<sub>1</sub>) had the following geometrical and constructive elements: mean depth 1.69 m, bottom length  $b = 0.50$  m and slope coefficient  $m = 1.25$ .

During the working period, the channel was clogged with one meter, the bottom length reaching 2.20 m, four times greater than the initial one, while the slope coefficient increased at 2.78 on the upstream side and at 2.41 on the downstream side.

Figure 2 Transversal section II through the belt channel (CC<sub>1</sub>)

The analysis of channel discharge section shows that initially it had the value of  $4.41 \text{ m}^2$ , while today, it is of  $2.31 \text{ m}^2$ , which means a diminution of about 50%. Channel clogging with almost one meter on this section was caused by excessive grazing on the channel section, the area being exclusively used as grassland and by repeated channel crossing by animals.

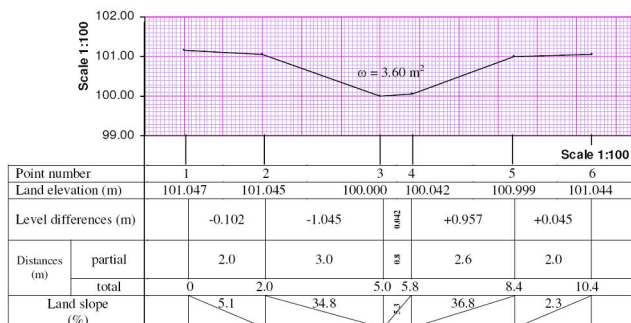
If on the studied section, the initial channel section had the value of 4.41 m<sup>2</sup>, we found a higher diminution in the transportation capacity as they advance downstream, because of channel bottom clogging. Thus, the area of the transversal section of the belt channel CC<sub>1</sub> decreases on the studied section every 25 m (fig. 4, 5, 6 and 7), from the value of 4.27 m<sup>2</sup> in point P<sub>1</sub> to the value of 2.31 m<sup>2</sup> in point P<sub>5</sub> (second section). Analysing the channel discharge sections on the studied section, we found a mean diminution in the transversal section by 30%.

Figure 5 Section through the belt channel (CC<sub>1</sub>), in point P<sub>2</sub>

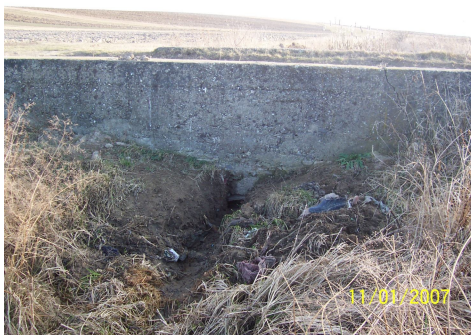
Figure 1

In the section comprised between 700 and 2100 m, the channel was clogged at a percent of 70-80 % and the capacity of taking over affluent flows diminished, while in the upstream, a water area of 1.00 ha appeared, because the bridge was totally obturated (*picture 1*) and there is no longer ensured the transfer of flows from slope runoff to the main Șomuzel collecting channel.

Upstream sector of the protection channel, where dry areas are used as grassland and channel crossing by animals is done both in the periods with few rainfalls but also when the field is overwet, thus determining high degradation and modification of the discharge section, there are necessary unclogging and recovery of channel section, designing bridges for animals, in order not to allow the moisture excess on low areas and the disturbance of downstream dry-drainage works, because of floods in the periods with abundant rainfall.

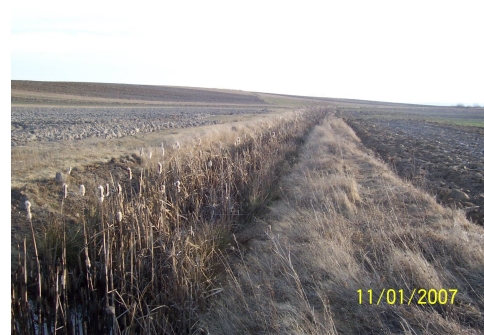
Figure 2

On a route of 850 m, upstream the obturated bridge, before the confluence of CC<sub>1</sub> channel to Șomuzel collector, the neighbouring areas are used as arable land and channel clogging is more reduced; instead, we found the hygrophilous vegetation that contributes to the diminution of discharges on this channel (*picture 2*).

For avoiding the acceleration of clogging in this section, too, removal of hygrophilous vegetation and recovery of channel section are required.
