IMPACT OF THE ANTHROPIC FACTOR AND CLASS OF USE ON THE DRYING-DRAINAGE NETWORK OF THE ROTOPĂNEȘTI-RĂDĂȘENI-FÂNTÂNA MARE SYSTEM IN SUCEAVA COUNTY

Abstract

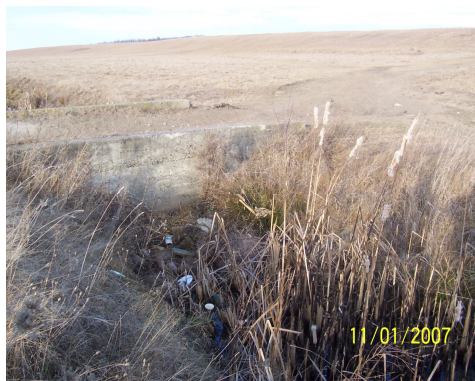
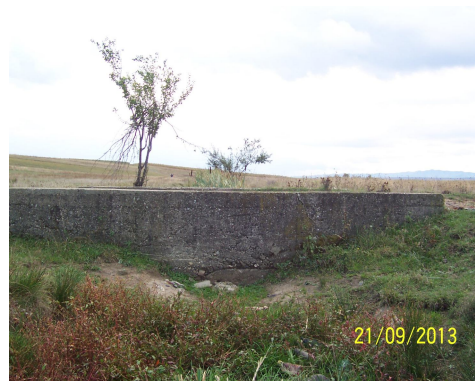
The culvert placed at 2100 m from the upstream of belt channel CC₁, on the separation line between pasture and arable land, is blocked due to improper operation of this section of the area surrounding the channel, which has since 1992 on it pasture, it has not been maintained and different plant debris, waste and packaging have been stored around it (*fig. 2*).

Figure 2 **Blocked culvert**

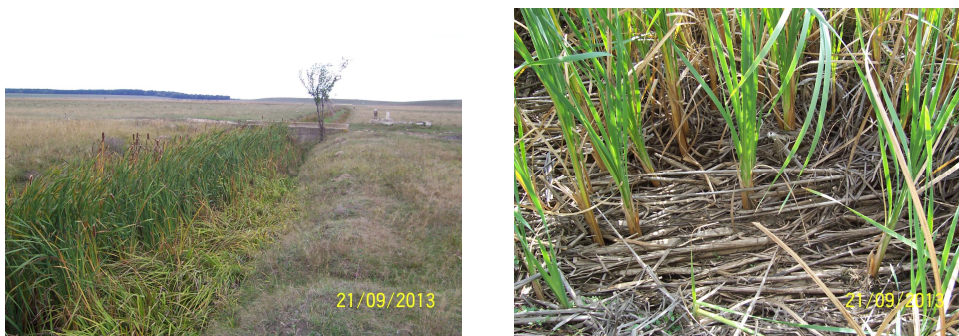
initial geometrical form, but the fact that maintenance works have not been done on time and the appearance of hydrophilic plants and shrubs, favor the slowdown of the speed of water flow, the alluvial sedimentation and clogging.

Also, hydrophilic plants represented by rush (*Typha latifolia*), grows the rate of clogging due to rich plant mass and high content of cellulose (fig. 8).

Figure 8 Rush plants on the channel
