## STUDIES AND RESEARCHES CONCERNING THE JOINTING OF REAL ESTATE CADASTRE WITH UTILITY NETWORK

### Abstract

The paper aims at developing a GIS model that includes information on the real estate cadastre (in the case of agricultural areas) supplemented with data from the cadastre of water supply systems. GIS models present a wide-ranging application of water supply and sewerage monitoring. The paper presents an analysis for water main transmission. It crosses its way from captation to reservoir, private property and public property. The water main pipeline requires investigative, annual repairs, rehabilitation and modernization interventions over long periods of time. In order to carry out the intervention works it is necessary to ensure the access to the site. The paper deals with the problem of the location of the conduits and there are signalized special situations on the water main transmission Timisesti - Iasi. Access to private properties may be restricted by owners. Through the GIS monitoring model and in collaboration with other analysis programs (Autocad, ArcMap), there were identified particular situations encountered on the two water main transmission pipeline. These si

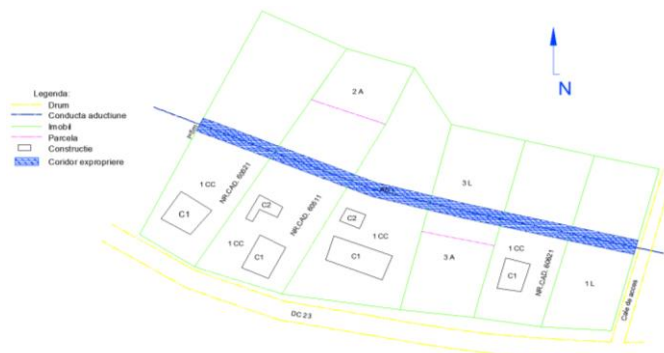
Figure 3 Outline of the expropriation corridor

In this case, it is recommended to make some access corridor to the duct and to define the pipeline and fireplace location areas.

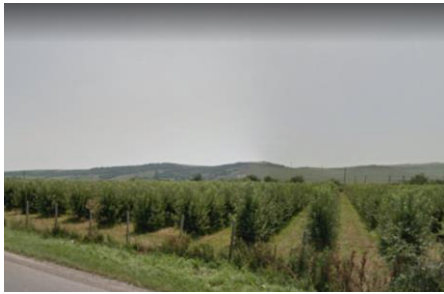
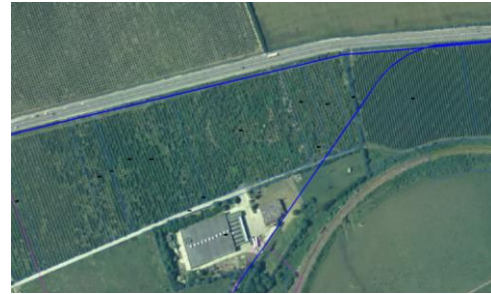
Figure 4. View D1 of the Pomicole Sârca area: a - general view; b - orthophotomal view of Sârca area

Following the analysis of the constructive structure of the Timișești - Iași pipeline are exemplified the following cases, considered as details in *figure 4*:

a) Private sector, owner is the Research and Fruit Production Resort, named Nursery Sârca, the buildings with the cadastral numbers 60468, 60569, 61320, 60976, 60977, 60978, 60317, 60518, 61383, 6182, 60381 situated in the outside of Bălțiți village, and 71, the parcels L 777, L 791 along the former DE 776, DE 792. The Ad II

pipeline runs parallel to DN 28 and the Ad I line aligns to the duct II on the building surface with cadastral number 60569. A particular situation encountered in this case is represented by the land use category, namely orchards. Thus, in the reported area, most of the buildings are stamped and the conduits pass under the plantation of trees. In order to achieve an expropriation corridor it is necessary to provide access in case of damage, so at least 2,5 m on the right or left side should be left with the pipe axis.

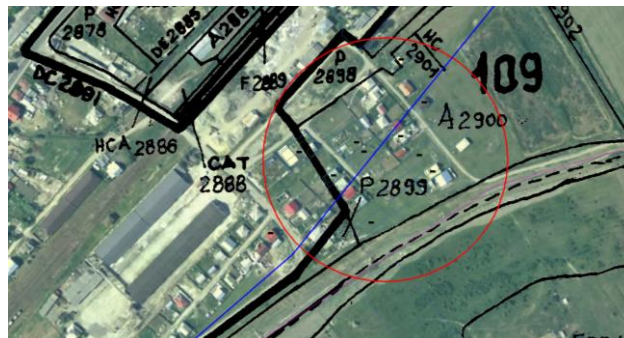
Figure 5 View D2 location location of the private ownership city Târgu Frumos

b) Private area, in the area of Târgu Frumos town, near the purification station, sector 109, plot A 2900. The identified area has both built-in properties and buildings without cadastral number. A case study in this area presents a particular problem because the pipeline has its way very close to the constructions raised in the area or even pass under them. For example, in the case of the building with cadastral number 60617, the axis of the pipeline passes at a distance of 3.56

m from the western corner of the building. In the case of the neighboring building located in the north it can be seen how the conduit passes through the construction itself.

If we consider that an opening of at least 5 m, in some cases 12 m, is necessary for the expropriation corridor, the expropriation corridor would pass through the construction located on that land.

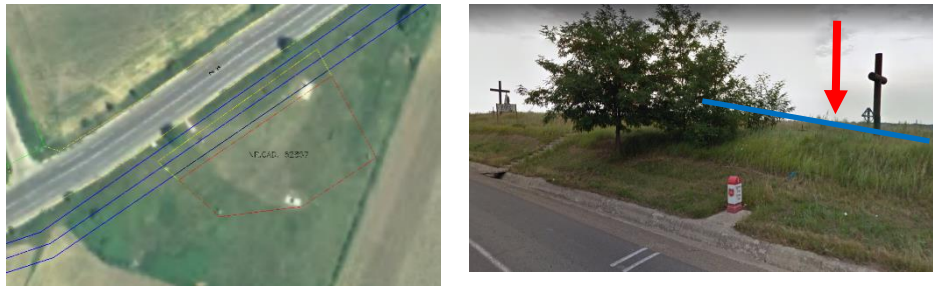
Figure 6. View of aduction location area: a - orthofotoplan; b - general building view with the water main transmission pipe II site ([www.googlemaps.ro](http://www.googlemaps.ro))

c) Public domain, in the case of the building with cadastral number 62857, located in the outside of A. I. Cuza village, sector 86, plot CC 573/1 with an area of 2910 sqm of land in the property of Butea commune. The water main transmission pipeline is located underground in the right of the national road DN 28 at a distance of about 4 m. If we consider that an opening of at least 5 m of the total area of 2910 m<sup>2</sup> is required for an expropriation corridor dismantled an area

of 800 m<sup>2</sup>, the surface of the building would be reduced to 2110 m<sup>2</sup>. In this respect, from the cadastral point of view, it is necessary to draw up a documentation of the detachment and compensation of the owner.

A special situation in this building is that there are graves from the Second World War on the ground, as well as the Cemetery of the Butea heroes, and the route of water main transmission passes even under some of the tombs (*figure 7*).

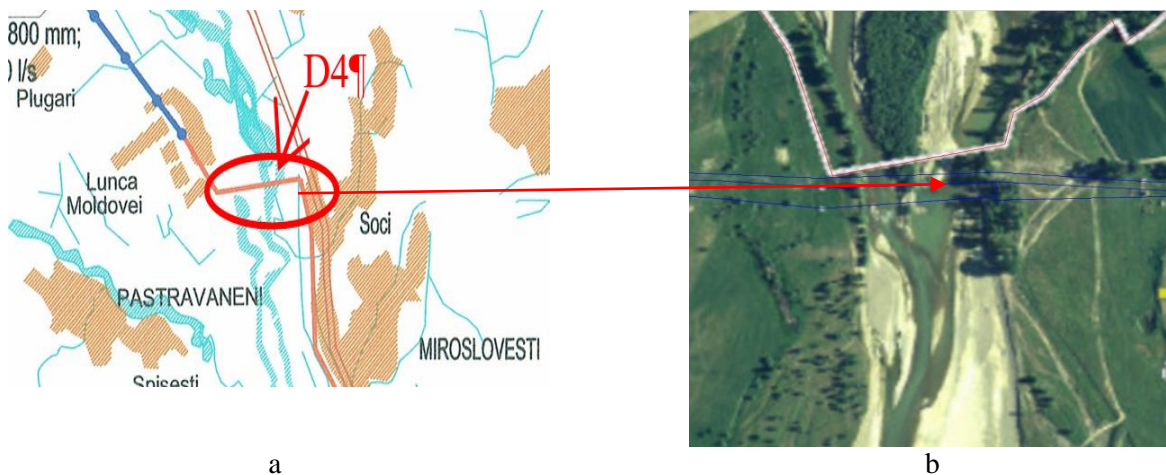
Figure 7 D4 view of the undertraversal area: a - plan with the flow diagram; b – orthotommap;

d) Analysis of detail D4 indicates the problems of interventions in damages on the pipeline that subtraverses the river Moldova. The undercrossing area is located in the Northwest part of the Miroslovesti commune, in an area outside the area, sector 49, the HC 478 plot, at the Moțca UAT limit near the European road E85.

Thus, the conduit I undercross the river Moldova, as can be seen in *figure 8*. The riverbed is continuously morphologically modified by annual floods and ballast operations. Intervention in case of damage to the conduit can be made difficult by these changes of the riverbed.

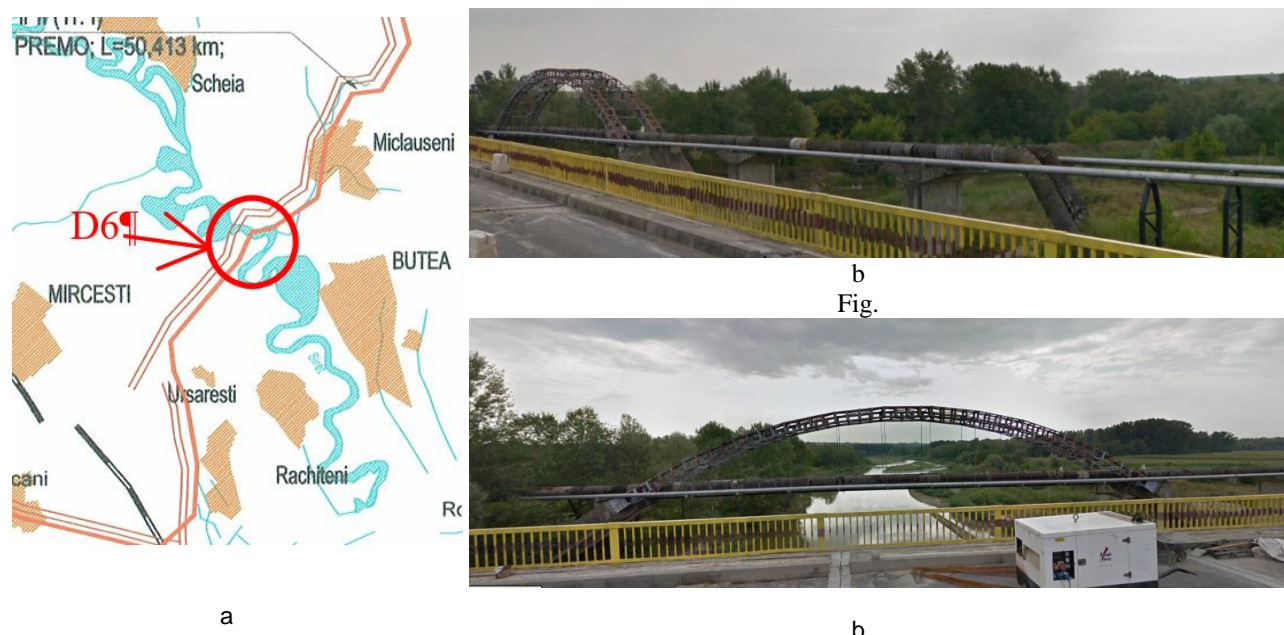
Figure 8 **Overflow of the water main transmission II over the Siret river in the Scheia area: a - visualization D6; b - lateral and general view**

f) Analysis of D6 indicates the problems of intervention in case of overloading. As a result of the field research, it can be noticed that the water main transmission overpasses the river Moldova in the area of Butea - Răchiteni. In the case of a damage to the direct induction pipeline is the water - canal channel SC APAVITAL, ABA Siret, UAT Butea and UAT Răchiteni. The studied section is located at the boundary between the two administrative territorial units Butea and Răchiteni, in the parcels HC 465 and HC 933 according to the cadastral plans of outside of village drawn at 1: 10000 scale. It is positioned parallel to the national road DN 28 crossing the Siret River.
