REHABILITATION AND MODERNIZATION OF IRRIGATION PLOTS FOR CURRENT OPERATING CONDITIONS

Abstract

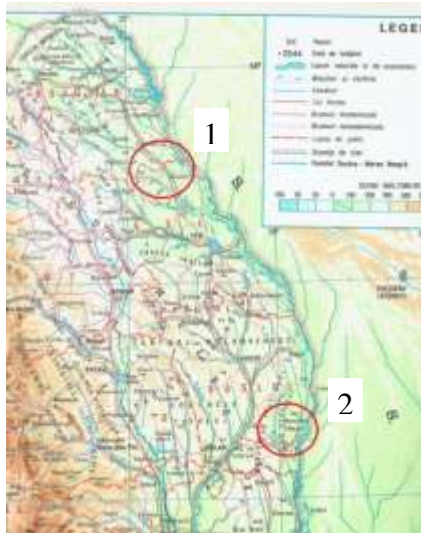
Figure 1 **Areas of study and research: 1 - South Soloneț irrigation system; 2 - Complex Irrigation and Drainage Development Albița - Fălciu**

The material used in the research consists of a series of irrigation plots located in the eastern part of Romania, especially in the counties of Iași and Vaslui (*figure 1*). Irrigation plots were analyzed by technical expertise on the structural and functional condition of the components.

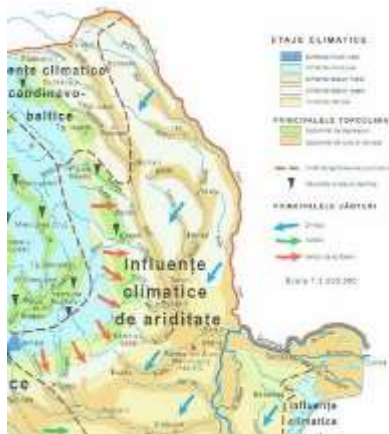
Figure 2 **Characterization of the climate zone in N-E Romania**

The research area belongs to the arid climate zone of Romania (*figure 2*). The irrigation systems analyzed are fed from the Prut River.

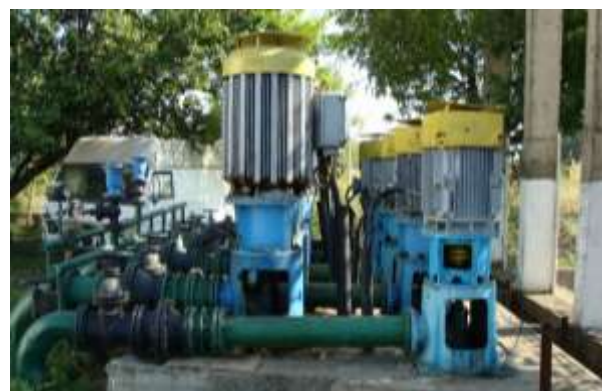
Figure 5 Hydromechanical equipment at SPP1b Soloneț South for bivalent watering (Luca 2012)

The pumping and pressurizing station (SPP) is equipped with two sets of pumps with differentiated flow and pressure. Pumps for surface drainage have high flow rates and medium pressures ($P = 3.5-4.5$ bar), and those for spraying have lower flow rates and high pressures ($P = 7.0 - 8.0$ bar). An example is represented by the pumping station from the SPP1b Irrigation Plot Solonet South with an area of 1428 ha, where the two types of pumps is present (table 2) (Luca, 2012).

Vertical pump MV 253 x 4	Vertical pump MA 200 x 5
Q = 504 m ³ /h	Q = 230 m ³ /h
P = 8.50 bar	P = 4.50 bar
n = 1500 rot/min	n = 1500 rot/min
N = 200 kW	N = 55 kW
U = 380/660 V	U = 380/660 V
$\eta = 60\%$	$\eta = 55\%$
5 pumps	5 pumps
