## RESEARCH ON THE BEHAVIOUR OF SHORE DEFENCES TO HYDRODYNAMIC EROSION

### Abstract

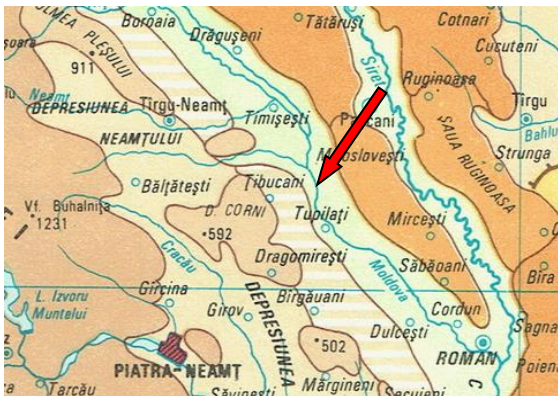
Figure 1 **Geo-physical characteristics in the research area of the Moldova River (The geographical Atlas of Romania, 1985)**

The researches were carried out on the lower course of the Moldova River (*figure 1*), in a large area near the town of Soci, Miroslavesti commune, Iași county. The Moldova River is part of the hydrographic basin of the Siret River. The BH surface of the Moldova River is 4326 km<sup>2</sup>, and the length is 205 km. The longitudinal profile of the river is balanced and has an average slope of 1% (Atlas of Water Cadastre in Romania).

The foundation of the river is made up of weakly cohesive rocks, a fact that favours bed erosion on the watered perimeter (Luca M., 2006, Luca M., 2012, Luca M. *et al*, 2019). The river bed in the research area consists of alternating layers of ballast, dusty sand and clayey sand (Luca M., 2006).

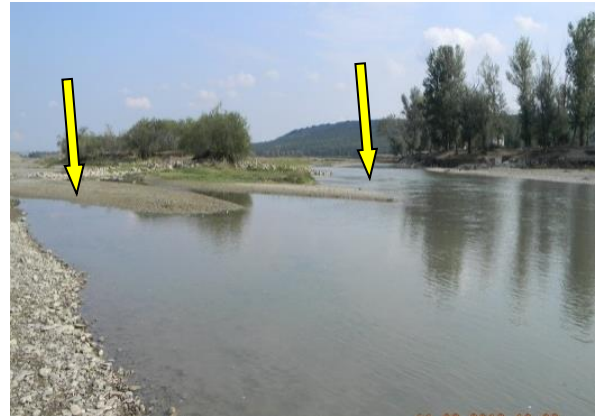
The research was carried out on a regularized river section with a length of 380 m and equipped with a bank defence made of geo-bags. The bed in the research area presents two arms separated by an island (*figure 2*). The arrangement of the river section was imposed by the presence of three pipes with large diameters (800 – 1000 mm), which cross the river bed transversely.

Figure 2 **General downstream view of the Moldova River bed with the two arms and the separation island (Luca M., 2006)**

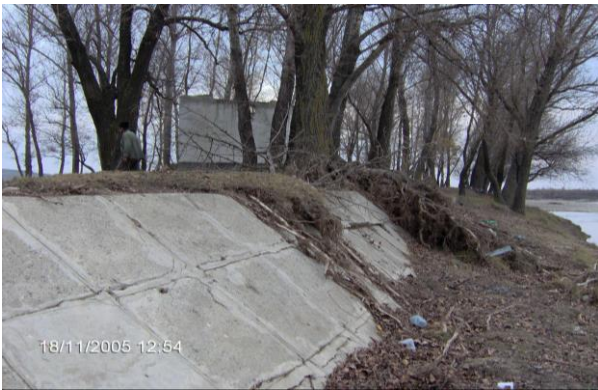
In the research area on the Moldova River, a hydrotechnical construction is located with the function of undercutting three intake pipes for the transport of drinking water. The pipelines are part of the Regional Water Supply System of Iași County. The first pipe has a diameter of 800 mm and the next two 1000 mm. The last two pipelines were executed in the years 1969 – 1971, when the river bed was regularized and a shore defence with concrete slabs was created (Luca M., 2012). The shore defence protected the shore in good condition until 2004 (*figure 3*).

Figure 3 The structural state of the left bank defence on the Moldova River in 2005 (Luca M., 2006)

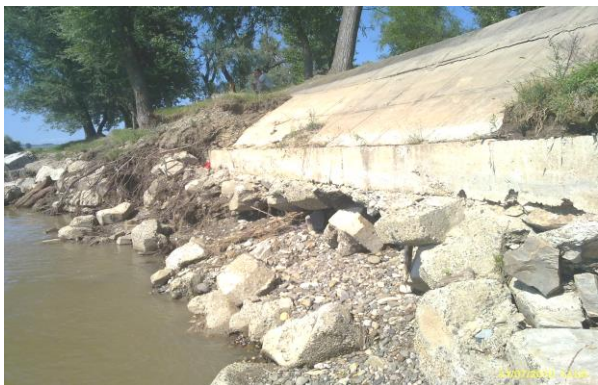
The phenomenon of hydrodynamic erosion, intensified by a series of natural factors (the high frequency of floods with high flows in the last 50 years), but also anthropogenic ones (limitation of maintenance works, intensive exploitation of ballast at the upstream limit of the sub-crossing area), determined the partial degradation (figure 4) and then the total degradation of the shore defence in the period 2005 - 2012 (figure 5).

Figure 4 The structural state of the shore defence made of concrete slabs in 2008 (Luca M., 2012)

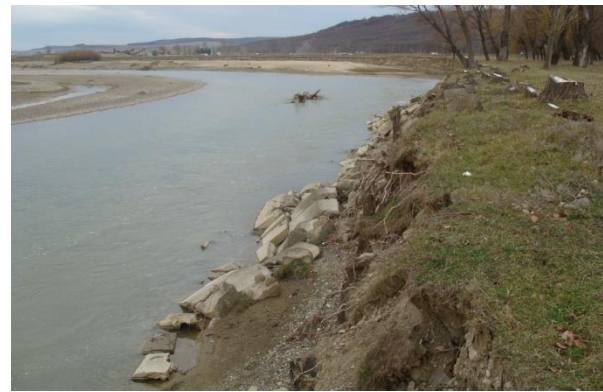
Figure 5 The total degradation of the defences on the left bank of the Moldova River, year 2012 (Luca M., 2012)

The technical expertise carried out in 2012 highlighted the state of degradation of the undercrossing construction, as well as the shore defence and indicated its rehabilitation (Luca M., 2012). The rehabilitation project was carried out in 2012 and applied in 2015 (Luca M., Luca Al. L., 2012).

Taking into account the extremely aggressive action of the phenomenon of hydrodynamic erosion, the foundation of the bed consisting of weakly cohesive rocks and the location of the undercrossing in a natural site, a shore protection made of elastic constructive elements was designed, which is adaptable to the conditions of the site. In this case, the shore defence was designed from elastic structures like geo-bags over a length of 520 m.

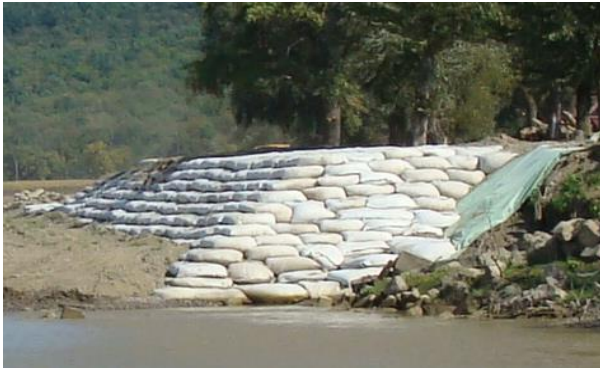
conditions were difficult, being determined by the presence of water originating from infiltration from outside the cofferdam. Geo-bag protection on the Moldova River was carried out in 2015 by using ballast as a filling material. The ballast was taken from the location area (figure 7).

Figure 7 Execution stage of the shore defense with geo-bags on the Moldova river (photo Luca M., 2015)

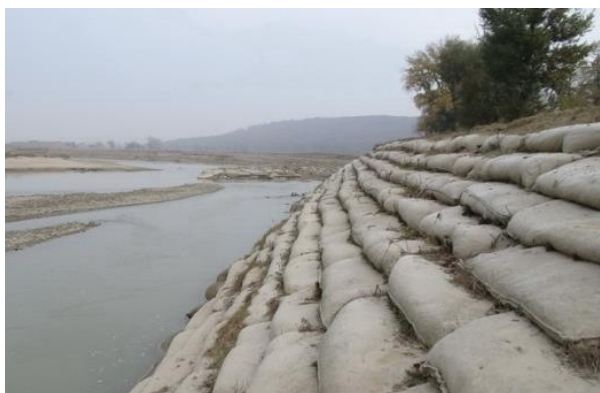
- the shore defence behaved differently along the length and height of the shore, generally during the seven years of operation; no important structural degradation generated by the water and especially the flood of 2016 can be highlighted (figure 8);

Figure 8 General view of the left bank defense after the 2016 flood (photo author, 2016)

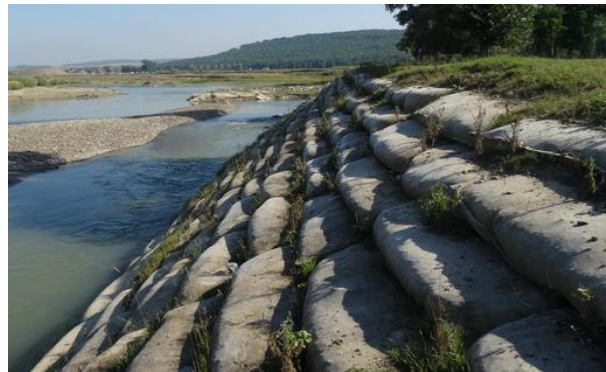
Figure 9 General view of the left bank defence after the 2018 flood (photo Luca M., 2015)

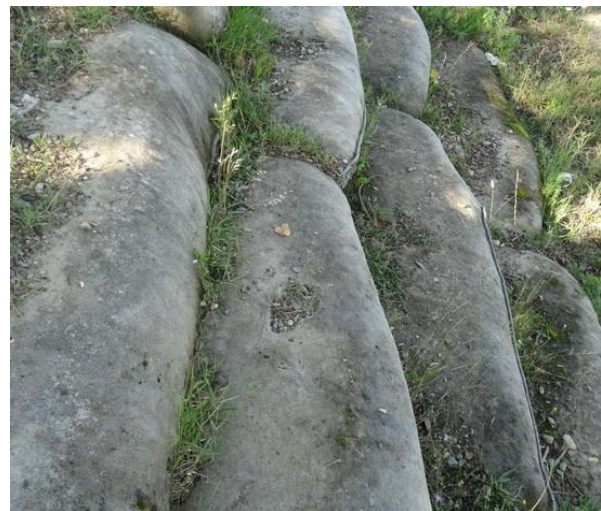
- a series of geo-bags placed in contact with water showed degradation in the form of tearing of the material; the tears are in the direction of flow and have lengths of 4-10 cm with widths of 2-5 cm through which part of the material was expelled (figure 10); the number and size of material breaks is greater for geo-bags located towards the base of the shore defence; the number of material breaks is random on the research sectors, being influenced by the quality of the material filling the geo-bags, as a result of the absence or decrease of the amount of cement;

Figure 10 Degradation of geo-bags through cracks and tearing of material 2018 (photo author, 2020)

The research carried out in the field highlights the need to apply annual maintenance works to restore the integrity of geo-bags degraded by natural and human action. Also, after the passage of a high-flow flood, a check of the structural condition must be carried out to highlight degradations.

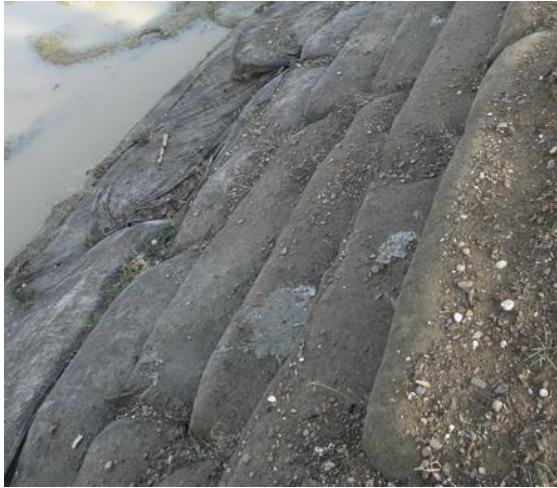
- the flood of 2018 caused significant damage to a series of geo-bags placed in contact with the water, by tearing the fabric in small lengths, but with an intense process of expelling the material from the inside (figure 11); the Moldova River transports coarse alluvium by creeping during floods, a situation that produces such degradations:

The hydrodynamic erosion of the water, as well as the action of the floaters, manifested itself extremely aggressively through the floods that

spread on the Moldova River in 2016 ( $Q_{\max} = 444 \text{ m}^3/\text{s}$ ) and 2018 ( $Q_{\max} \approx 1200 \text{ m}^3/\text{s}$ ).

Figure 11 **Degradation of geo-bags in contact with water in the flood of 2018 (photo author, 2018)**

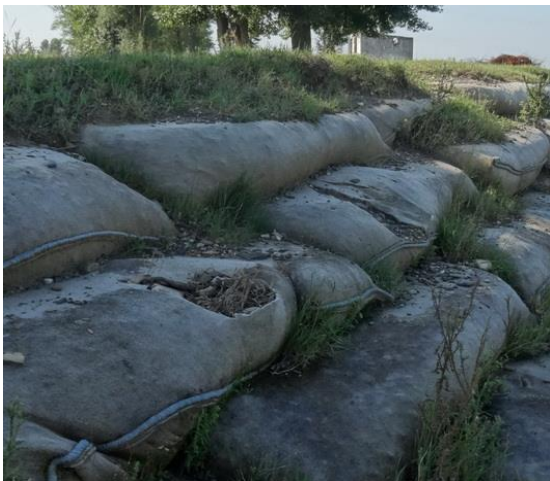
The shore defence made of geo-bags has been degraded at the top by anthropogenic actions. Some activities such as fishing (figure 11) and grazing by herds of sheep and goats have contributed to the degradation by tearing and breaking of the geo-bags (figure 12, figure 13).

Figure 12 **Degradation of the geo-bags located at the top of the coastal defence by anthropogenic actions (photo author, 2022)**

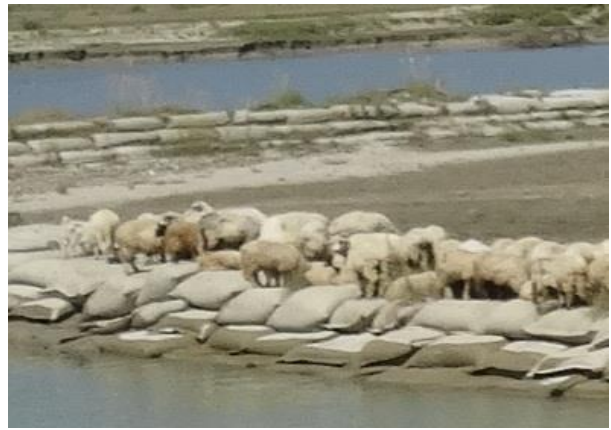
Figure 13 **Degradation of the geo-bags located at the top of the coastal defence by the movement of sheep flocks (photo author, 2020)**

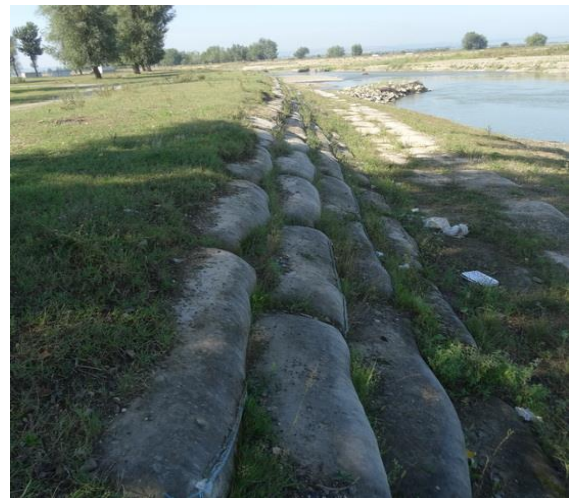
A good performance presents the shore defence from geo-bags to ensure the environmental requirements demanded by the aquatic and riparian environment. The mounting structure of geo-bags allows the deposition of alluvial material following floods or level variations, an aspect that favors the growth of aquatic and riparian vegetation (figure 14).

Figure 14 **Coastal defence area with the presence of vegetation and alluvium deposits (photo author, 2019)**
