RESEARCH ON MINOR RIVERBED MORPHOLOGY IN THE PRESENCE OF ANTHROPOGENIC RISK FACTORS

Abstract

The aim of the work was to research the morphological transformation of the minor bed of the Bahlui River on the trunk adjacent to the "Era Park" Commercial Complex following the action of natural and anthropogenic risk factors. Also, the influence of the way of operating the rainwater outlets within the commercial complex on the morphology of the bed was analyzed. The research section presents very different regularization works on the two banks.

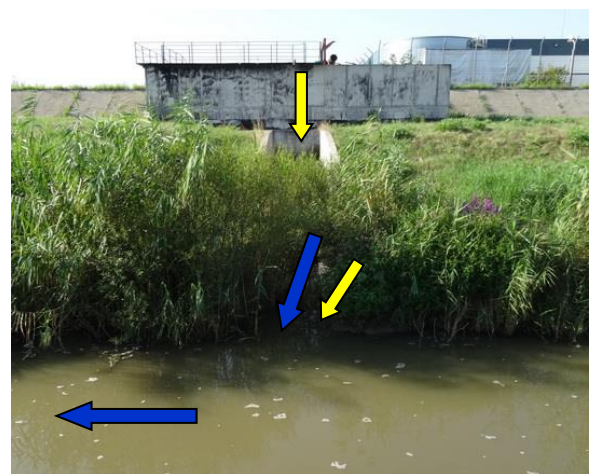
A commercial complex consisting of several buildings is located in the research area on the Bahlui River. Rainwater collected from the platform of the complex and the roof of the buildings is transported with a sewage network and stored in two tanks. Rainwater from each reservoir is discharged into the Bahlui River by gravity and pumping (figures 2). The discharge mode is used according to the water level in the river bed in the discharge section. The water from the reservoir is taken by a channel located on the slope of the bed and which connects to the bed of the Bahlui river through an outlet (GV2 – GV3) (figure 2) (Luca M., 2019).

Figure 2 The location on the bank of the Bahlui river of the rainwater storage and drainage tanks (Luca M., 2019)

channels. The two canals discharge rainwater into the Bahlui River through two outlets (GV1 and GV2) (Luca M., 2019).

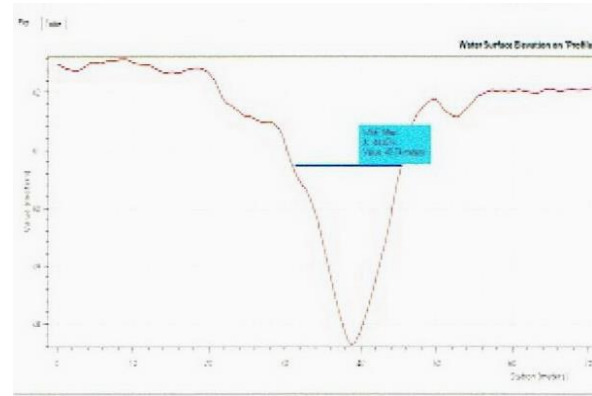
The applied regularization works formed a bed with a mixed shape: at the base, the bed has a relatively parabolic shape for low flows; the bed has a trapezoidal-rectangular shape for medium flows (figure 3). The width at the bottom is approximately constant along the length.

Figure 3 Simulation of the transverse section through the bed of the Bahlui River in the first third of the research section (Water Basin Administration Prut – Barlad, 2016 - 2021)

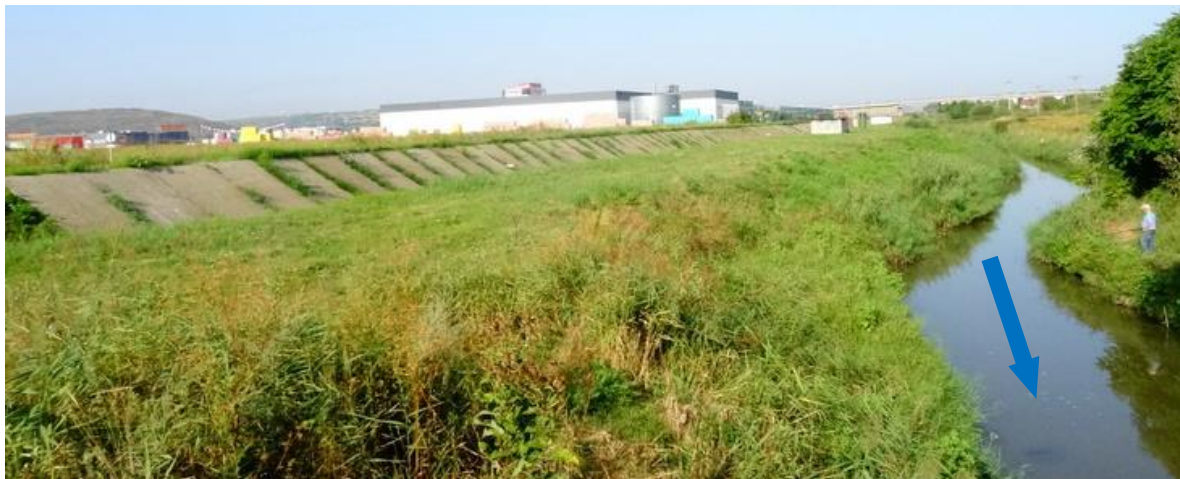
The riparian area of the right bank is laid out in steps. The slope of the right bank is arranged unevenly along its length (natural and regularized) and has a slope of 1:1. The slope is interrupted by a berm on which the four storage tanks with pumping stations are located. The berm continues with a profiled slope with a 1:1 slope and protected

with large concrete slabs according to the norms in force (GE 027, 1997). At the top of the slope are a road and the concrete platform of the shopping complex (figure 4).

Figure 4 General downstream view of the research sector on the Bahlui River (Luca M., 2019)

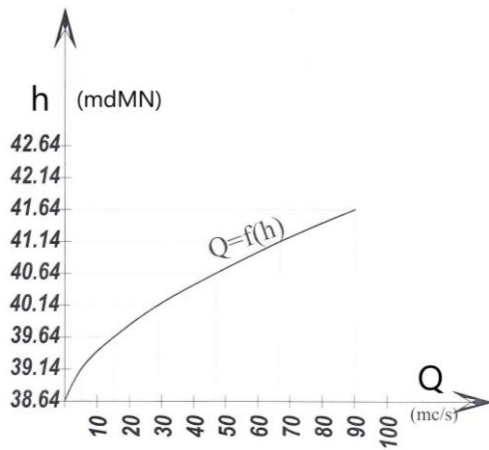
The calculation rate of regularization works on the research section is $Q_{1\%}$, and that of verification $Q_{0.1\%}$ (table 1, figure 4) (Luca M., 2019, Water Basin Administration Prut – Barlad, 2016 - 2021). The calculations performed on the research section highlighted the values presented in table 1. The variation of the flow rate (Q) according to the water depth (h) was calculated and represented graphically.

Figure 5 The limnometric key of flows on the research sector on the Bahlui River (Luca M., 2019)

The variation of the water level on the investigated section has an important influence on how the rainwater is discharged from the storage tank. At high water levels in the river, the gravity drainage pipes are blocked, in which case rainwater drainage is used through the use of pumping stations.

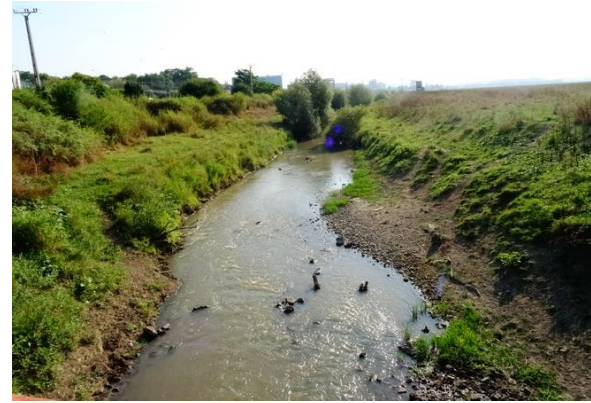
- The regularization works, with the role of stabilizing the right bank and allowing the rapid evacuation of rainwater flows, changed the geometric shape of the minor bed. The minor bed in the initial stage had a mixed shape, where the lower part was an elongated parabola, which continued with a trapezoid (figure 6). The regularized minor bed has approximately the same shape, except that the right slope is terraced at a lower slope (figure 7).

Figure 6 General view of the minor bed downstream of the research section (Luca M., 2019)

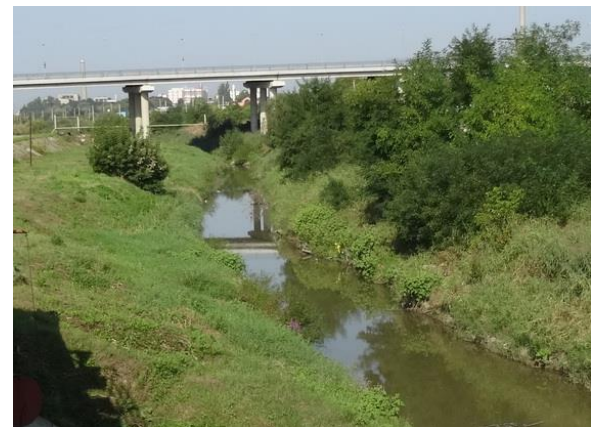
Figure 7 General view of the regularized minor bed on the research section (Luca M., 2019)

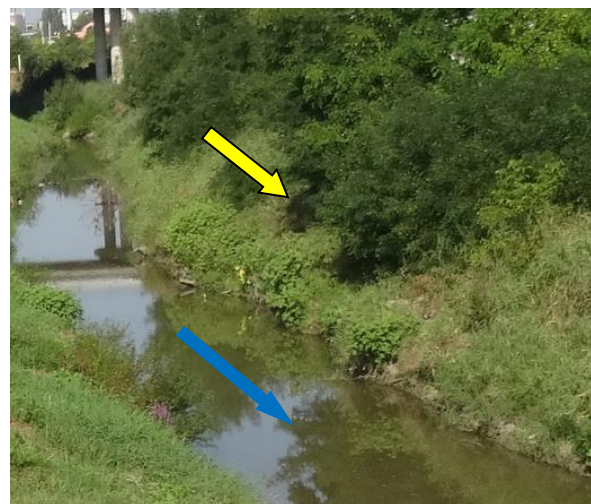
- The left bank of the minor bed is affected by erosion phenomena and clogging in the middle level area. The bank is grassy and covered by a vegetation of shrubs and trees specific to the riparian area (figure 8). The way of structuring the left bank influences its roughness coefficient during the transit of average and maximum flows.

Figure 8 General view of the left bank at the minor bed of the Bahlui River on the research section (Luca M., 2019)

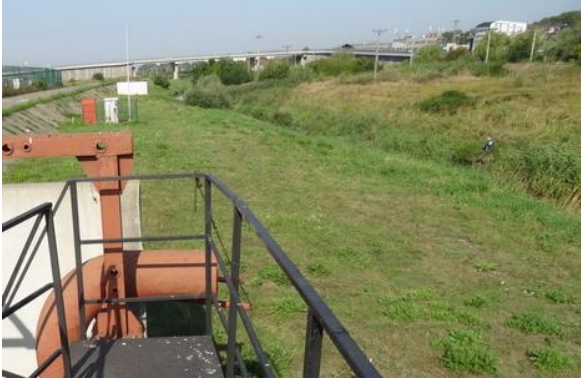
Figure 9 The structure of the right bank of the Bahlui River bed on the research section and the location of rainwater storage tanks (Luca M., 2019)

- The shape of the right slope of the bed is fragmented along its length by the presence of the four outlets of rainwater into the river (figure 9). The spillways were made with a reduced length, a situation in which the water current evolves on the unprotected slope of the bank. This situation determined the appearance of local erosions of the bank, continued with the degradation of the canal and the outlet (figure 9).

Reducing the phenomena of erosion and clogging of the Bahlui riverbed requires the design and execution of works to rehabilitate and modernize the outlets for rainwater collected from the premises of the commercial complex.

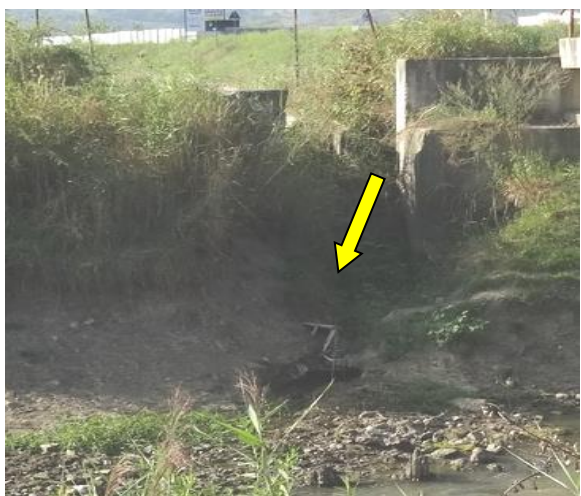
- The evacuation of rainwater from perimeter channels 1 and 2 into the Bahlui River is carried out without the existence of an adequate hydrotechnical construction. In this case, the jet formed by the exit of the water from the canal produces an erosion of the right bank (figure 10).

Figure 10 Intense phenomenon of erosion on the right bank of the Bahlui River bed at the outlet of perimeter channel 2 (Luca M., 2019)

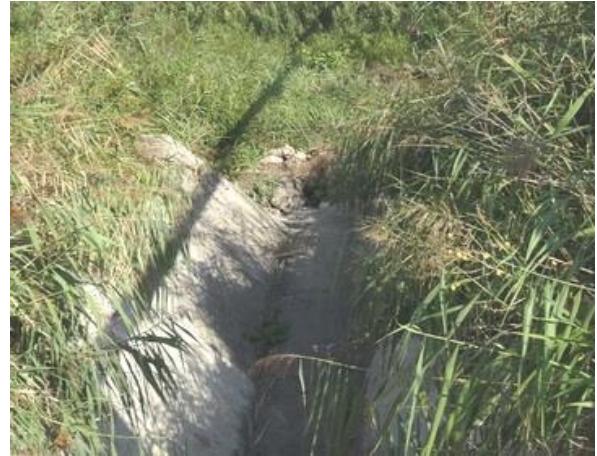
- The bank of the Bahlui river in the GV1 area shows local erosions, which over time advanced the bank and caused its loss of stability. The water from the river eroded the foundation of the drainage channel causing the concrete to crack and parts of the channel to collapse. The discharged water inflow caused the formation of abundant bank and aquatic vegetation, which also obstructs the flow of water in the canal (figure 11).

Figure 11 State of the evacuation sector (GV1) on perimeter channel 1 (Luca M., 2019)

An indicative element of the need for the application of rehabilitation works is represented by the fact that the four mouths/rainwater drainage channels have not been structurally completed in their entirety up to the minor bed of the Bahlui River. This situation caused the collapse of the GV1 and GV4 concrete channels and the erosion of the bank, but also of the discharge channel near the GV2 and GV3 empties from the rainwater pumping stations (Luca M., 2019).
