## RESEARCHES ON ENVIRONMENT DEGRADATION IN THE NATURAL SITES ON MOLDOVA RIVER LOWER COURSE

LUCA M.<sup>1</sup>, SION P. V.<sup>2</sup>, AVRAM Mihaela<sup>1</sup>

**Abstract.** *The European Ecological Network Natura 2000 in Romania is present on the lower course of the Moldavian River through the "ROSC10364 Community Site of Rila Moldova between Tupilati and Roman". Research over 15 years has shown that part of the natural reserve is affected by degradation phenomena. In the researched river sector (the minor and major riverbed, the riparian area) are located ballasts, bridges, water catchments, constructions, agricultural holdings, trees and bushes areas, etc. All these have influenced the arrangement of the river bed and the riparian area, which led to the degradation of the river and riparian habitat. Natural and anthropic risk factors have contributed to the degradation of the environment in the researched river area. The most important influences were the floods of the last 15 years, the exploitation of the ballast, the shore circulation areas, the absence of maintenance works in the river bed, etc.*

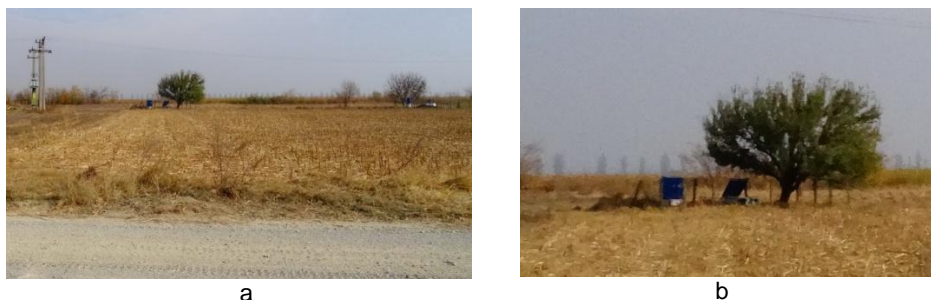
In the riverside area on the Moldova River, downstream of Pildești, there is a Roman water catchments area. Water capture consists of 66 capture wells and seven reinforced concrete boxes located parallel to the river bank. Current maintenance works - repairs and conservation of the sanitary protection area have negatively

influenced the habitat in the meadow area (fig. 2). The sanitary protection zone requires an environment without agricultural crops and the use of fertilizers. This situation does not allow the existence of optimal habitat conditions for some species.

**Fig. 2** The riparian area on the left bank of the Moldova River downstream Pildești, with the water catchment area: a - general view of the habitat area; b - detail of the sanitary protection area of the capture well, year 2018.

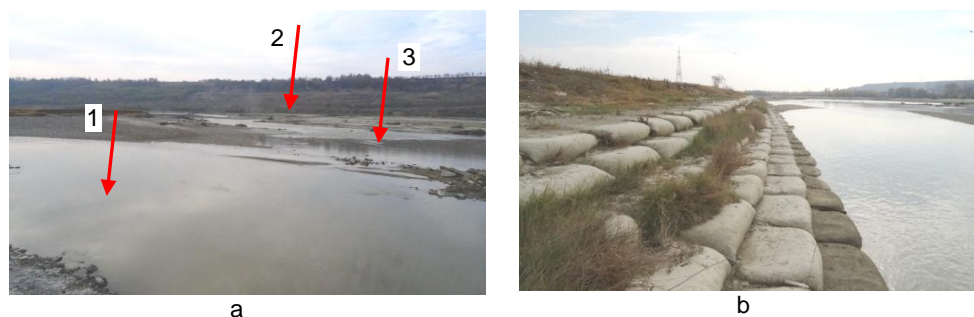
Ensuring the hydraulic parameters at the capture wells required the calibration of the Moldova river bed. Albia has a width of about 400 - 750 m across the catchment section, which causes the migration of the minor bed from the left bank to the right bank to pass through the floods. In order to ensure the water level in the catchment area, regularization works were carried out to move the small bed to the left bank (routing dams, docks, sleepers, bottom sills, shores, etc.) (fig. 3). Multi-annual average flow is  $33.0 \text{ m}^3/\text{s}$ , situation that imposed the presence of the bottom thresholds to ensure a water depth of 0.90 - 1.20 m (fig. 3.a). The works of this type influenced the habitat in a series of species protected in the natural site.

**Fig. 3** The state of the natural site in the Pildești area on the Moldova river: a - the riverbed branching zone (year 2015), 1 - the new bed in the capture area, 2 - the old riverbed, 3 - digging dam; b - view of calibrated bed and shore defence in capture area (year 2018).

The shore defence is made of geo-bags (fig. 3.b). By way of vertical and horizontal installation of geo-bags, favourable conditions for restoration of the habitat in the minor riverbed of the Moldova river are achieved. Geo-bags reduces water speed, deposition of alluviums and the creation of flora and fauna in the shoreline environment (Luca *et al.*, 2018).

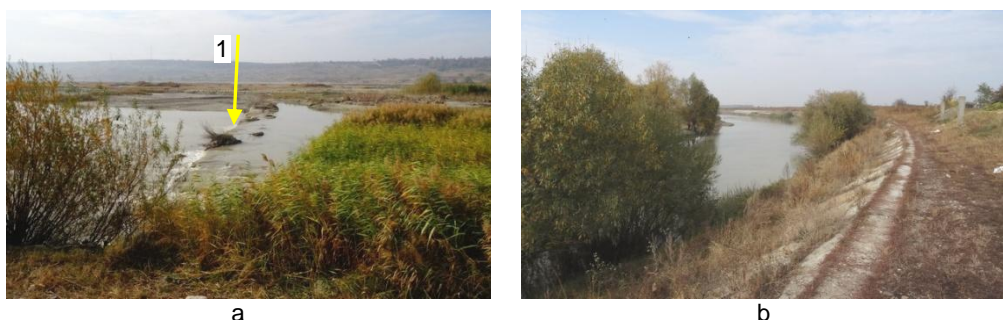
The frequent floods of the years 1992, 2005, 2006, 2008, 2010, 2016, 2018 modified the bed and degraded the river-related settlement work in research. Flows recorded at floods showed high values that exceeded the probability of calculating the adjustment works ( $Q_{\max} = 600 - 1200 \text{ m}^3/\text{s}$ ). The repeated morphological modification of the bedrock has altered the conditions of existence of the aquatic habitat (fig. 2.a and fig. 4.a). The restoration of the bed stability ensures optimal living conditions for the species protected in the natural site.

**Fig. 4** The state of the "Tupilati-Roman" natural site on the Moldova River: a - bottom (1) in the calibrated riverbed, Pildești area; b - protection of the concrete slab in the Cordun catchments area (year 2018).

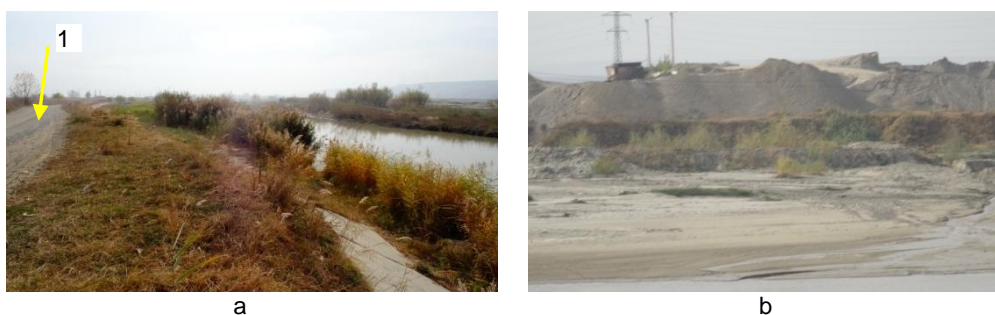
A degradation of the natural environment within the site is determined by the intense movement in the riparian area of the ballast transport machines (fig. 5.a). The road is from the ground, with varying widths, with penetrations on the natural ground, which causes a continuous degradation of the riparian area. Noise, dust, and especially pollutant gases dispersed in the air by Diesel engines severely affect the quality of air, water and soil in the natural site area (Sion, 2019).

**Fig. 5** State of the natural site in the riparian area: a - earth road (1) used for ballast transport, (year 2018); b - the presence of ballasts in the riverbed and the riparian zone.

A degradation factor of the aquatic environment is due to the presence of the ballasts in the locality of Pildești and Cordun (fig. 5.b). The research showed the change of the turbidity of the water and the increase of the solid flow

transported on the bedside sector located in the natural site. This situation has greatly disrupted the aquatic habitat of protected species within the natural site.

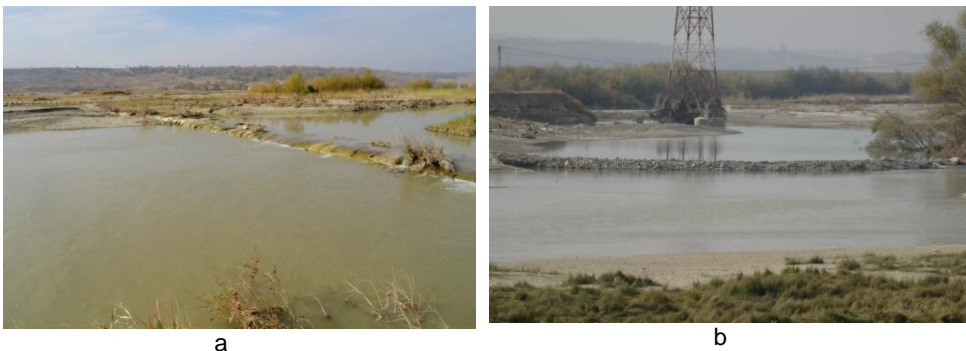
**Fig. 7** Degradation of the aquatic habitat through works in the riverbed of Moldova River: a - transverse works (bottom threshold); b - exploitation of the ballast with morphological degradation of the bed (year 2018).

Hydro-hydraulic work done in the natural site must ensure the living and conservation conditions of mammalian species, which is among the few sites designated for *Spermophilus citellus* and *Lutra lutra*. It is worth mentioning that some constructions and works for regulating the river bed of Moldova exist from a period before the designation of the natural site.
