RESEARCH ON POLLUTION OF THE GROUNDWATER CAPTURE

LUCA M.^{1*}, STICEA A.S.,¹ LUCA A.L.²

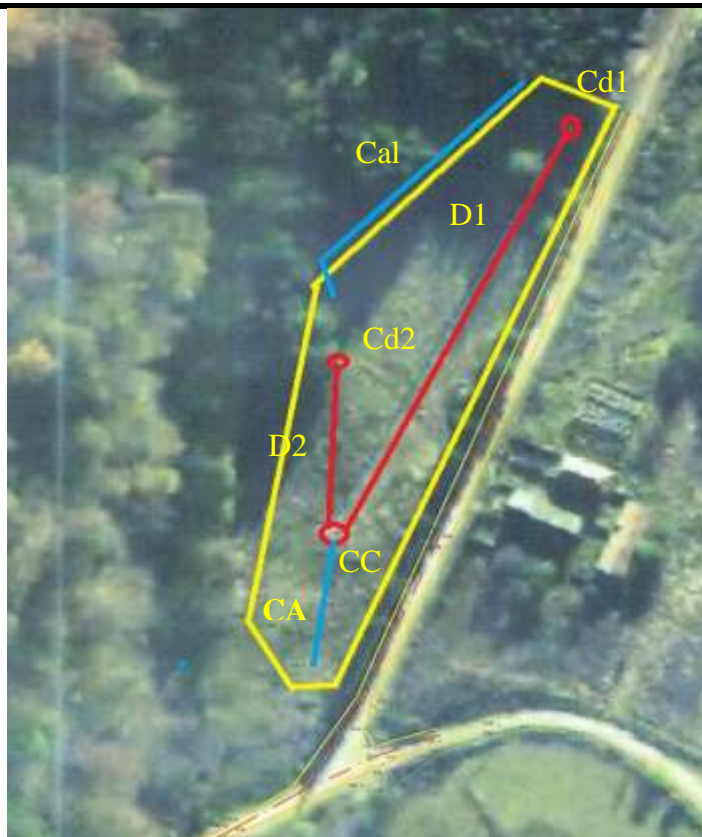
The groundwater catchment is located at about 300 m from the confluence of the streams Leșunțul Mic and Leșunțul Mare. The captured flow is 4.8 l/s at a hydrostatic level of 1.40 - 1.70 m. The capture consists of the following components (fig. 2):

1. Two catch drains (D1, D2) located on an area at the base of a slope. The drains are 75 m long, are made of stone and gravel and are mounted at a depth of 3.50 m.

2. Two visiting homes (Cd1, Cd2) provided in the upstream section of each drain. The visiting home have an inner diameter of 1.50 m, a depth of 3.50 m. The visiting home are made of reinforced concrete.

3. A collecting visiting home (CC) to which the two catchment drains are connected. The collecting visiting home has an inner diameter of 1.50 m, a depth of 4.50 m and is made of reinforced concrete. In the collecting chamber is located the suction of the supply pipe that transports the captured water to the storage tank and the treatment station.

4. A channel located perimeter of the catchment surface with the role of supplementing the volume of water in the underground layer. The canal is fed by a diversion from a mountain stream located near the catchment front.

5. Sanitary protection works for groundwater abstraction consisting of: 1 - "severe sanitary protection area" protected by fencing, protection distance 72.0 m, about 2.0 ha; 2 - "restricted health protection area", protection distance 180 m, about 6.0 ha.

Fig. 2 Orthophotoplan with the location of groundwater abstraction: Cd1, Cd2 – visiting home 1, CC - collector visiting home, D1, D2 - drain, Cal - supply channel, CA - adduction pipe (Luca 2020).
