ENVIRONMENTAL DEGRADATION PHENOMENA IN IRRIGATION SYSTEMS

LUCA M.^{1*}, STICEA A.S.¹, LUCA AL. L.², SION P.V.¹

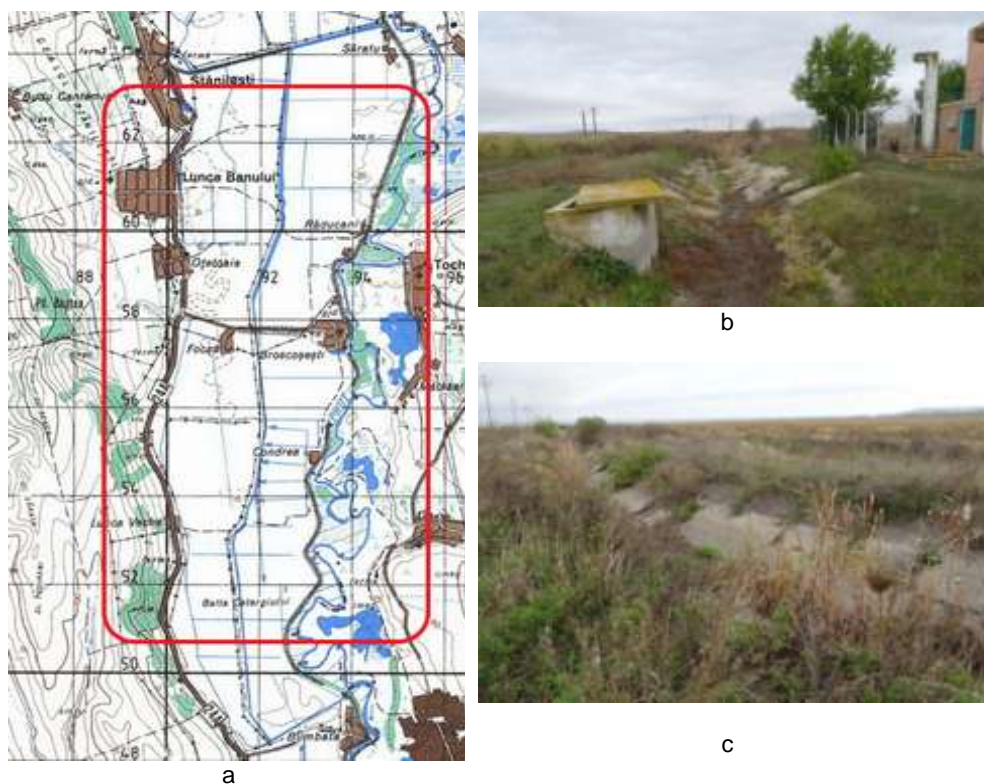
Fig. 1 Study and research area: a - location of irrigation systems in the Prut river meadow; b - channel CA3 and SPP 9 Oțetoaia; c - supply channel CA3, Plot SPP8 Oțetoaia (Luca, 2020)

I.a - Alluvium transported by irrigation water on the route from the source to the emission from the sprinkler system. Alluvium contributes to the clogging of the supply channels of the pumping stations (fig. 1.b, fig. 1.c) and of the drainage channels (fig. 2). Alluvium influences the texture and structure of irrigated soil. Alluvium contributes to increased wear of nozzles on watering equipment. This phenomenon is mainly registered in the irrigation plot SP7 Doniceasa - Fălciu, on the main supply channel CP5 for SPPM 7/4 ... 7/8. The canal is clogged at a height of about 65% (Luca, 2016).

which they are distributed with the sprinkler irrigation equipment evenly on the agricultural land (fig. 1.b, fig. 1.c). The CA3 supply channel from the SPP8 and SPP9 irrigation plots Oțetoaia has rich grass vegetation in the area adjacent to the canopy. Vegetation has become a source of soil pollution by taking seeds into irrigation water.

- degradation of the structure of the water supply channels of the system, a situation that caused large water losses and influenced the characteristics of the environment in the area; most of the supply channels have a degraded structure due to the exceeding of the exploitation period of the protection material due to the infiltration phenomenon (protection with large reinforced concrete slabs); the degradation of the concrete slabs led to the appearance of large water losses, a situation that influenced the stability of the canal and the constructions on it; a significant example is represented by the supply channel CA3, Plot SPP 9 Otetoaia at which the degradation phenomenon is very extensive (fig. 1.b)

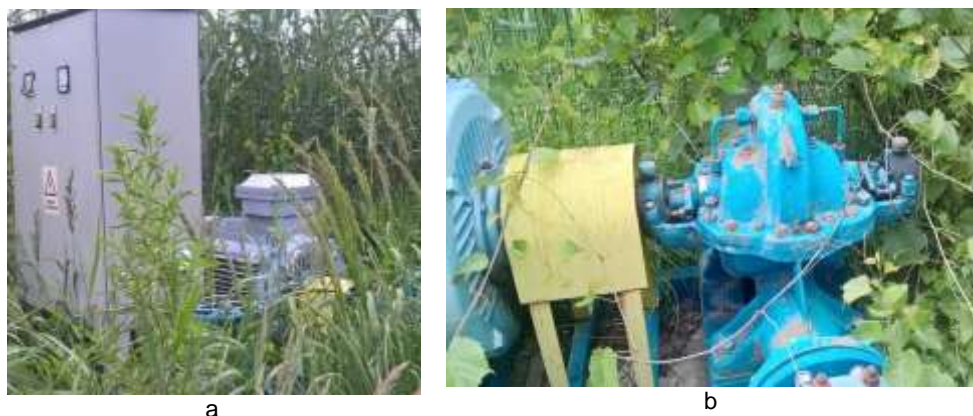
Fig. 2 The impact of the meadow vegetation (reed) on the hydro-mechanical and electrical installations from SPPM, Plot 7 Doniceasa-Fălciu: a - occupying the location of the pumping station with vegetation; b - the influence of vegetation on the operating conditions of the pumping unit (Luca 2016)

I.c - Biological material specific to the river meadow area, especially reed (*Phragmites australis*) excessively developed in the location of the constructions and installations of the pumping stations (fig. 2). The presence of groundwater at shallow depth favoured the development of reeds in the area of pumping stations, but especially in the drainage channels (they have water permanently (fig. 2)), but also in the irrigation channels (fig. 1.b). This situation is present in the location of the pumping stations SPPM 7/1 ... 7/8 from the irrigation plot SP7 Doniceasa - Falcu fed from the main channel CP5. The reed-like vegetation extended over the entire area adjacent to the crown of the CP5 canal. The pollution phenomenon negatively affects the structural condition of the pumping units, of the electrical installations and of the hydraulic installation (fig. 2).

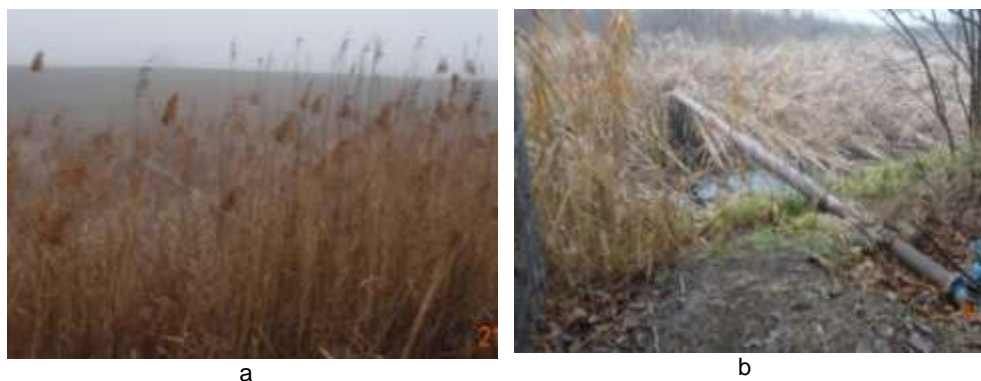
Fig. 3 Impact of canals on the research area: a - drainage canal filled with vegetation and inoperable; b - CP5 supply channel, Plot 7 Doniceasa – Falcu clogged on variable lengths (Luca 2016)

- blocking the flow in the drainage channels and increasing the groundwater level in the soil, a situation that determines the salting of the soil and changes in the habitat of the area; some of the drainage channels are clogged and have blockages of the flow section; the high level in the drainage channels determines the increase of the groundwater level in the soil, a situation that favours the appearance and maintenance of the salting phenomenon (Marinov and Safta, 2001);

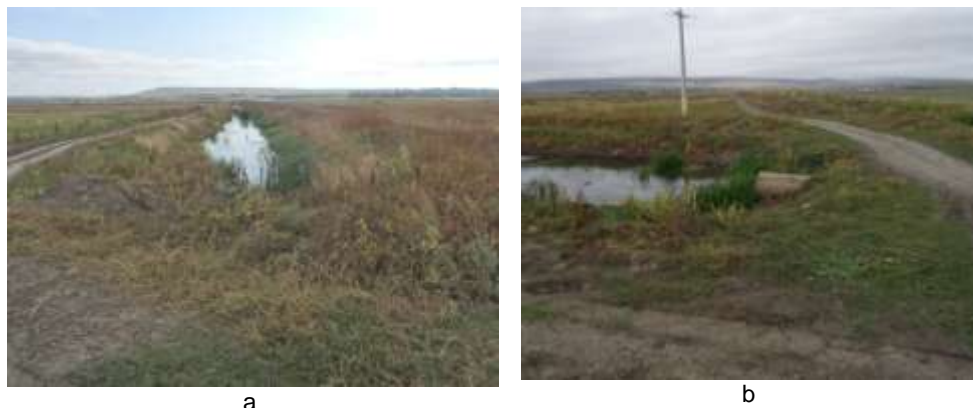
Fig. 5 State of degradation of traffic routes in the irrigation system with environmental impact in Plot SPP8 Oțetoaia: a - exploitation road along the canal; b - bridge on the drainage channel (Luca 2020).

- the presence of excess hydrocarbon dust, dust and aerosols in the area of the exploitation roads in the irrigation system (the roads are unmaintained and the bridges are not repaired); the pollution phenomenon is widespread throughout the irrigation system; as an example it is presented in figure 5 of the exploitation sump from the SPP8 Otetoaia Irrigation Plot;
