BALSH-STURDZA PALACE GARDENS OF IASSY

DASCĂLU Doina Mira¹

Abstract. *Often, the occasion of some buildings rehabilitation or restoration lead to the discovery of important details, far older than the original historical dating. This is the case of the imposing palace Balsh-Sturdza, today the Central Post Palace of Iassy. The main building was located in the middle of a wide enclosure, containing both the annex buildings and the boyar courtyard gardens. Deciphering data of nineteenth century plans, coupled with evidence provided by archaeological researches, led to the reconstitution of the old boyar courtyard plan organization.*

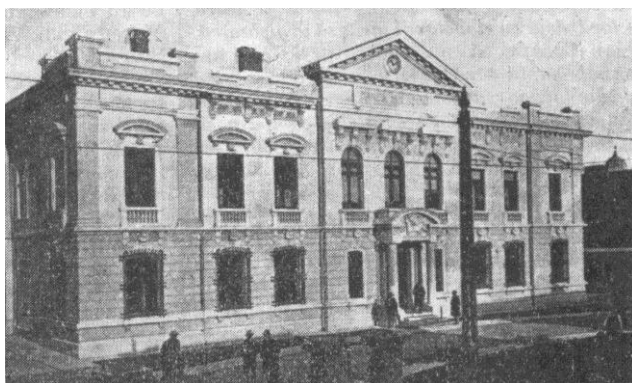
Fig. 1 - Façade of the palace in 1913 (Bogdan N. A., 1997)

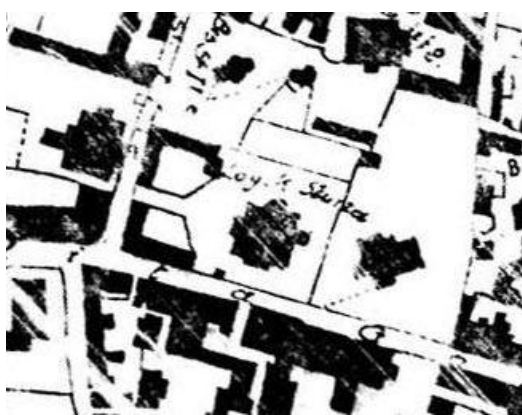
Fig. 4 - The courtyard in Peytavin plan

in time kept a large enclosure. This fact can be found out from Iasi planning executed in 19th century by engineer Bayardi in 1819 (fig. 3) and by engineer Peytavin in 1857 (fig. 4). In a detailed analysis we notice from these plans that the palace was retreated from St. Ilie lane (today Alecsandri street) and from Golia lane (today Cuza-Voda street) and located in the middle of the boyar courtyard. This retreat in the boyar courtyard intimacy is characteristic to 17th-18th centuries when the palaces defended their intimacy to the street by walls and areas planted with trees and shrubbery – in Iasi, especially with lilac, acacia and lime trees conferring a charm and perfume (Cantacuzino G. M., 1999). In the 19th century, wishing to expose their richness and rank, the nobility renounced to the protecting walls of the enclosures and brought closer the palace building to the street to make more visible the splendors of the facades. The enclosure and location of Bals palace, retreated from the street in the middle of the boyar courtyard, confirm, alongside the above mentioned archeological signs, the edifice age. By a compared analysis of Bayardi's and Peytavin's plans we notice that the space around the central building was structured in some enclosures: a large court for reception in front of the main western access way and secondary courtyard located to north, south and east. In the Bayardi's plan from 1819 (fig. 3) we may observe a partition of the boyar enclosure in three courtyards: the western courtyard, the northern one as well as a courtyard to south-east. In the Peytavin's plan of 1857 (fig. 4), we can not notice any delimitations of any inside courtyards so that we may emit hypotheses only by examining the site and the neighborhoods. The main access way to the boyar courtyard from St. Ilie lane (present day Vasile Alecsandri street) was flanked by a set of two outbuildings which can be noticed even today on the location (fig. 5).

In Peytavin's plan, the two administrative building sets, that flanked the access way to the street, had proper enclosures. In 19th century, according to the époque's style and due to financial needs, the ground floors of these administrative buildings were transformed in commercial spaces bringing income to the palace and the courtyard owners. The commercial function was partly maintained till nowadays at the ground floor of the buildings. As we previously mentioned, the archeological research discovered elements of the main entrance

in the palace, centrally located, on the western façade, e.g. to St. Ilie lane. In both plans of 19th century, we may notice that in front of this entrance, a large reception court was opening. The other entrance, discovered by archeologists to the north side, mentioned in the previous section, offers signs of northern enclosure of the boyar courtyard. From the fact that this secondary entrance was architecturally treated with much care, with decorative pillars and a stair head plated with apparent bricks, we may presume that there was an important access way to an outdoor space of the palace, probably in a landscape arrangement. The placing to the north shows the existence of a shady summer garden intended for relaxation and rest. The only courtyard where it was possible to have existed useful plantations along with other outhouses could be the third courtyard, visible in Bayardi's plan to south-east. However, a small orchard and a vegetable garden could be placed only to the inside of the courtyard; to the street a protection plantation was created. In the context of Peytavin's plans, the location of the southern courtyard to an important lane of Iasi, Golia lane (present day Cuza-Voda street) excludes any utility function that could have offered an unaesthetic image. It is possible that this southern area would be decoratively planted with trees and shrubs. Therefore, only the space from the east, neighboring another property, could have been destined to utility plantations.

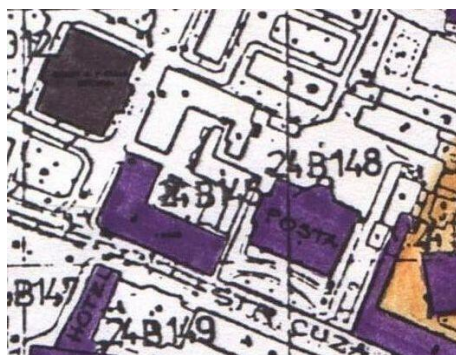
Fig.5 - Nowadays situation
