EVOLUTION OF THE GEOMETRIC AND HYDRAULIC PARAMETERS OF THE CHANNELS OF THE ROTOPĂNEȘTI-RĂDĂȘENI-FÂNTÂNA MARE DRYING- DRAINING SYSTEM OF SUCEAVA COUNTY, AFTER 27 YEARS OF OPERATION

RADU O.

University of Agricultural Sciences and Veterinary Medicine Iași

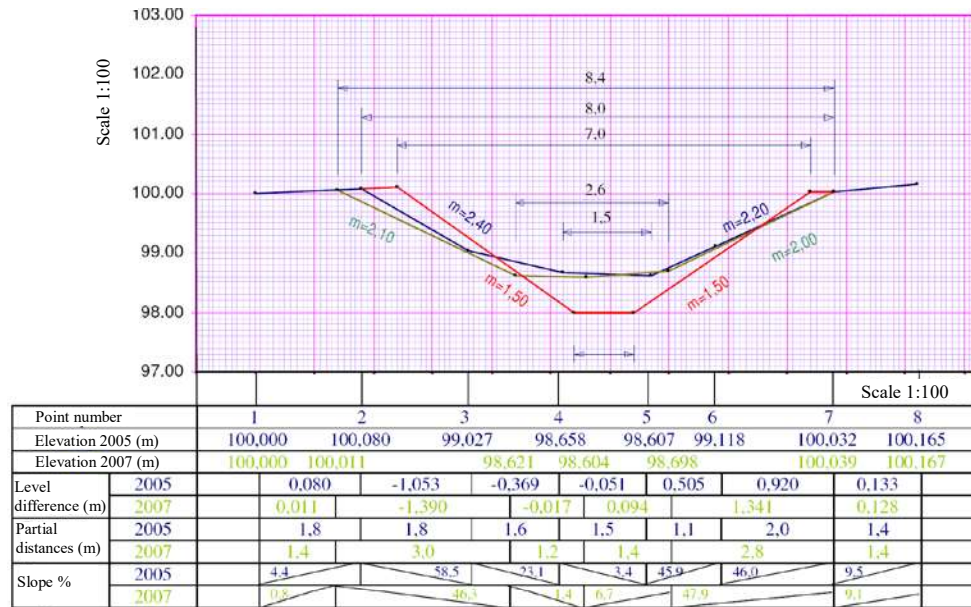
In the studied section, located at about 1 km downstream from the origin of the channel collecting the waters on an area of about 80 ha, the following items, shown in figure 1, were determined by measurements in 2005:

- channel depth $H = 1.40$ m;
- width at the bottom of the river bed $b = 1.50$ m;
- slope of the left bank $m_s = 2.40$ and slope of the right bank $m_d = 2.20$;
- B collecting channel light = 8.00 m.

Further to these determinations, we found a 0.60 m silting, which resulted into an increase in the width at the bottom of the channel from 1.00 m to 1.50 m. At the same time, the bank erosion was found to be more marked on the left side (0.60 m), since this side of the channel collects the surface water and the water from accidental spills from the CC_1 belt channel, located upstream, on the border of the dried area, located 400 m away. Bank erosion resulted into changes of the slope coefficient from 1.5 to 2.4 and 2.2 , respectively, and also to an increase in the channel light from 7 to 8 m. As a consequence of these phenomena, the channel carrying capacity in this section decreased from 8 m^2 to 6.65 m^2 .

Figure 1 – Cross-section in the „Şomuzel” main collecting channel

Based on the observations and measurements carried out in 2007 in the same location, we found significant changes to the shape of the cross-section, namely an increase of the width at the bottom from 1.5 to 2.6 m and of the channel light from 8.00 to 8.40 m. The changes occurred on the left side of the channel, since on this side continued the interceptions of the surface water flows from the upper neighboring areas discharged in the same CC₁ channel, which is unable to collect and discharge these flows.

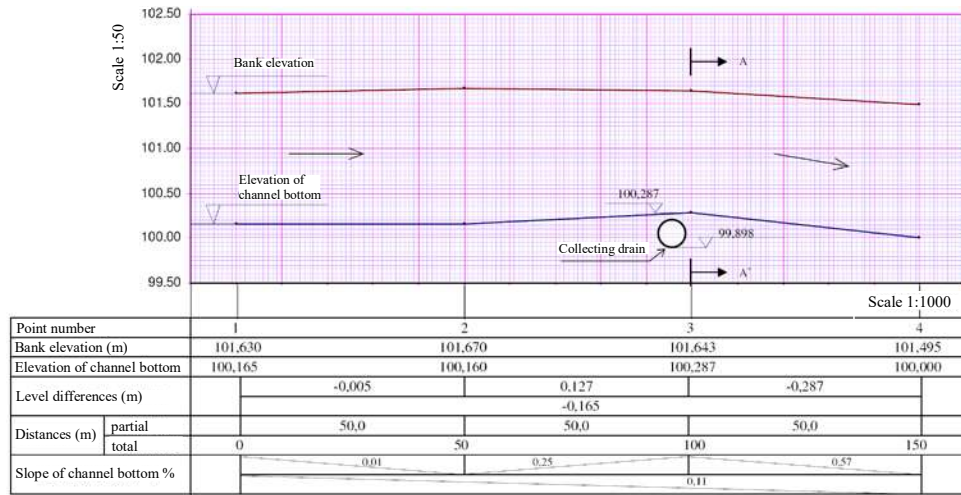
In the longitudinal profile performed upstream and downstream from the cross section of this channel section (figure 2), we noticed a change in the longitudinal slope caused by channel silting, which produced a 0.25% and 50 m long counter-slope. Downstream from the section, the longitudinal slope increased to 0.57% due to the unevenness caused by the counter-slope. Due to this counter-slope, a hygrophilic vegetation grew upstream caused by stagnant water for a longer period of time. On the 150 m of the studied channel section, a mean flowing slope of 0.11% is however maintained, designed to provide water flow transfer along the channel during high-flow seasons.

Figure 2 – Longitudinal section through the „Şomuzel” main collecting channel

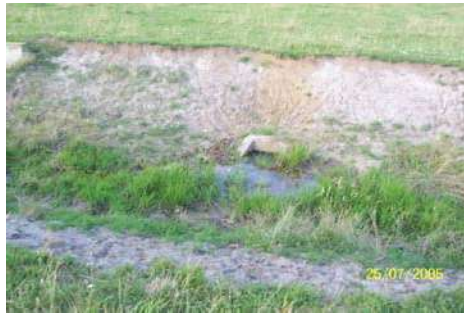
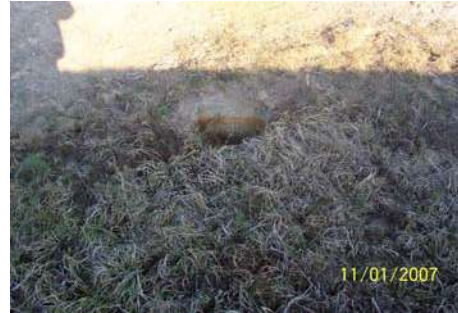
In this section we noticed a discharge opening of a collecting drain with a nominal diameter of 200 mm, with the lower generator located at a depth of 0.39 m below the current level of the bottom of the collecting channel, in which it was actually supposed to discharge (photo 1 and 2). This obstruction of the collecting drain occurred because of the silting of the bottom of the channel further to the high flows of its 27 years of operation. Therefore, we may estimate a mean silting rate of about 2.4 cm/year, which would lead to the onset of the unsilting, cleaning and renewal works on the carrying section, after about 25 years of operation.

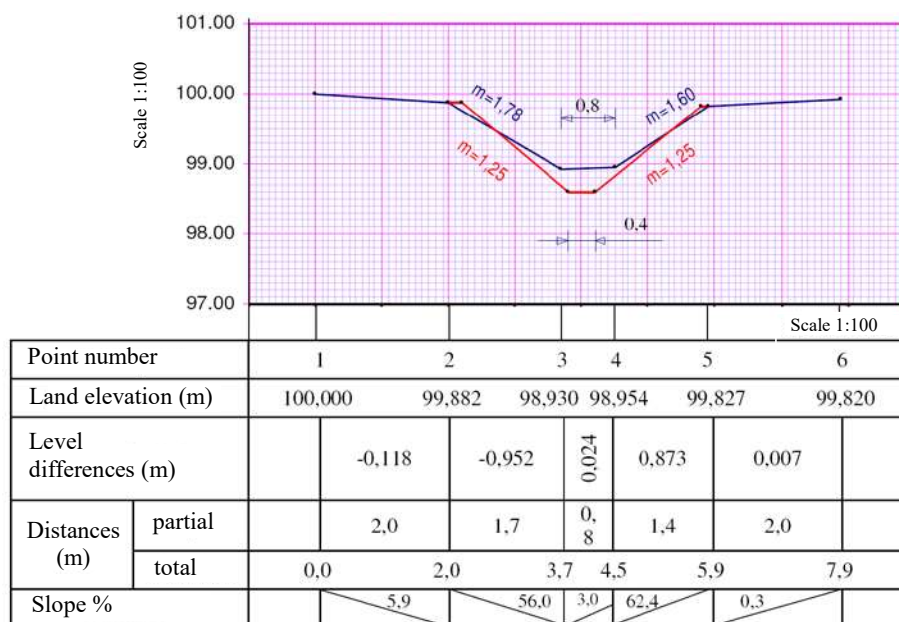
The geometric and structural parameters of this channel upon its building (figure 3), were: length = 1400 m, width at the bottom $b = 0.40$ m, slope coefficient $m = 1.25$, mean depth = 1.52 m (upstream = 1.30 m to ensure the discharge of the suction drains, and downstream = 1.74 m).

After 27 years of operation, the cross section in the A-A' channel section in figure 3 shows that a silting of about 35 cm also occurred here, which led to changes in the width at the bottom from 40 to 80 cm, and the slope coefficient changed from 1.25 to 1.78 on the left side slope and from 1.25 to 1.60 on the opposite (right) side. Due to collecting channel silting, the upstream discharge openings of the suction drains on this channel were completely covered, while downstream, due to the greater channel depth, the discharge openings are silted only partially and the water stagnates in the draining pipes.

Figure 3 – Cross section through the (Ccst₉) sector collecting channel
