INFLUENCE OF THE CHANGES OF THE GEOMETRIC AND STRUCTURAL PARAMETERS OF THE DRYING NETWORK, ON THE REMOVAL OF EXCESSIVE WATER, IN THE ROTOPĂNEȘTI-RĂDĂȘENI-FÂNTÂNA MARE SYSTEM IN SUCEAVA COUNTY

RADU O.

University of Agricultural Sciences and Veterinary Medicine Iași

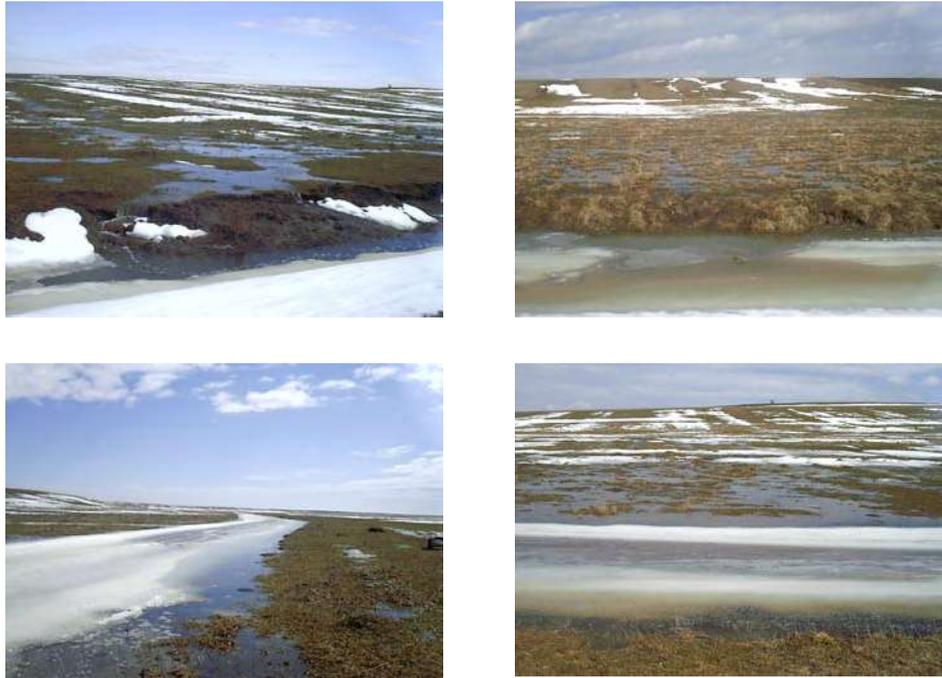
During the studies performed, we noticed that the CC₁ belt channel of the Rotopânești-Rădășeni-Fântâna Mare system filled up due to the slope flows after heavy rains of 48 to 72 hours, as well as after snow melting (photo 1).

Photo 1- CC₁ belt channel filling up

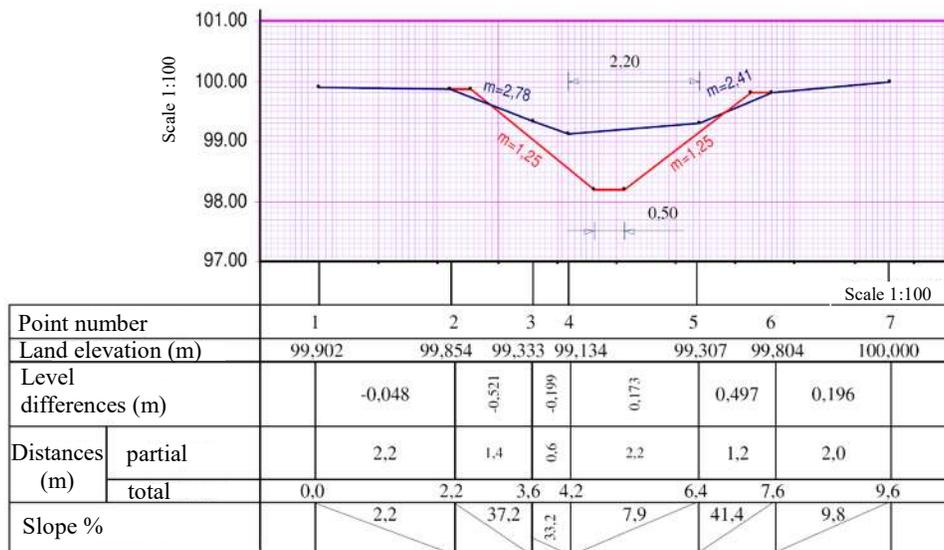
After 27 years (1980-2007) of operation and especially in the last 17 years, the original section of the CC₁ channel was silted by about one meter, with a mean depth silting rate of 3.7 cm/year (figure 1).

Figure 1 – Cross section through the CC₁ belt channel

The analysis of the flowing section of the channel shows that it originally had a value of 4.41 m^2 and it has now reached 2.28 m^2 , which means a decrease of the collecting and carrying capacity of about 50%. The one meter channel silting in this section is caused both by the higher reception surface and the water flowing from it, and by the smaller longitudinal slope of the channel as compared to the upstream section.

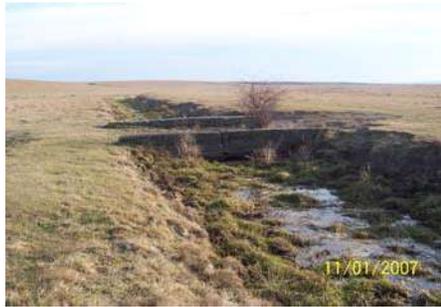
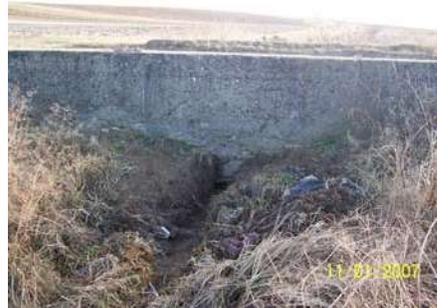
Due to the silting of the bottom of the channel with silts brought by the slope water flows and by the bank erosion they cause, and due to the presence downstream of a footbridge whose pipe section is silted (photo 2), the belt channel is no longer able to carry the water to the Şomuzel collecting channel, which means water spills and flooding of the neighboring areas (photo 3). Therefore, the CC_1 belt channel can no longer protect the dried-drained surface; on the contrary, it collects large amount of water on its right side, which are collected by the Şomuzel collecting channel, the latter having in this sector a route approximately parallel with the CC_1 .

Photo 2- Channel section and silted footbridge

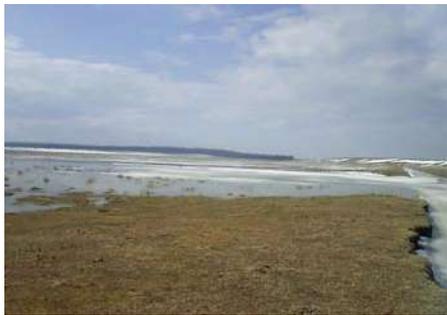
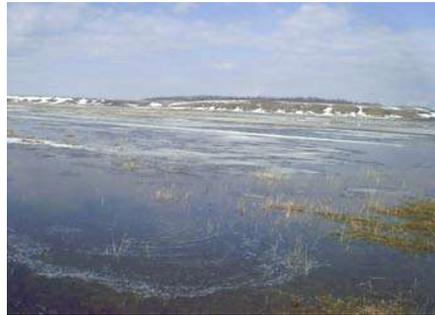
Photo 3 – Spills and flooding of the neighboring land

3. The degradation of a channel section may determine spills of the water collected by it, the flooding of the neighboring land, longer excessive humidity periods and hygrophilic vegetation growing.

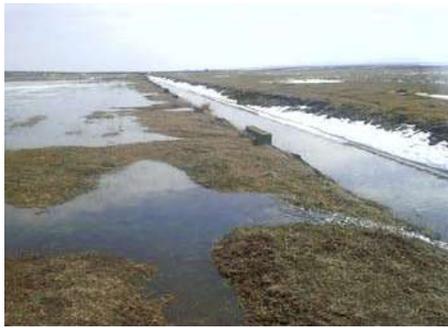
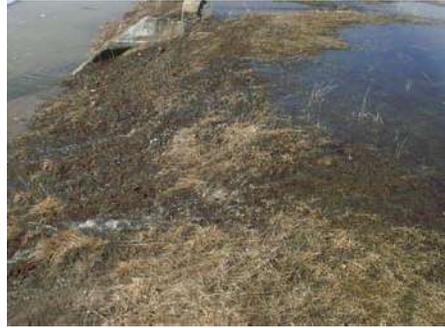
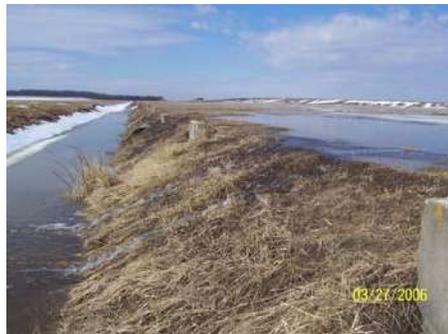
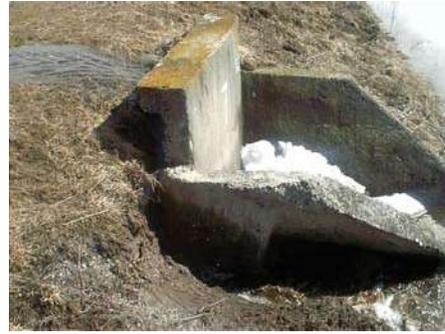
This water spills from the CC_1 belt channel, and also the heavy precipitations in the last 24 hours and/or in the last 1-5 consecutive days, result into a higher surface water flowing speed (photo 4), which accelerates the bank erosion phenomenon of the Şomuzel main collecting channel (photo 5) and also drags along sediments and soil particles that clog the bottom of the channel.

Photo 4 – Collection of the water spills from the „Şomuzel” channel

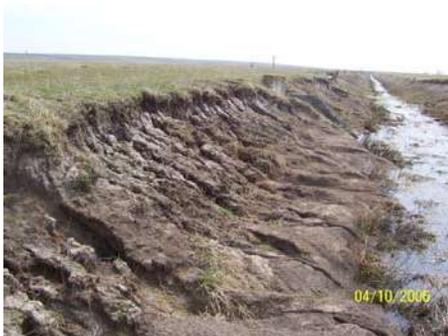
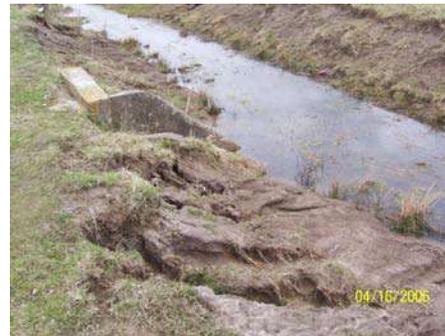
Photo 5 – Slope erosion and channel bottom silting

2. During study performace, we found a highly marked bank erosion and channel silting in the areas where the dried-drained land was used as grazing field. In these areas, there is little or no grass grown on the slopes, due to inadequate grazing and to the fact that the animals are allowed to cross the channels, which is harmful especially during excessive humidity seasons. The slopes of the channels in the areas used as arable land, have much grass grown on them, which, on the one hand, diminishes bank erosion and, on the other hand, in time, if this grass is not cut, it facilitates hygrophilic vegetation and bush growing, which disturbs water flowing and accelerates silting.

4. Even the smallest deficiency in the operation of a component of the drying-draining systems should be fixed immediately, to prevent degradation acceleration in time, or their placing out of operation.
