MONITORING THE TEMPORARY STABILITY OF THE PODIȘU DAM FROM IASI COUNTY BY ADVANCED TOPOGRAPHIC MEASUREMENTS

The paper presents elements of analysis of the temporal stability of earth dams by using topographic methods. Structural deformations and displacements are determined and processed by data obtained from advanced topographic studies on the geometry of the dam construction. The studies and researches were carried out for the Podișu earth dam located on the Valea Oii river, Bahlui river basin, Iași county. Special hydrological events recorded in recent years in the Bahlui river basin and especially on the Valea Oii river, have influenced the stability of the earth dams in cascade in this area. Monitoring the structural condition of dams and obtaining stability analysis data were made by topographic surveys in 2006, 2017, 2019. To carry out in accordance with the legislation in force the monitoring of the behavior of constructions, they must be equipped with settlement tracking landmarks but also fixed landmarks. This situation is not fulfilled at most class C and D earth dams. In the absence of tracking marks, in 2019 four landmarks were installed at the Podișu dam and a local t

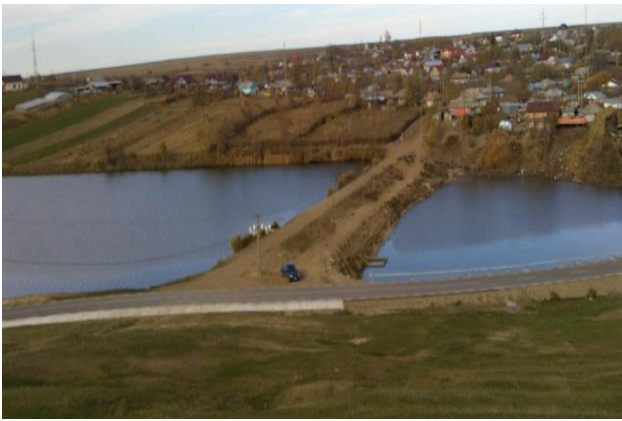
Earth dam Podișu (*figure 2*) is located in the southwest of Podișu village. The Podișu dam is a homogeneous type of earth dam made of local materials with a trapezoidal shape and a circulated crest.

Figure 2 Overview of the Podișu earthdam (photo: Agapie I., 2019)

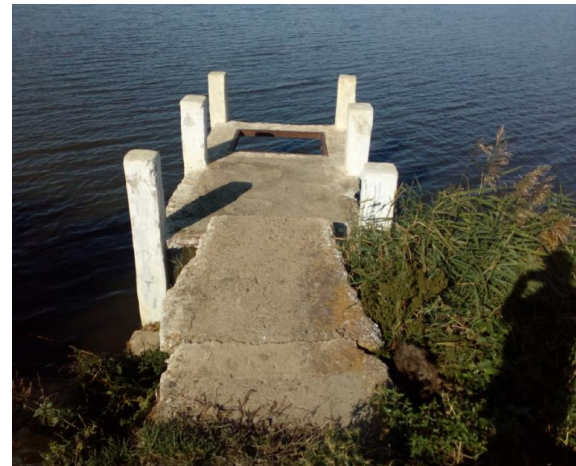
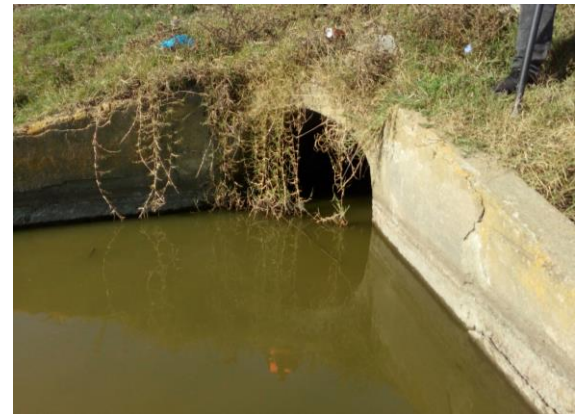
Spillway C1 (*figure 3*) built of reinforced concrete has a rectangular section of 2.00 x 3.70 m. Its height is 3.5 m and the length of the water access front is 1.0 m. Spillway C1 is provided with wooden valves to control the water level in the lake and flows discharged downstream. Spillway C1 is also provided with a window equipped with metal grilles.

Figure 3 Photo representing the spillway C1: a – upstream; b – downstream bottom discharge (photo: Agapie I., 2019)

Pipe conduit has a length of 19.50 m and is constructed of reinforced concrete. The pipe shaft is at 82.70 m elevation. Spillway C1 flows into the energy dissipation channel made of reinforced concrete.

According to the last technical inspection carried out in 2016 (Tănăsescu, 2016), the concrete surfaces of the spillways C1 and C2 were in satisfactory condition with no significant cracks or exfoliations. During the visual inspection of the earth dam, the state of protection of the upstream and downstream slopes was examined. Their condition is satisfactory, without the presence of wetting or infiltration. The analysis shows that the discharge of bottom drain at the spillway C1 requires repair work.

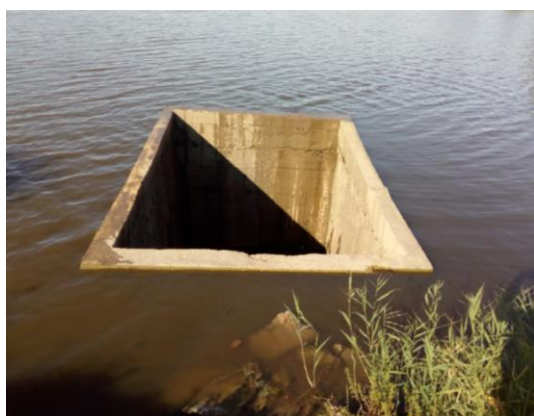
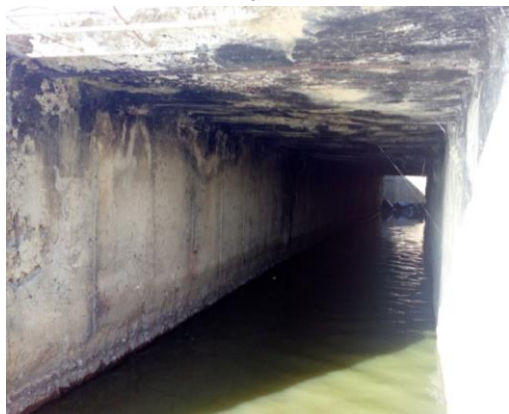
Spillway C2 (*figure 4*) is made of reinforced concrete, has a rectangular section measuring 3.8 x 5.0 m and a height of 3.5 m. For free access to water the spillway has a window equipped with metal grilles. Also, the presence of wooden valves can be noticed, with the help of which the water level in the lake and the flow discharges downstream can be controlled. The length of the water access front is 2.0 m.

Spillway C2 outlet, of reinforced concrete has a length of 22.0 m and a square section measuring 2.0 x 2.0 m. The pipe shaft is at 83.30 m elevation. Also, in the case of spillway C2, outlet flows into the energy dissipating channel.

Figure 4 Photo representing the spillway C2:
a – upstream; b – downstream bottom discharge
(photo: Agapie I., 2019)

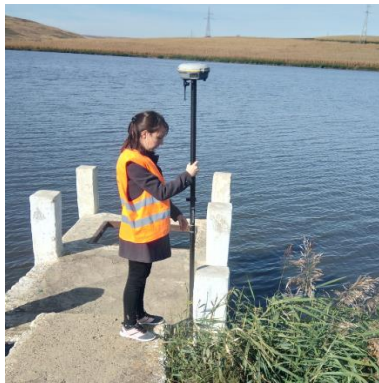
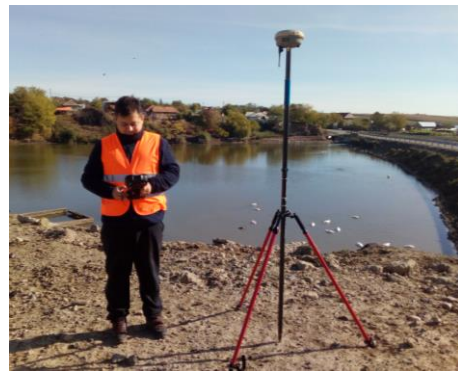
In 2019, a topographic survey was carried out to verify the elevations of the upstream and downstream slopes and the crest. Thus, 10 transversal profiles were made. In figure 7 the situation plan is represented for two profiles, one of which corresponds to the spillway C1. Compared to the last expertise performed in 2016, there is again an increase in elevations which indicates the realization of the consolidation works of the dam through increased height by about 40 cm.

To made the topographic plan, the geodetic measurements were performed using Trimble equipment. A Trimble R8S fixed receiver (figure 7.c) and a Trimble R8S mobile rover (figure 7.b) were used. The measurements were performed in real time, in RTK (Real Time Kinematic) mode having a horizontal and vertical positioning accuracy of 8 mm. This method of positioning in real time the coordinates of stationary points is called differential positioning (DGNSS). The situation plan was made in Stereo 70 projection, reference plan for elevation, Black Sea 1975.

Figure 7 Making the topographic study: a – situation plan in the area of the spillway C1; b – field measurements with the Trimble R8S mobile rover; c – Trimble R8S fixed receiver

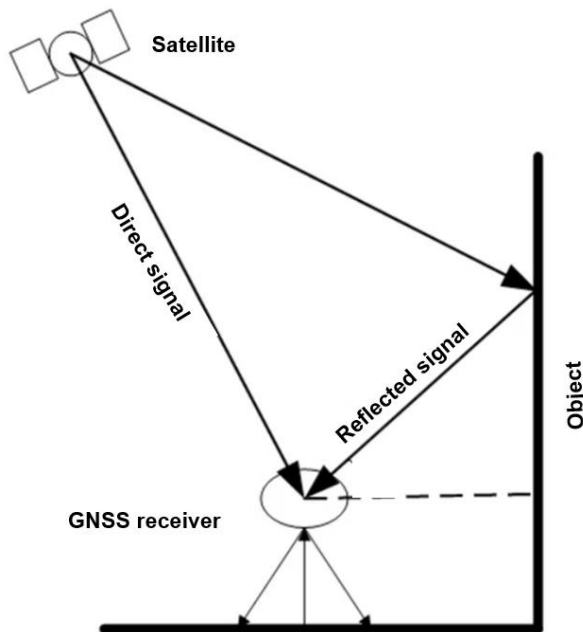
Multipath (figure 9) is a disturbance of the satellite signal resulting from the fact that the signal received by the GPS antenna includes both

the direct component and the signals reflected from walls, water surfaces etc.

Figure 9 Schematic representation of the multipath error in the process of performing measurements with GNSS technology (source: Dai W. *et al*, 2017)
