## STUDIES AND RESEARCH ON WATER LOSSES FROM IRRIGATION SYSTEMS

### Abstract

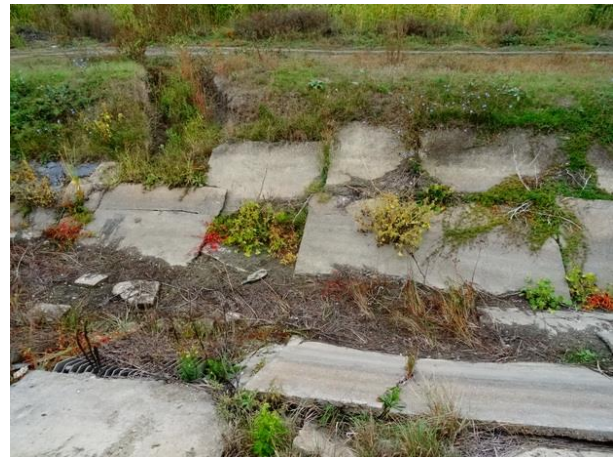
- water losses on the adduction channel network (AC and CD) of the pressurization stations (SPP) produced by the advanced state of degradation of the constructive structure: degradation of the joint between the concrete slabs; breaking and moving the tiles on the slope, washing the support layer of the tiles, compacting the slope from the ground, etc. (*figure 3*); the value of water losses is estimated at about 35% - 45% of the volume of water introduced into the canal;

**Figure 3 The state of degradation of the canals in the SPP Irrigation Plot 8 Oțetoaia with factors to increase water losses (Luca M., 2020)**

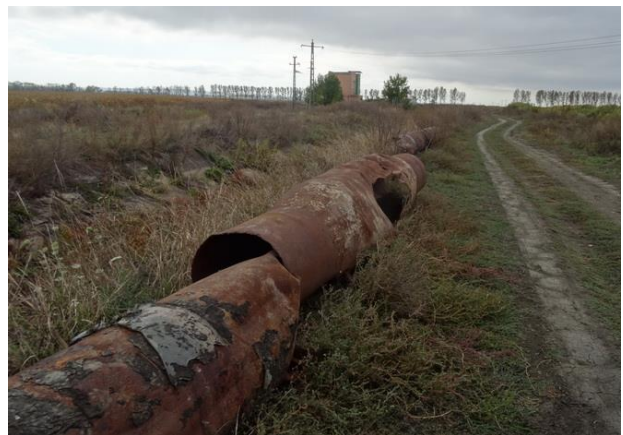
- water losses on the pipe network of the irrigation plot (main pipes - CP, secondary pipes - CS and tertiary pipes - A); the main pipes made of steel were degraded by chemical corrosion on some sections, a situation that caused large water losses (*figure 4*); the water losses evaluated on the main pipe are about 17 - 24% of the pumped flow, a situation that determined the replacement of the degraded sections.

**Figure 4 Degradation status of the main steel pipes in the SPP Irrigation Plot 8 Oțetoaia with water loss increase factors (Luca M., 2020)**

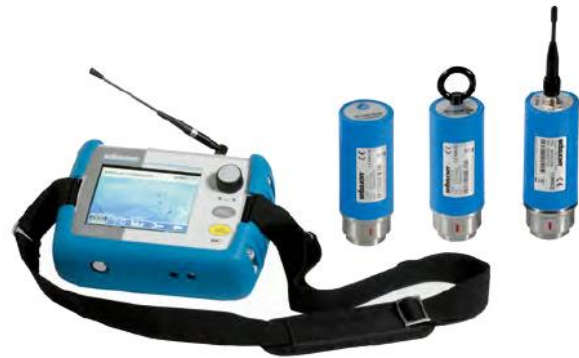
Water leaks from the pressure pipes cause vibrations in the pipe walls (*figure 5*). These vibrations can be recorded with the help of loggers. The equipment detects both the noise produced by the fault and the frequency. Based on these factors, the probability of a network fault can be determined, as well as its relative position in relation to other loggers mounted in the system (Chirica Ș., 2019).

Figure 5 Noise loggers for monitoring and acoustic detection of water leaks in pipes (Chirica Ș., 2019)

Loggers record the sounds produced on the network by the presence of water emission zones. The loggers are mounted on different areas of the inspected pipe sector. so that the result is not influenced by other noises. Depending on the values obtained, it is established whether detailed investigations are necessary or another area is inspected.

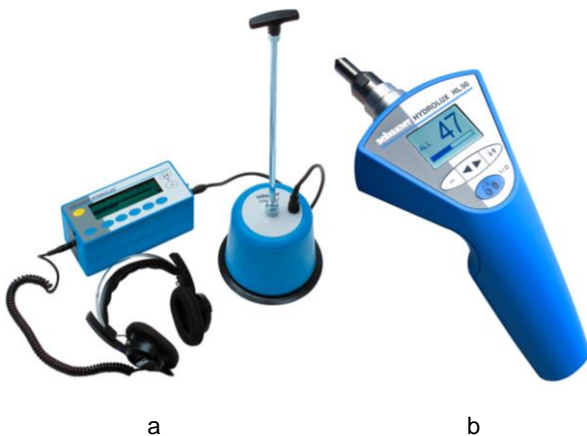
Ground microphones are mechanical or electronic equipment (figure 7). Microphones use sound amplification devices produced by vibrations caused by damage to pipes. The microphones have noise filtering devices so that the recorded results are relevant to the leak detection activity. The efficiency of the investigation method is largely based on the professional experience of the operator.

Figure 7. Ground microphones: a - equipment with digital signal processing technology; b - equipment with integrated sensor (Chirica Ș., 2019).

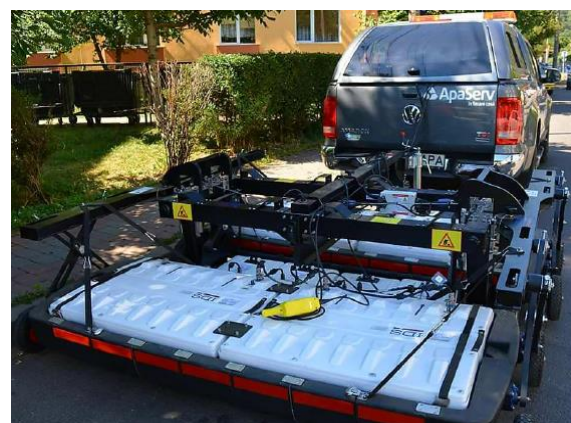
For the investigation of old pipelines and in the absence of initial situation plans, the "Georadar" can be used (figure 9).

Figure 9. Pipe detection equipment type Georadar

Georadar uses radio waves (electromagnetic waves) to investigate construction elements and underground installations. The technology has been adapted to locate water leaks in buried pipes and investigate the condition of underground

networks. Leaks are identified due to differences in the density of the land in which the pipes are embedded and its water content.

The penetration power of the equipment depends on the length of the radiation wave and the electrical permittivity of the rock in the site. The use of this technology requires knowledge of the geotechnical properties of the site and especially its electrical conductivity.
