DEGRADATION OF EARTH'S DAMS UNDER THE EFFECT OF CLIMATE CHANGE

Abstract

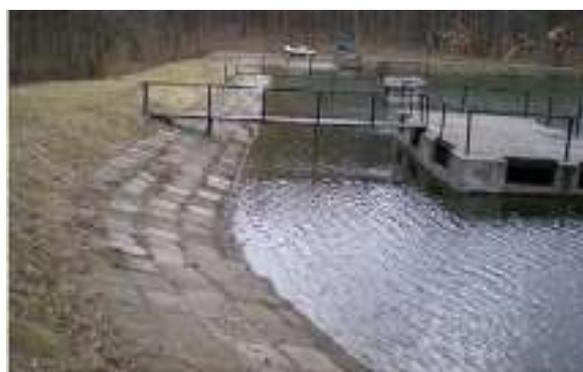
1. The Crujana hydrotechnical arrangement, located on the Pătrăuțeanca brook, falls into category C, importance class IV. It has a homogeneous earth dam, two bottom drains and a large water drain (figure 2) (ABA Siret, 2010).

Figure 2 Dam canopy overview - Crujana Dam, Suceava County (ABA Siret, 2010)

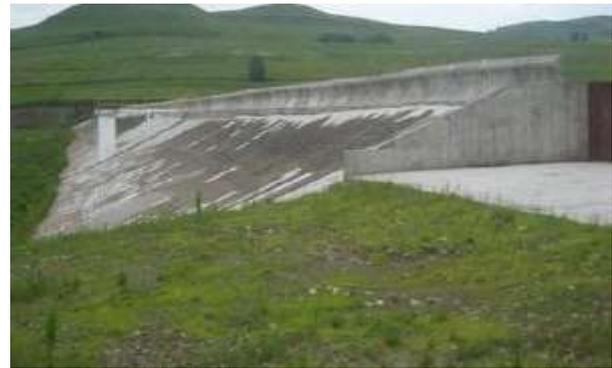
2. The Granicesti complex, Located on the Horait River, it is a permanent accumulation placed in the C importance category. It consists of a reservoir, a homogeneous dam, a bottom drain and a large water drain (figure 5) (ANIF, 2008). It was affected by floods in 2005, which caused significant damage to the structure. The dam was rehabilitated in 2006. The massive floods of 2008 reactivated the landslides in the Grănicești dam area.

Figure 5 Grănicești Dam, Suceava County, 2008 - general view (ANIF, 2008)

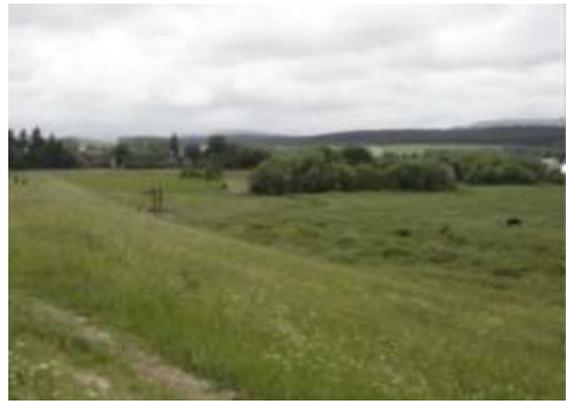
Figure 9 Non-permanent accumulation Horodnic 1, Suceava County, (CTM, 2010)

Following the measurements for the reconstitution of the flow during the flood period, it was found that dam no. 1 has a settlement of approx. 1.0 m. During the flood, the dam was discharged over a width of approx. 300 m and the water blade had in the central area approx. 0.80 m. Dam no. 2 was discharged on approx. 100 m and the water blade had a height in the central area of approx. 0.50 m. The flow that discharged dam no. 1 was 82 m³/s, and at dam no. 2 the discharged flow was 30 m³/s. In 2006, an expertise was carried out which recommended works to raise the dams by 0.50 m, but these works were not executed.
