RESEARCHES ON THE MODERNIZATION OF THE CONDUCT NETWORK FROM OLD PRESSURE IRRIGATION SYSTEMS

Alexandru-Lucian LUCA¹, Ilie LOGIGAN², Mihail LUCA², Fabian TĂMĂȘANU¹

Abstract

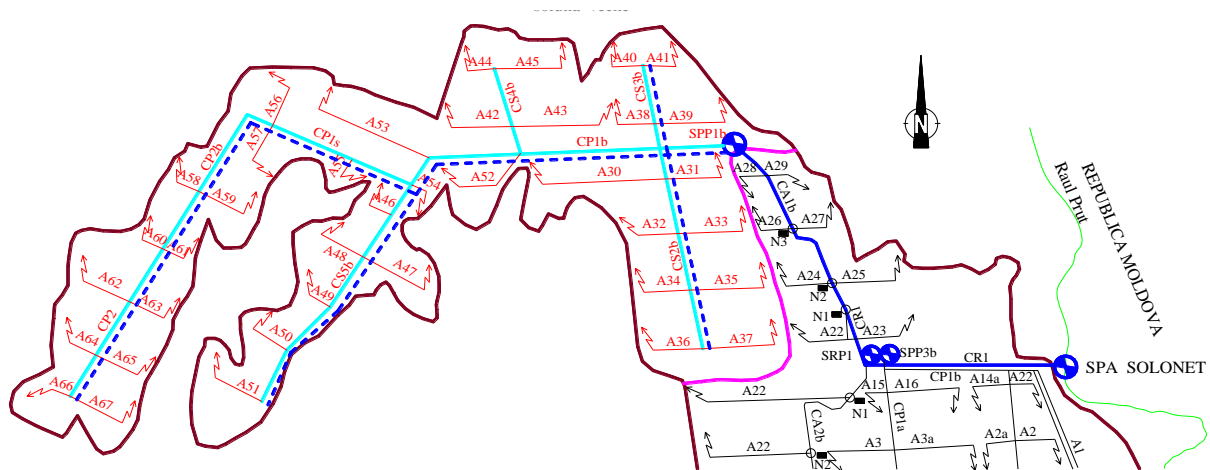
The analysis carried out in the Irrigation Plot SPP1b Soloneț revealed that the pipeline network is in branched form (*figure 3*) and has the following components (Luca, 2012):

Figure 3 **Initial plot of irrigation plot SPP1b South Solonet: continuous line - main / secondary high pressure pipelines; interrupted line - main / secondary medium pressure pipes** (Luca, 2015)

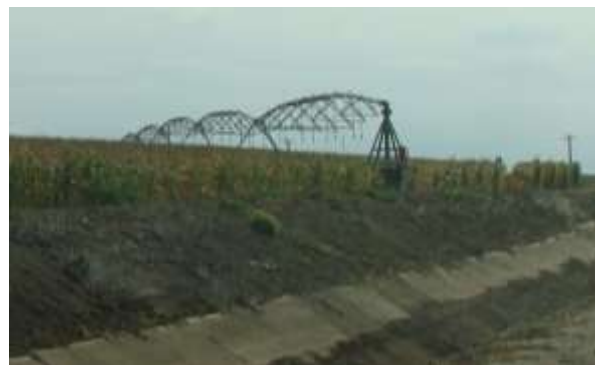
Figure 5 Pivot type watering system in the "SPP1b South Solonet" pressure irrigation plot (Luca, 2015)

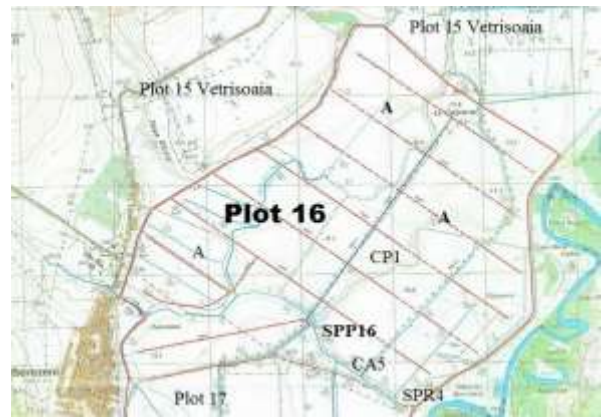
The analysis carried out at "Plot 16 Berezeni" from the Albița - Fălciu Complex Irrigation and Drainage System (figure 6) revealed the totally unsatisfactory state of the constructive structure of the pipeline network under pressure (Luca M., 2015).

Figure 6 **Layout scheme of the of the pressure irrigation plot „Plot 16 Berezeni”** (Luca, 2015)
