## OPERATING BEHAVIOR OF THE IRRIGATION SYSTEM UNDER OUAI "AQUA" NORTH SOLONEȚ BIVOLARI

**Key words:** rehabilitation of irrigation system, increase production, maize cultivation

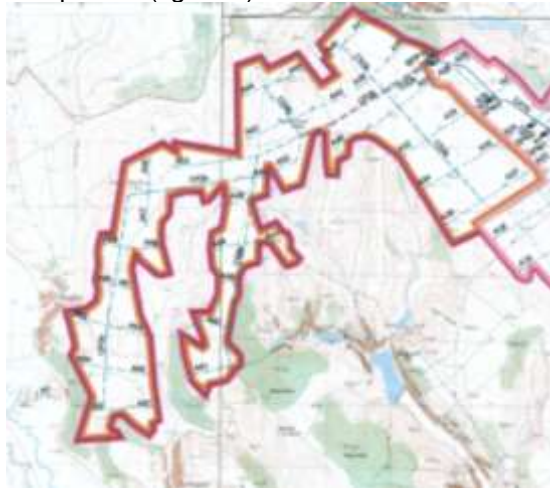
Figure 1 OUI „AQUA” North Soloneț-Bivolari

The study and research material is represented by the irrigation systems within OUI „AQUA” North Soloneț-Bivolari, which carries out its activity on an area of 1428 hectares, in Iasi County. Pumping station serving these lands - Pumping and pressurization station SPP 1.b. - is part of the Tabăra-Trifești-Sculeni Irrigation Development. (*figure 1*)
