TECHNICAL SOLUTIONS REGARDING THE REHABILITATION OF THE IRRIGATION SYSTEM UNDER THE OUI "AQUA" NORTH SOLONEȚ BIVOLARI

Adriana Mihaela TOTOLEA (HUȚANU)¹, Ionuț Bogdan TOTOLEA¹, Daniel BUCUR¹

Abstract

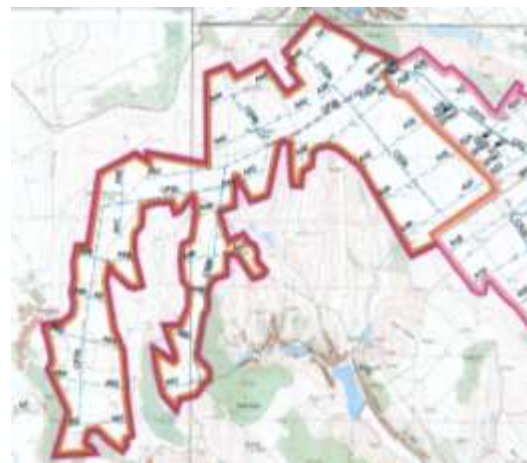
Figure 1 OUI „AQUA” North Soloneț-Bivolari

The study and research material is represented by irrigation systems within OUI „AQUA” North Soloneț-Bivolari, which operate on a surface of 1428 hectares, in Iași county. Pumping station serving these lands - Pumping and pressurization station SPP 1.b. - is part of the Tabăra-Trifești-Sculeni Irrigation Development. (figure 1) The irrigation system is supplied with water taken from the Prut river and pumped with the SPA Soloneț supply station through the CR 1.b pipe to the SRP1 pumping station.

From here the water is pumped back through the discharge pipe CR 2.b then transported through the open supply channel with trapezoidal section Ca 1.b to the pumping and pressurizing station SPP 1.b. The entire arrangement is located in the Prut meadow.
