THE IMPACT OF INDUSTRIAL WASTE DUMPS ON THE ENVIRONMENT IN THE AREA OF MOLDOVA

LUCA M.^{1*}, TOMA D.¹, MARCOIE N.¹, DOMINTE (CROITORU) Violeta

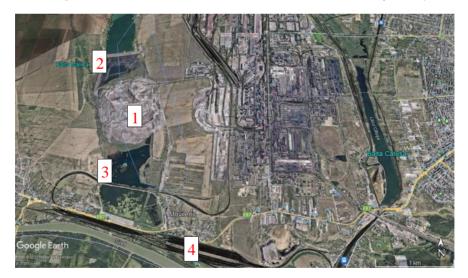
The industrial waste landfill (fig. 1) is located in the western part of the steel plant and borders with Mălinei Pool to the north, west and south, and to the east of the exploitation road of Şendreni commune City Hall. The location of the dump starts from the elevation of 10.00 m on a plateau located between the Cătuşa and Mălina valleys and on the agricultural lands of Smârdan and Movileni localities, Galați county.

Fig. 1 General view of the slag dump and Balta Mălina, year 2021 (image Google earth): 1 - slag dump; 2 - Balta Mălina nord; 3 - Balta Mălina sud; 4 - the Siret river.

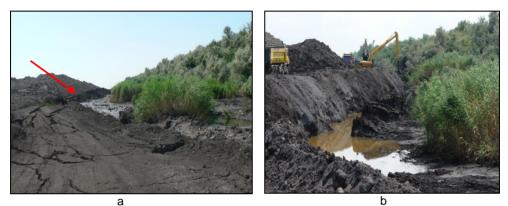
The extraction method is defective, uncontrolled and influences the geometry and stability of the dump. The repeated collapse of the deposition fronts led to the production of flood waves in the Mălina North Technological Pond. Also, the collapse of a slope of the dump led to the dam of the Mălina Creek bed (fig. 3), a situation that caused floods in the riparian area (Bălan, 2010). The floods disrupted the operation of technological ponds through discharges between treatment plants.

Fig. 3 Phenomena of slag heap collapse in Mălina Creek: a - riverbed blockage; b - works to restore the riverbed (Bălan, 2010).

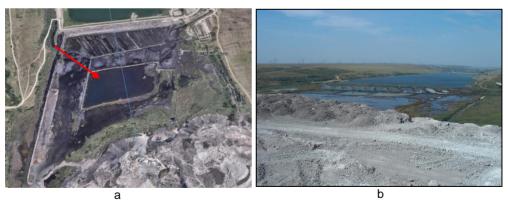
Fig. 4 Lake Mălina North with the location of the wastewater treatment ponds: a - general view (image Google earth, 2021); b - general view, year 2008 (Bălan, 2010).

From the field studies (Luca and Bălan, 2008) it was found a state of intense pollution of Lake Mălina North in the area of the treatment ponds, but also of the Mălina stream downstream of the ponds (fig. 4).

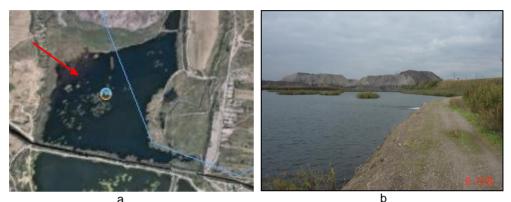
In the southern part of the dump is the Mălina South tailings pond. Through it, the industrial wastewater collected from the perimeter of the steel complex is discharged into Lake Mălina. The Mălina South technological pond (fig. 5) has several compartments separated by earth dams and slag. The functions of the pond are to decant and accumulate the suspensions from the wastewater discharged through the collectors C8 and C - sludge furnaces. By unclogging the pond by dredging the sludge is recovered, which is introduced in the steel technological process.

Fig. 5 Mălina Sud pond with the location of wastewater treatment ponds: a - general view (image Google earth, 2021); b - general view, year 2008 (Bălan, 2010).
